Study of Residential Attic Fire Mitigation Tactics and Exterior Fire Spread Hazards on Fire Fighter Safety

UL Firefighter Safety Research Institute

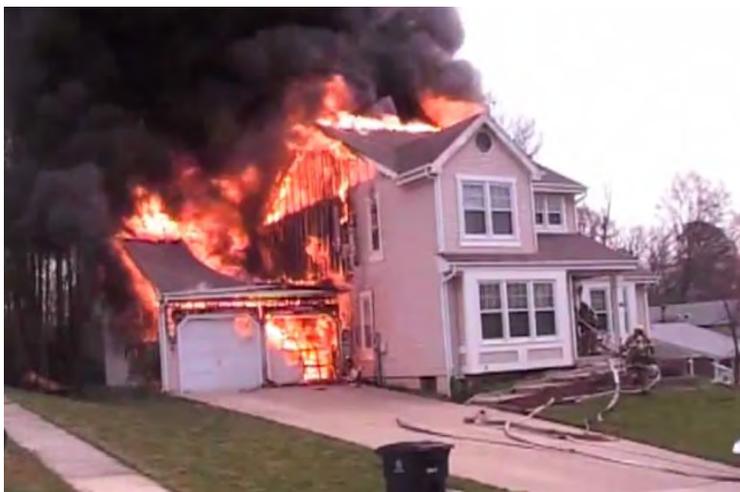
Figure 1. 1: A fire that started in the garage spread up the exterior of the home and into the attic.

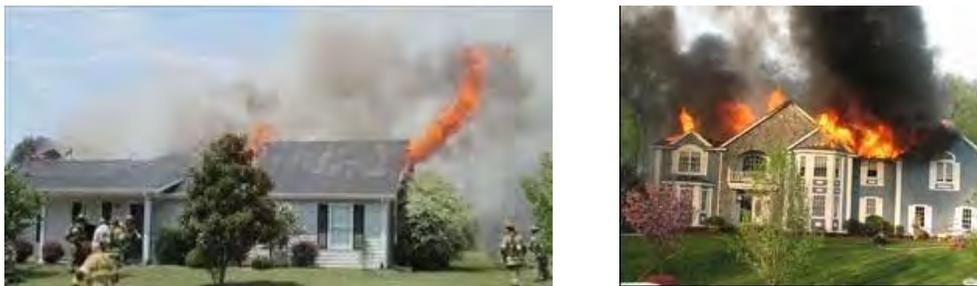
Figure 1. 3: Attic fires with older (left) and newer (right) attic construction

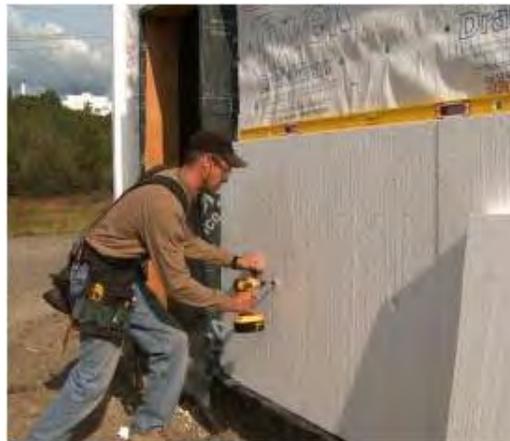
Figure 1. 4: Rigid foam insulation applied to an exterior wall

stucco on the exterior of the structures walls. Construction practices evolved and vinyl siding was introduced over a wood sheathing with a vapor barrier. Today, it is common to find vinyl siding over a rigid foam sheathing to increase energy efficiency in homes. Residential construction allows architects to use expanded polystyrene and polyisocyanurate foam core sheathings in their designs¹⁸. The 2012 International Energy Conservation Code wall insulation requirements have become more stringent in several climate zones. For the first time, builders in some climate zones will be required to install exterior rigid foam insulation (or to use some other comparable wall insulation strategy)¹⁹. For example, in Northern Illinois exterior walls are required to have an insulative value of R20 or R13 cavity insulative value with an additional R5 continuous insulation provided by the foam sheathing (because the foam sheathing is continuous over the studs it is equivalent to R20). To accomplish this the exterior walls are constructed with nominal 2 by 6's and filled with insulation, which achieves a R18 insulative value. In order to get to R20 equivalent a layer of rigid foam would be added.

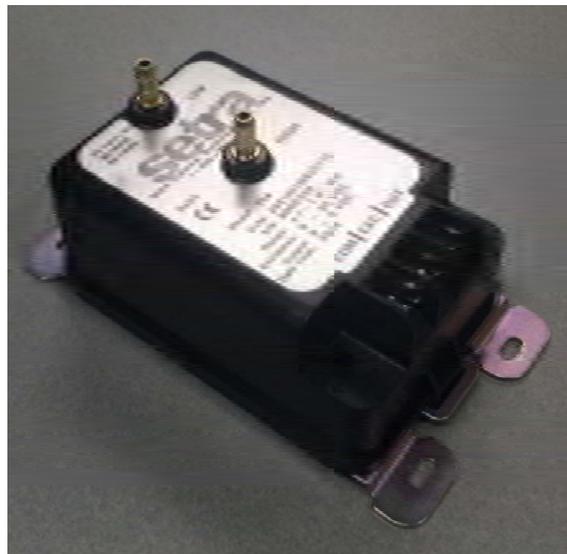
Pressure was recorded through the use of a Setra Model 264 differential pressure transducer with a range of $\pm 0.5''$ Wc (± 124.5 Pa) (Figure 5. 3). The transducer was used to evaluate the pressure difference from ambient. The uncertainty given by the manufacture is $\pm 1\%$ or ± 1.2 Pa.⁴³

Figure 5. 3: Setra Model 264 Differential Pressure Transducer.

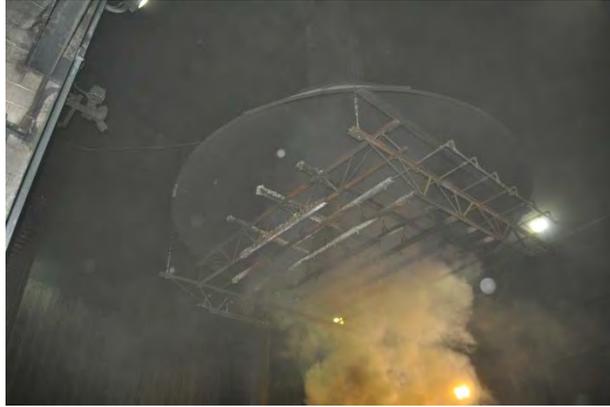
The heat release rate is measured through the use of oxygen consumption techniques. The oxygen consumption calorimeter is capable of accurately measuring the heat release rate up to 10 MW. Above 10 MW, larger inaccuracies are expected due to the combustion products overflowing the collection hood. Figure 5. 5 shows the collection hood utilized for the calorimetry data.

Figure 5. 5: Calorimetry Hood

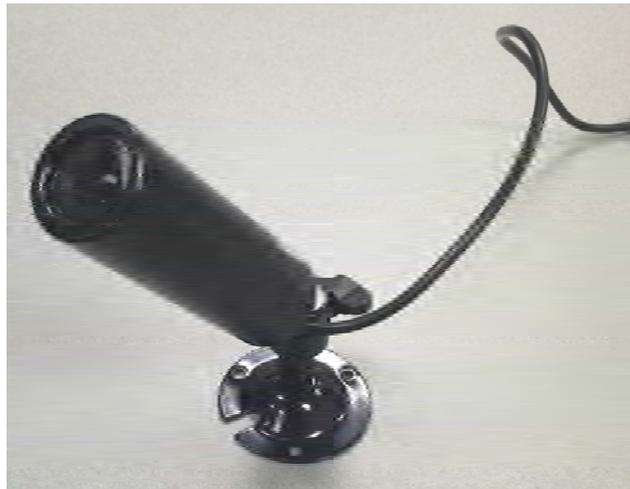
Stand video was obtained through the use of Marshall Electronics V-1255-B-BNC and Bosch VTC-206F03-4 video cameras (Figure 5. 6). Thermal imaging of the front and rear of the structure was taken using ISG Infrasy Elite XR (Figure 5. 7). The thermal imaging camera has a fixed emissivity value of 0.9 and was utilized for visual representation of relative conditions, no temperature measurements or analysis were derived using the camera. All cameras were recorded using a TriCaster 8200 video acquisition system.

Figure 5. 6: Bosh VTC-206F03-4 B&C Video Camera

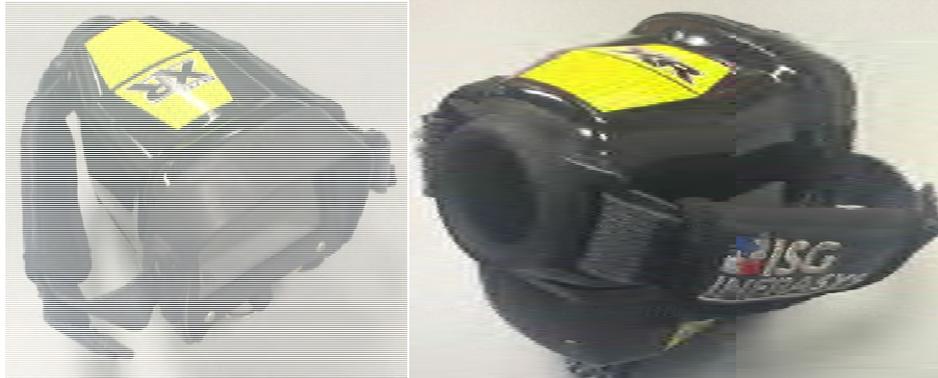
Figure 5. 7: ISG Elite XR Fire Service Thermal Imaging Camera

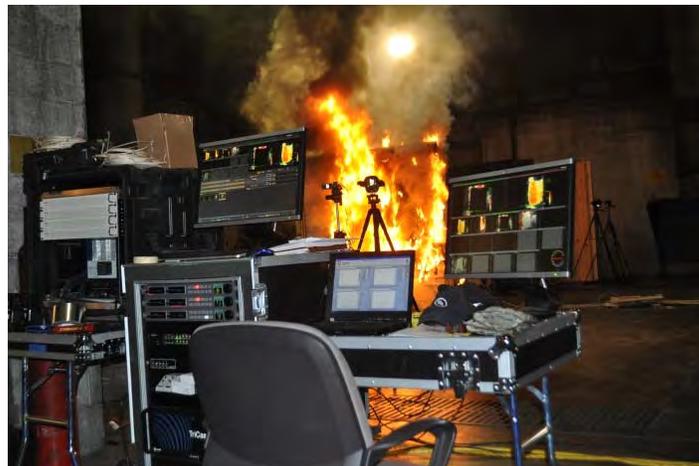
All data was logged through the use of a national instruments data acquisition system incorporating a SCXI-1001 chassis with 8 SCXI-1102C 32-Channel modules (Figure 5. 8). The system is configured for a total of 256 channels capable of reading values between 0-10 volts DC. Values are recorded once a second and translated to quantities of interest through the use of LabVIEW software specifically programmed for use with the system.

Figure 5. 8. Data acquisition and video systems

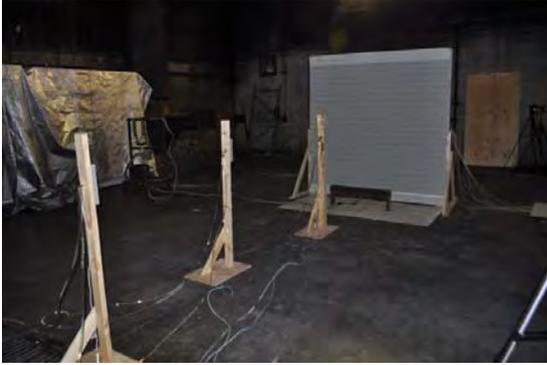
Figure 6. 1: Exposed Side of Wall

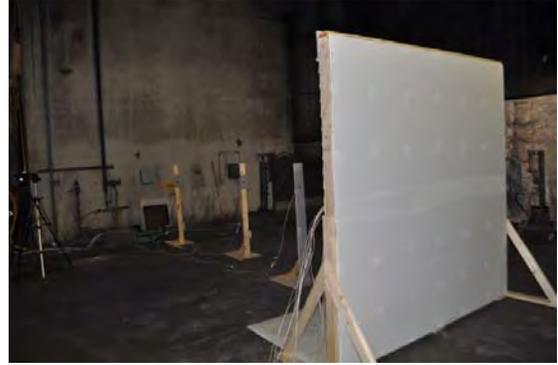
Figure 6. 2. Unexposed side of wall

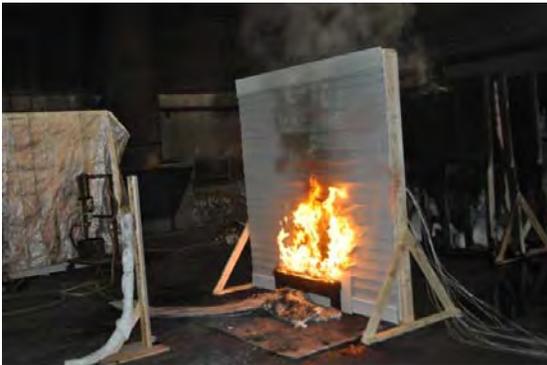
Figure 6. 3. 100 kW fire from 36 in. line burner

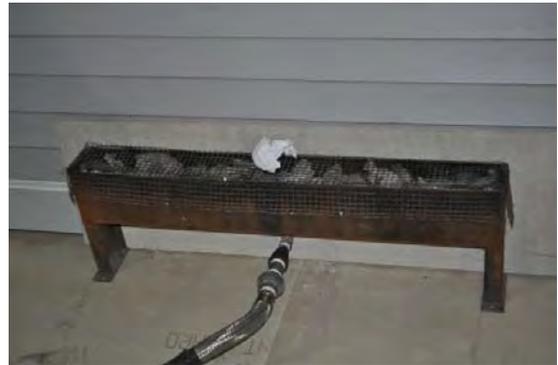
Figure 6. 4. Line burner

For most of the experiments, the heat source was a line burner with dimensions 39 in. wide, 4 in. thick, and 16 in. high. A picture of the natural gas flow controller and burner can be seen in Figure 4.12 and Figure 4.13, respectively. The burner operated at 50 kW, 100 kW, 150 kW, 200 kW, and 300 kW. The actual heat release rate of the burner fell within $\pm 10\%$ of the targeted heat release rate. This was determined by examining the actual data in the early stages of the experiment before the wall became involved. For Experiments 15 and 16, a Nexgrill 720-0783C propane gas grill was located 1 in. off the wall and used as the heat source. For Experiments 23 and 24, a 1 ft. by 1 ft. sand burner operated at a heat release rate of 25 kW, with the fuel flow rate to the burner controlled by the natural gas flow controller. The uncertainty of the sand burner heat release rate was determined by examining the heat release rate in the early stages of the experiment before the wall became involved and was determined to be $\pm 20\%$ of the targeted heat release rate.

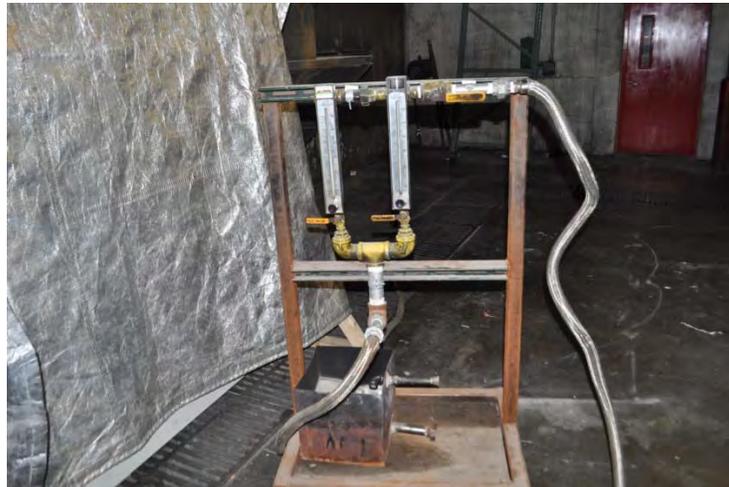
Figure 6. 5: Picture of Natural Gas Flow Controller

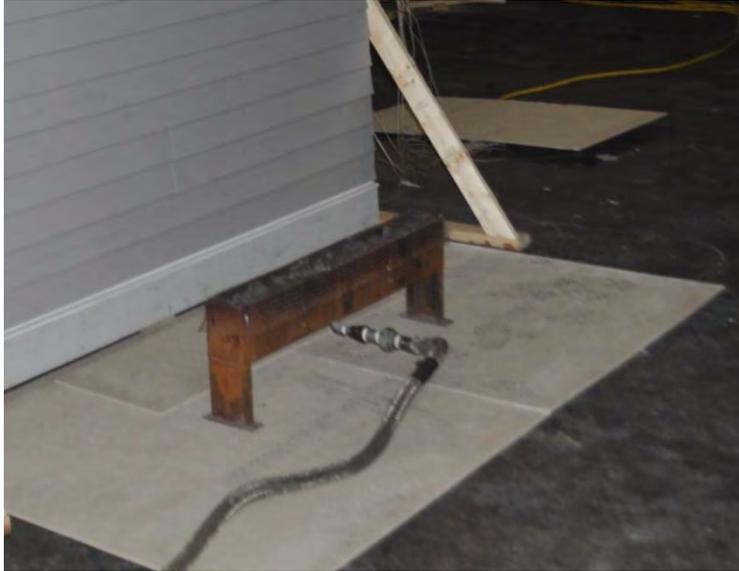
Figure 6. 6: Picture of Line Burner

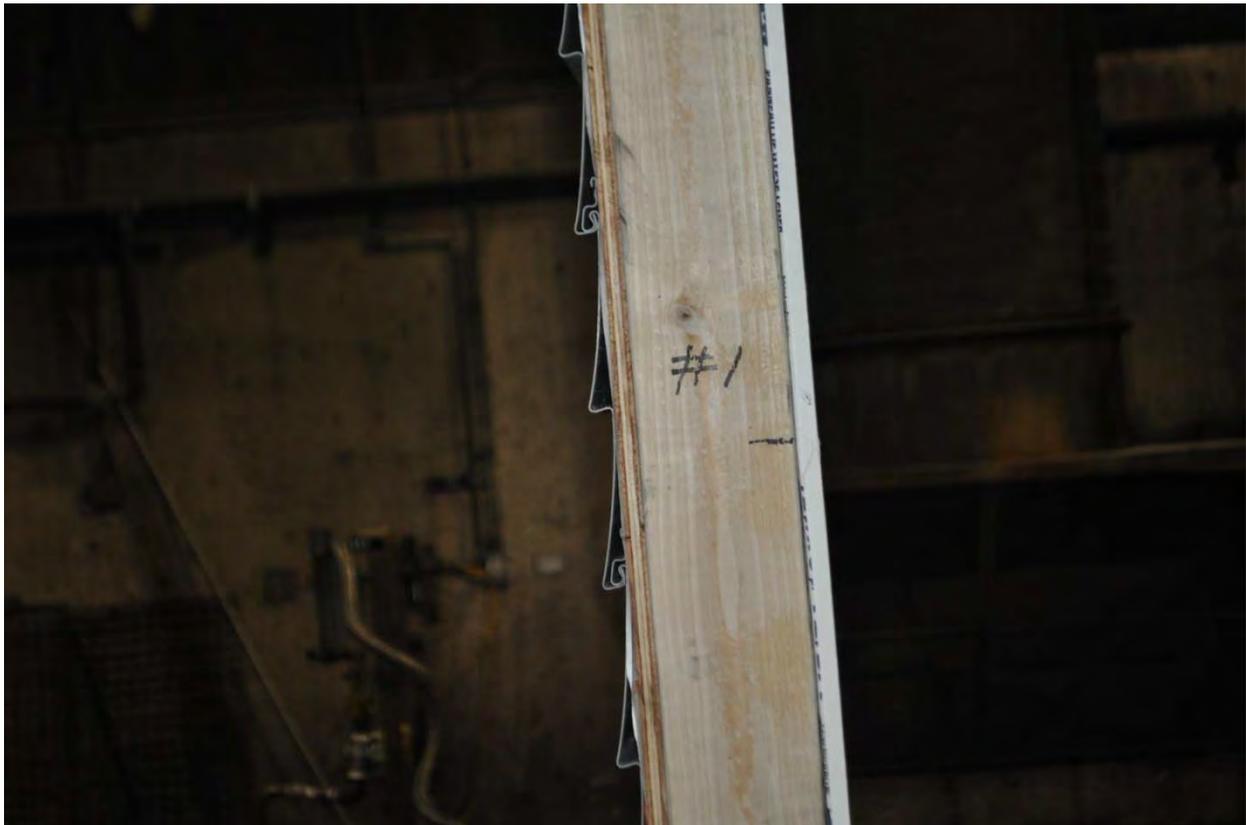
Wall Type	Siding	Additional Material	Sheathing	Insulation	Back Wall
Wall 1	Double 4" Vinyl Siding	Weather-Resistant Barrier	1/2" Plywood Sheathing	2x4, R-13 KFI w/ IVB*	1/2" Gypsum Board

Figure 6. 8: Wall Type 1 Side View

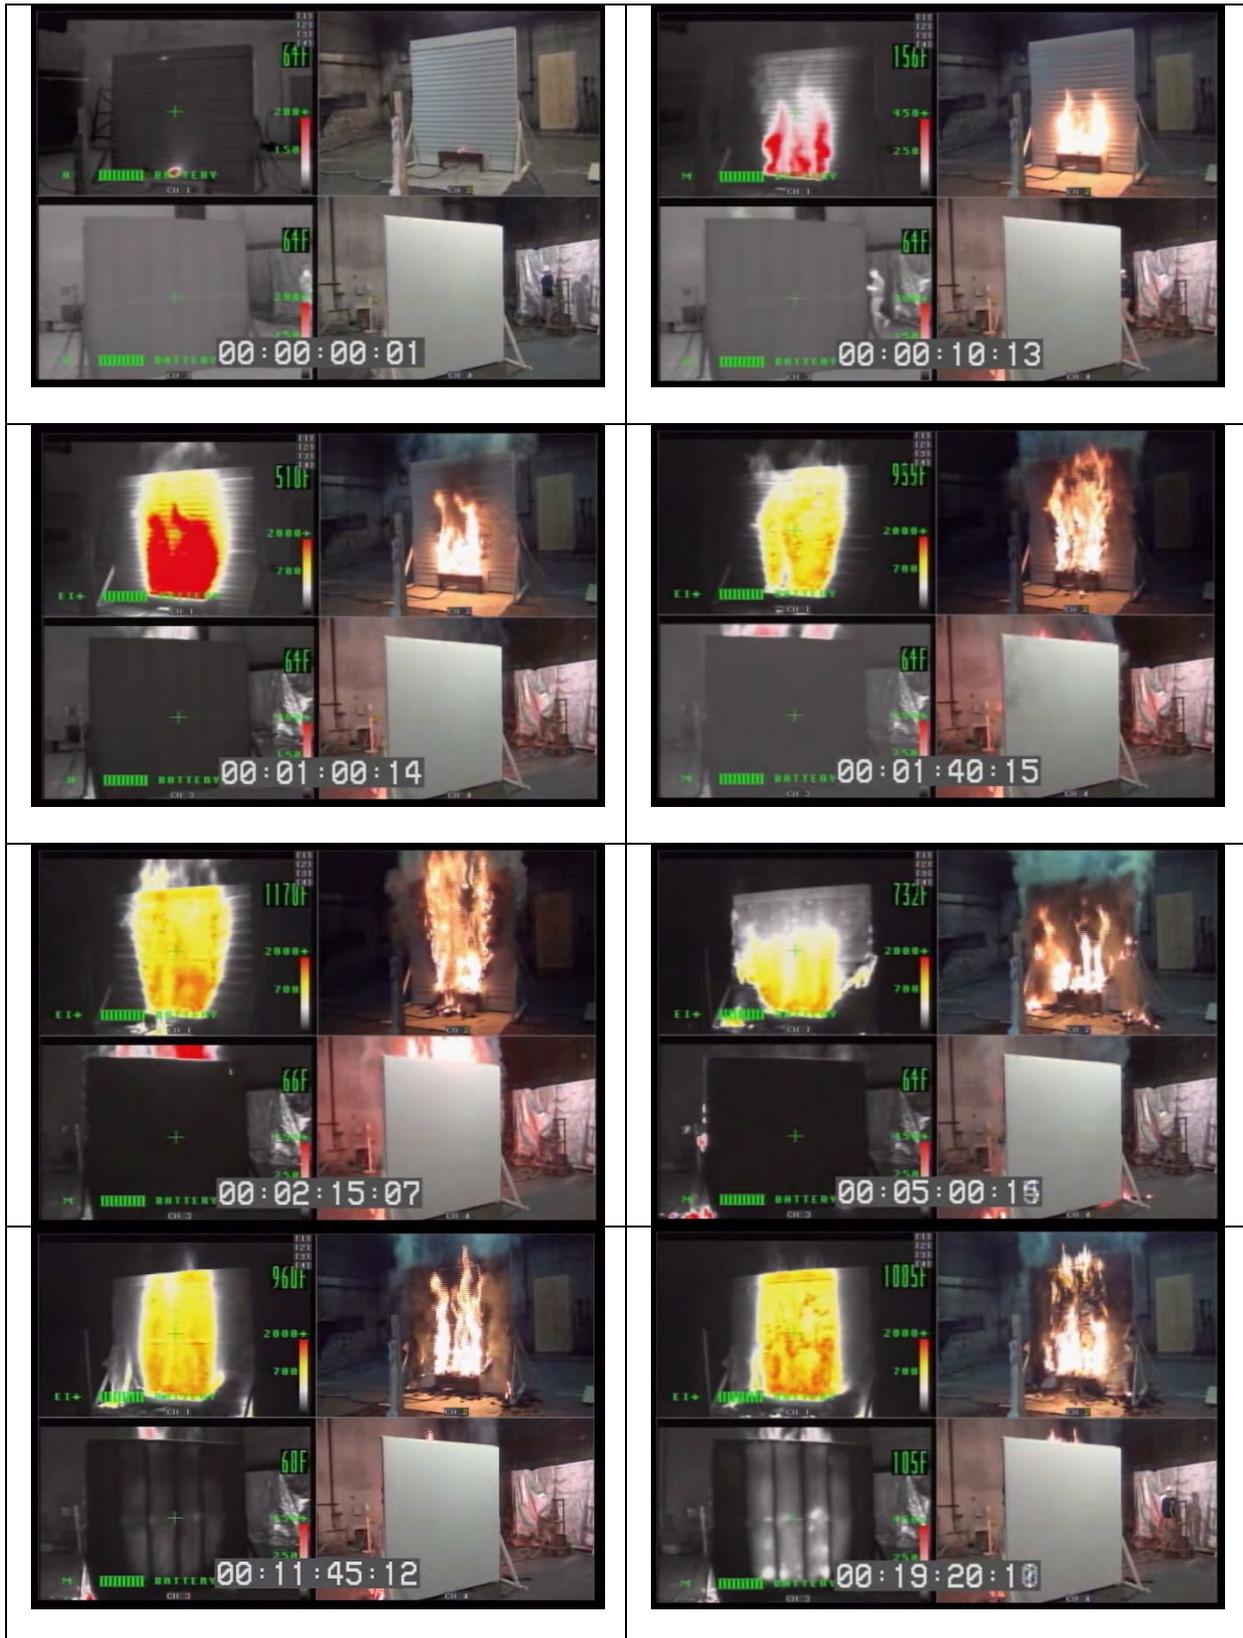
Table 6. 3: Experiment 1 Pictures (Timeline starts at ignition [hr:min:sec:frames])

Time (mm:ss)	Description
00:00	Experiment begins
00:10	Burner reaches 150 kW
01:00	Vinyl Siding is melting and burning, flames are beginning to spread up the wall
01:40	Flames have reached the top of the wall
02:15	Flames have extended above the wall, the fire is beginning to spread horizontally along the wall
05:00	Most the vinyl siding has burned or fallen off the wall, smaller pieces of still burning vinyl siding can be seen on the ground in front of the wall
11:45	Insulation and the studs get involved in the fire
19:20	Shows the fire just before the burner is turned off
19:35	The burner is turned off, there is still a small amount of fire near the bottom of the wall by the burner and near the top of the wall
31:10	Most of the fire has self-extinguished, end of experiment

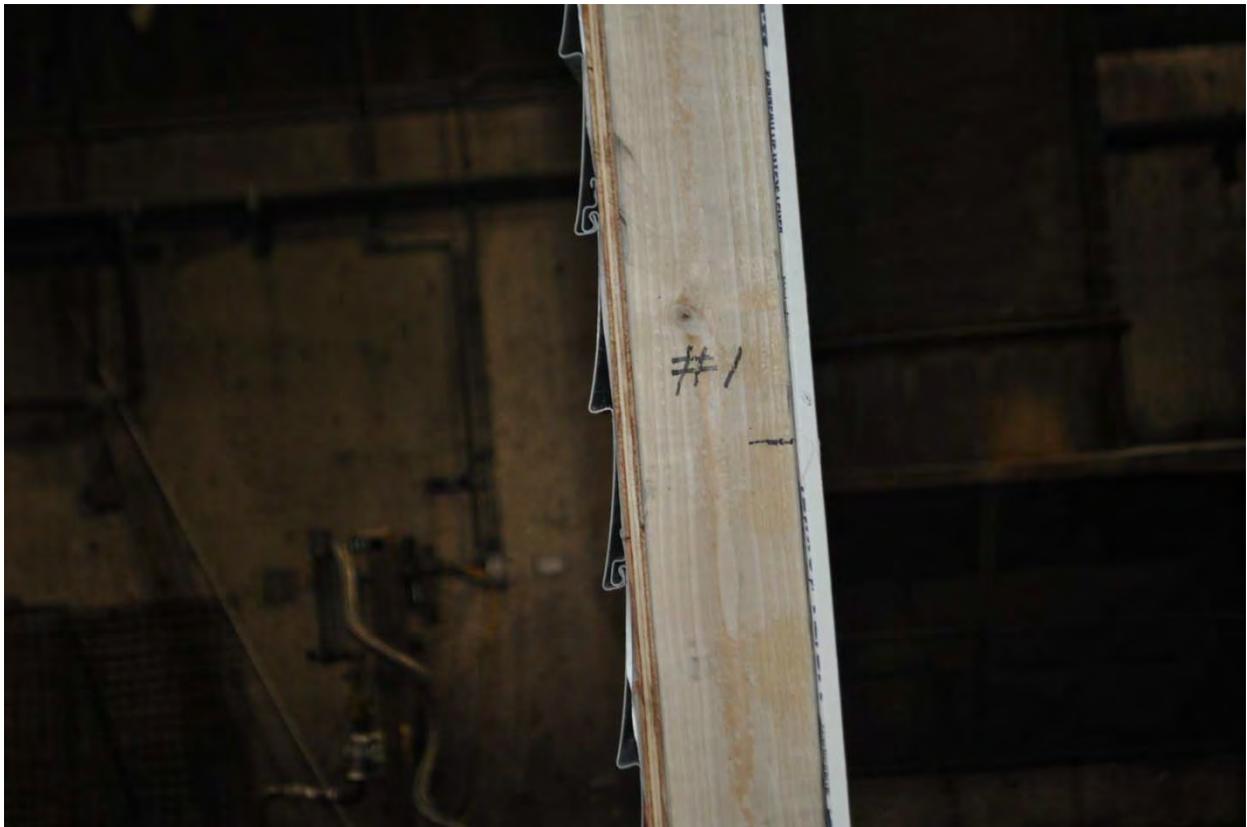
Wall Type	Siding	Additional Material	Sheathing	Insulation	Back Wall
Wall 1	Double 4" Vinyl Siding	Weather-Resistant Barrier	1/2" Plywood Sheathing	2x4, R-13 KFI w/ IVB	1/2" Gypsum Board

Figure 6. 9: Wall Type 1 Side View

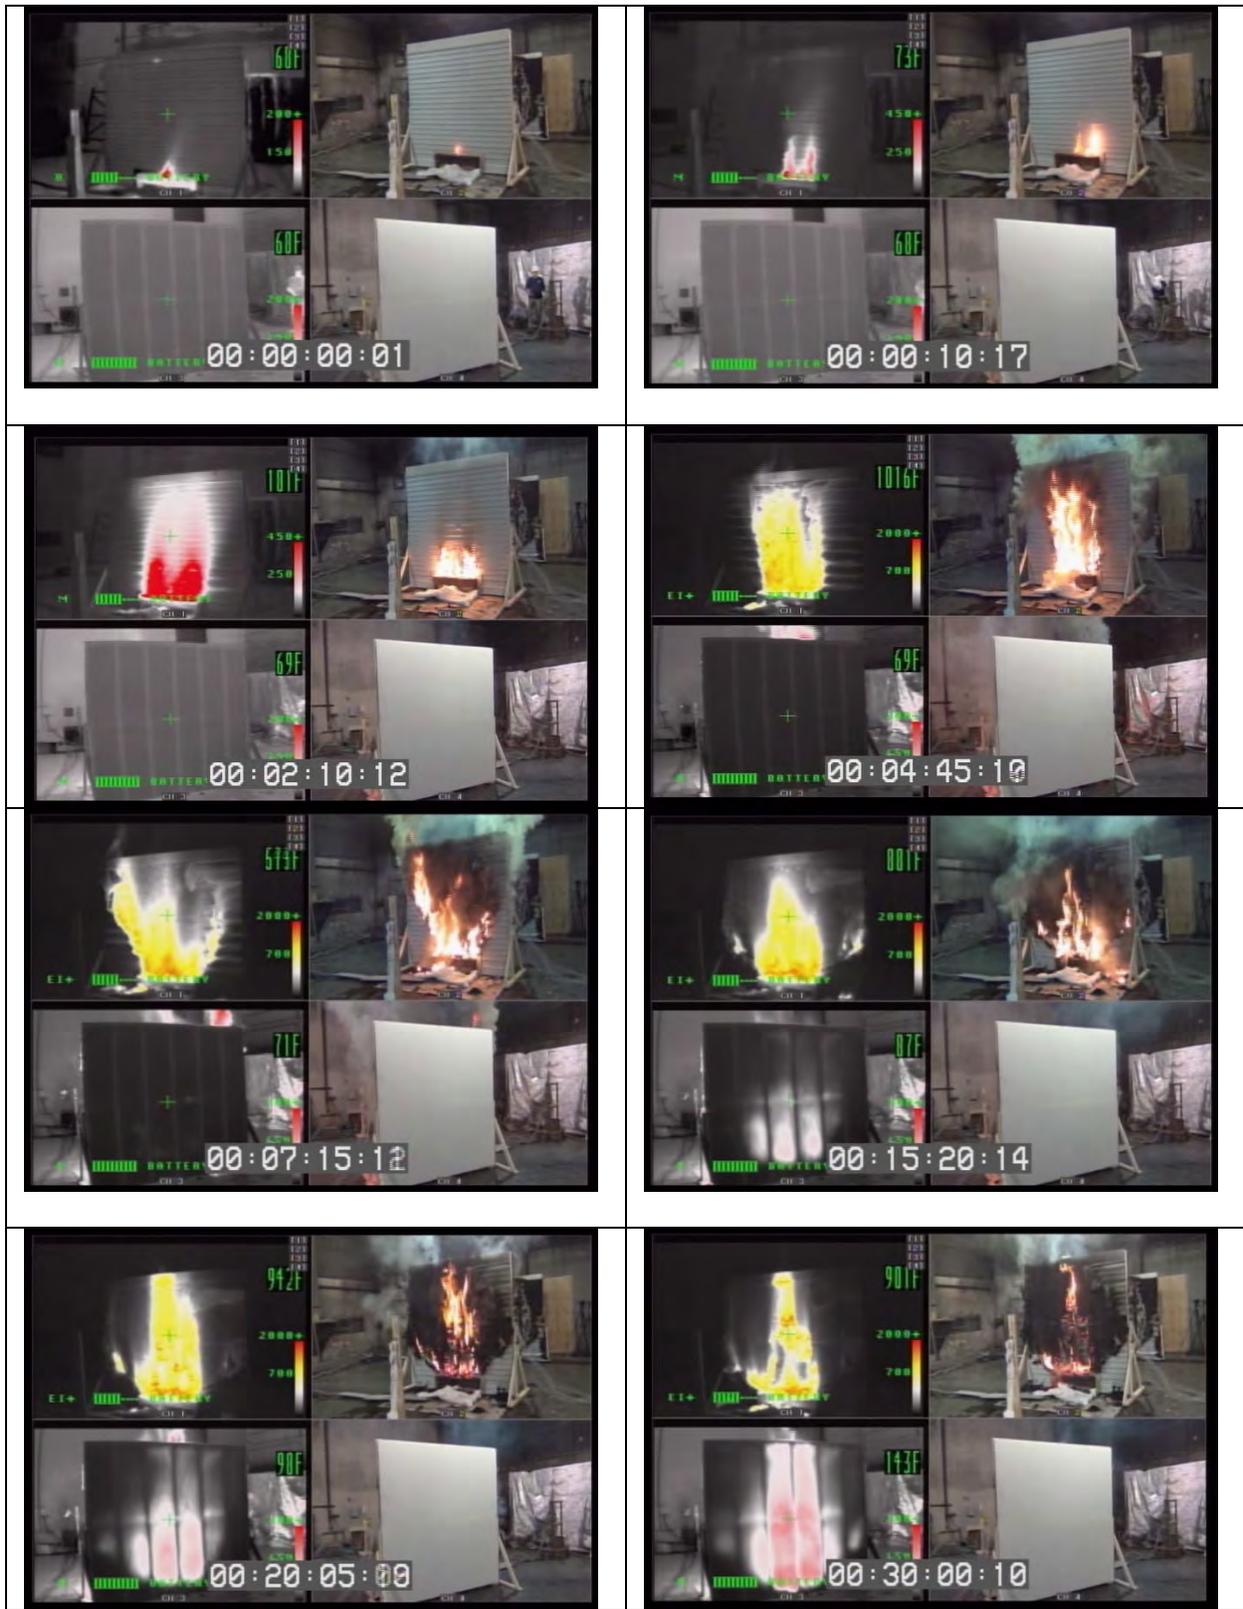
Table 6. 6: Experiment 2 Pictures

Time (mm:ss)	Description
00:00	Experiment pre-ignition
00:10	Burner is on and reaching desired 50 kW heat release rate
02:10	Vinyl siding is beginning to melt and burn, flames are spreading up the wall
04:45	The vinyl siding at the top of the wall has melted and fallen to the sides, flames have almost reached the top of the wall
07:15	Large portion of the vinyl siding has melted and burned away, the flames have reached the top corners of the wall
15:20	Small amount of burning extending up the insulation and studs
20:05	The burner is turned off, fire remains in the center of the wall
30:00	Still some flame near the top of the wall but most the fire has self-extinguished, the experiment ended

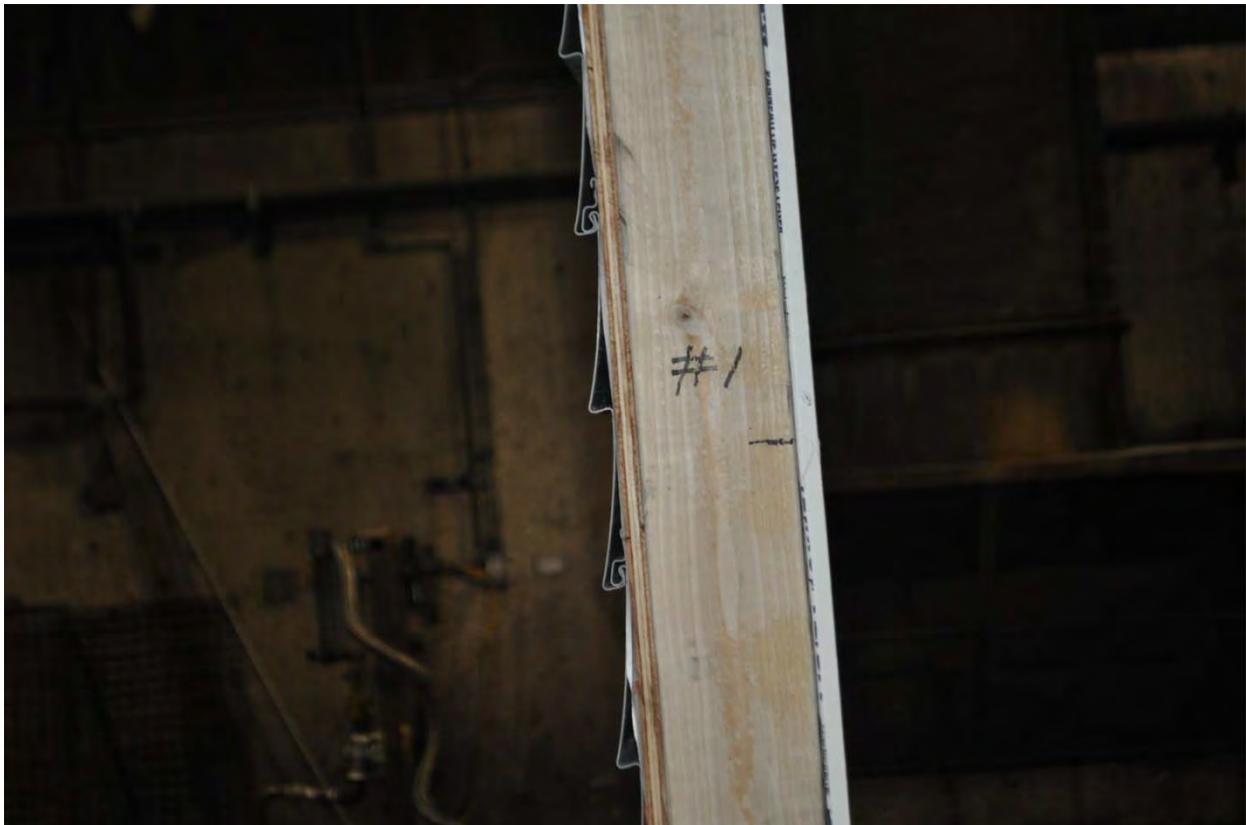
Figure 6. 10: Wall Type 1 Side View

The layout of the wall and materials used for each layer of the wall are specified in Table 6. 8. A side view of the wall is shown in Figure 6. 10. The burner heat release rate (HRR) was 100 kW for Experiment 3 while the burner was on. Photos from Experiment 3 are displayed in Table 6. 9. A timeline of the events within Experiment 3, matching with the photos in Table 6. 9, is shown in Table 6. 10. Heat release rate data, heat flux data, and temperature data from Experiment 3 are shown in appendix G, figures G.13-G18.

Wall Type	Siding	Additional Material	Sheathing	Insulation	Back Wall
Wall 1	Double 4" Vinyl Siding	Weather-Resistant Barrier	1/2" Plywood Sheathing	2x4, R-13 KFI w/ IVB	1/2" Gypsum Board

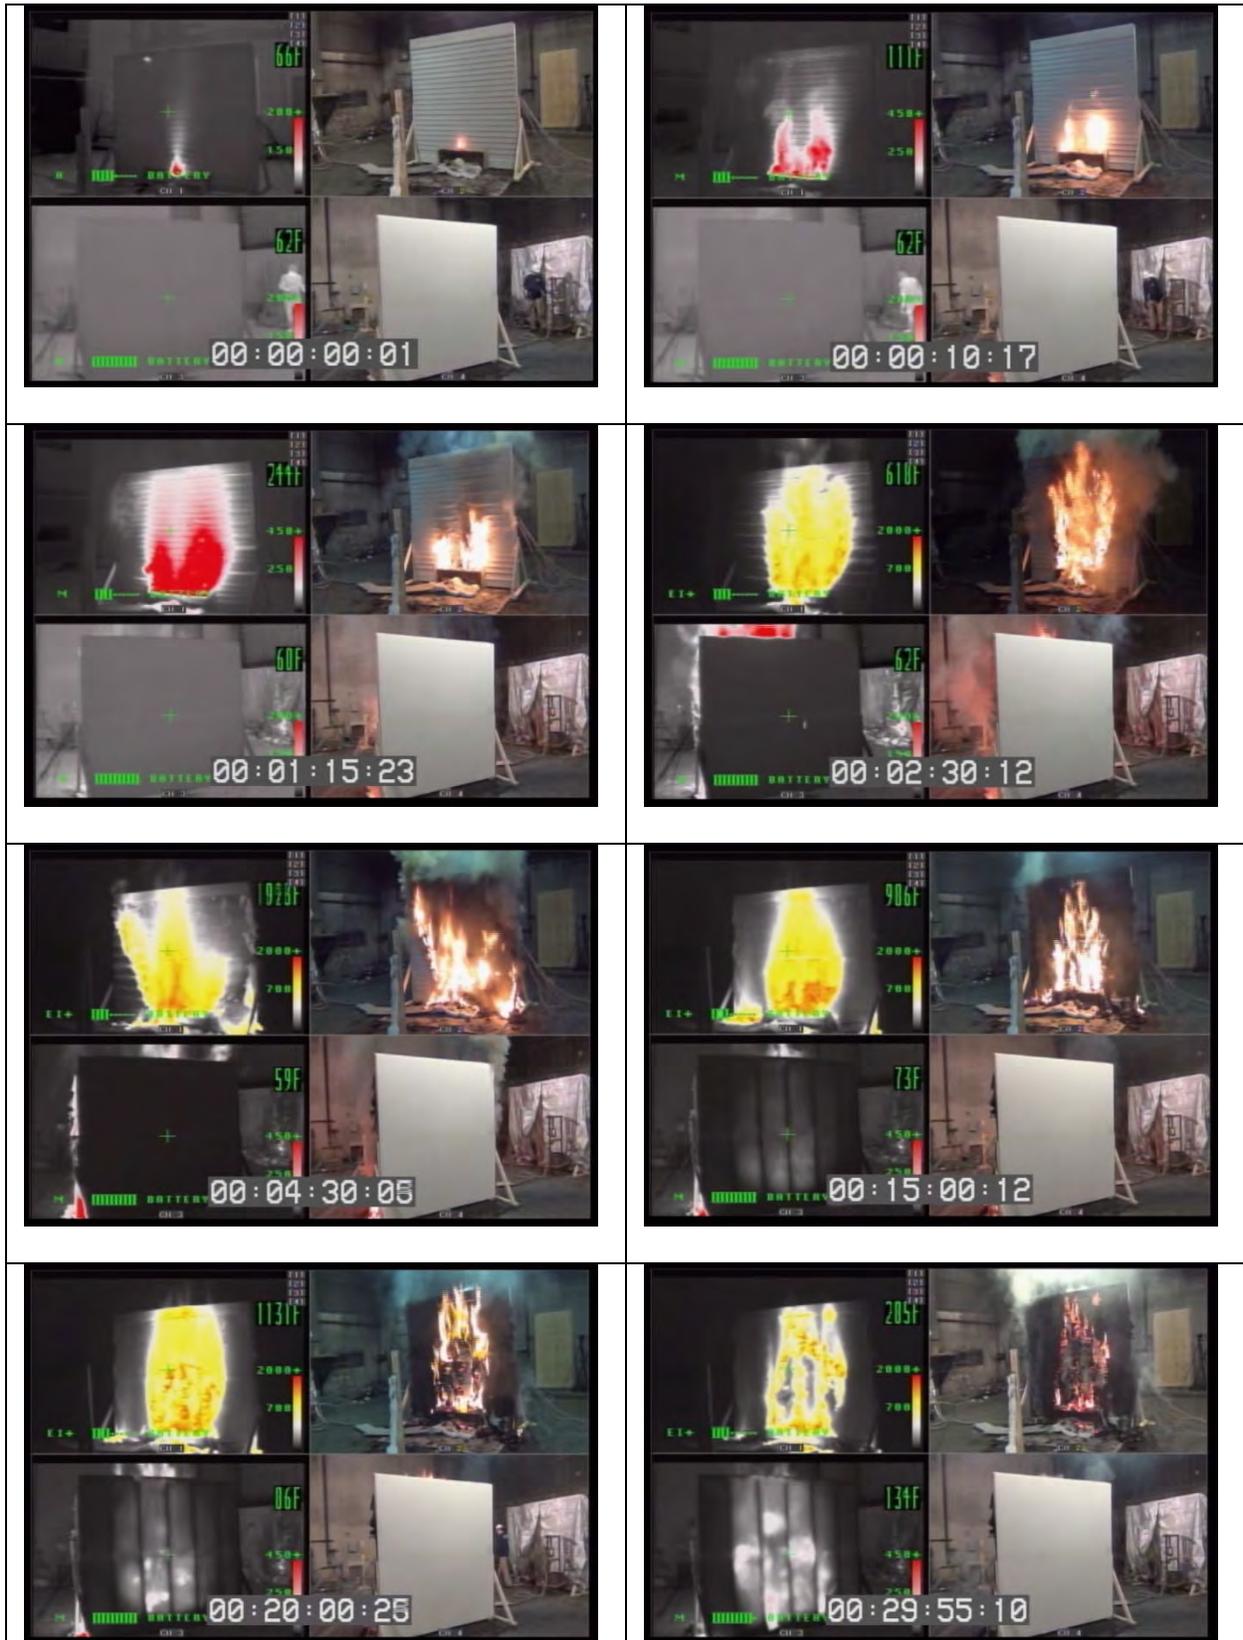
Table 6. 9: Experiment 3 Pictures

Time (mm:ss)	Description
00:00	Experiment pre-ignition
00:10	Burner is on and reaching desired 100 kW heat release rate
01:15	Vinyl siding begins to melt and burn, flames are spreading up the wall
02:30	Flames have reached the top of the wall
04:30	Most of the vinyl siding has fallen off or burned
15:00	Insulation and wall studs are involved and fire has again reached the top of the wall
20:00	The burner is turned off, fire is still present near top of the wall
29:55	Most of the fire has self-extinguished, the experiment is over

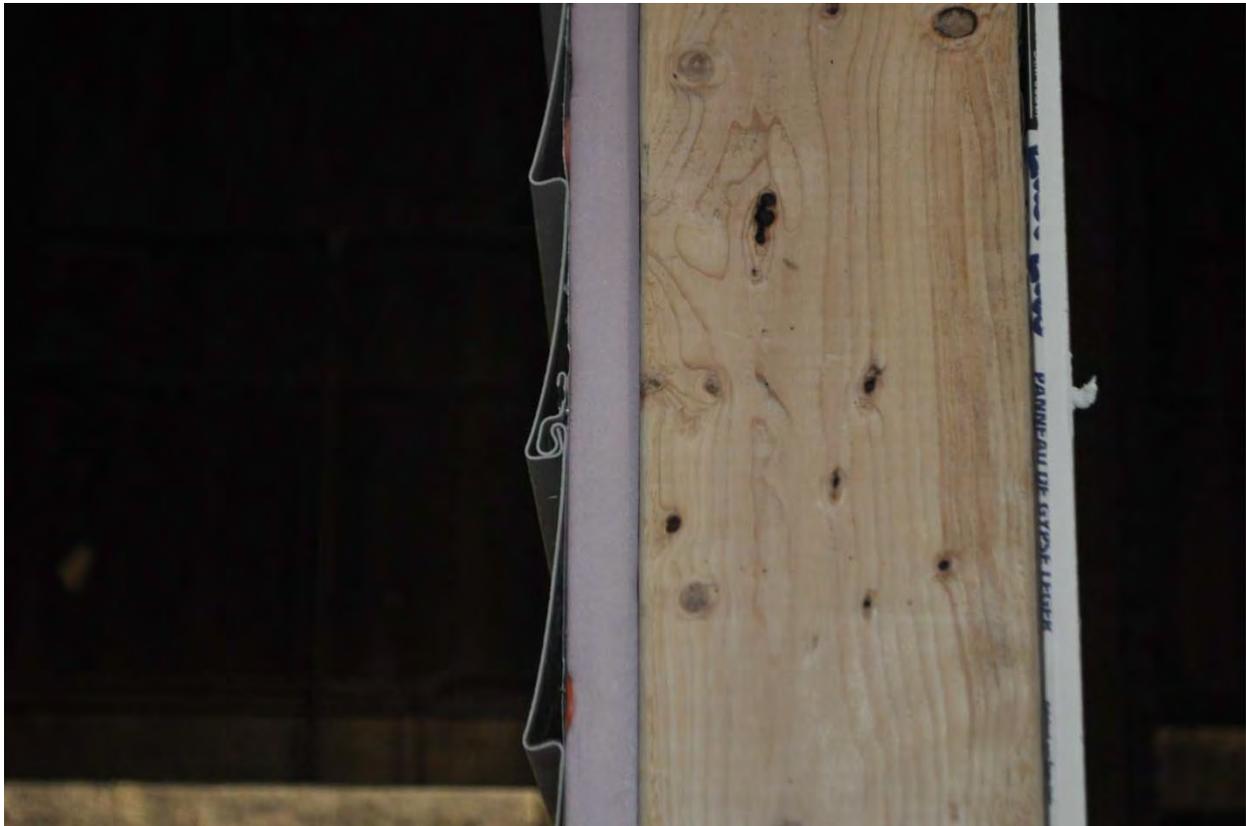
Figure 6. 11: Wall Type 8 Side View

The layout of the wall and materials used for each layer of the wall are specified in Table 6. 11. A side view of the wall is shown in Figure 6. 11. The burner heat release rate (HRR) was 150 kW for Experiment 4 while the burner was on. Photos from Experiment 4 are displayed in Table 6. 12. A timeline of the events within Experiment 4, matching with the photos in Table 6. 12, is shown in

Wall Type	Siding	Additional Material	Sheathing	Insulation	Back Wall
Wall 8	Double 4" Vinyl Siding	Weather-Resistant Barrier	1" R-5 EPS Insulation Board	2x6, R-19 KFI w/ IVB	1/2" Gypsum Board

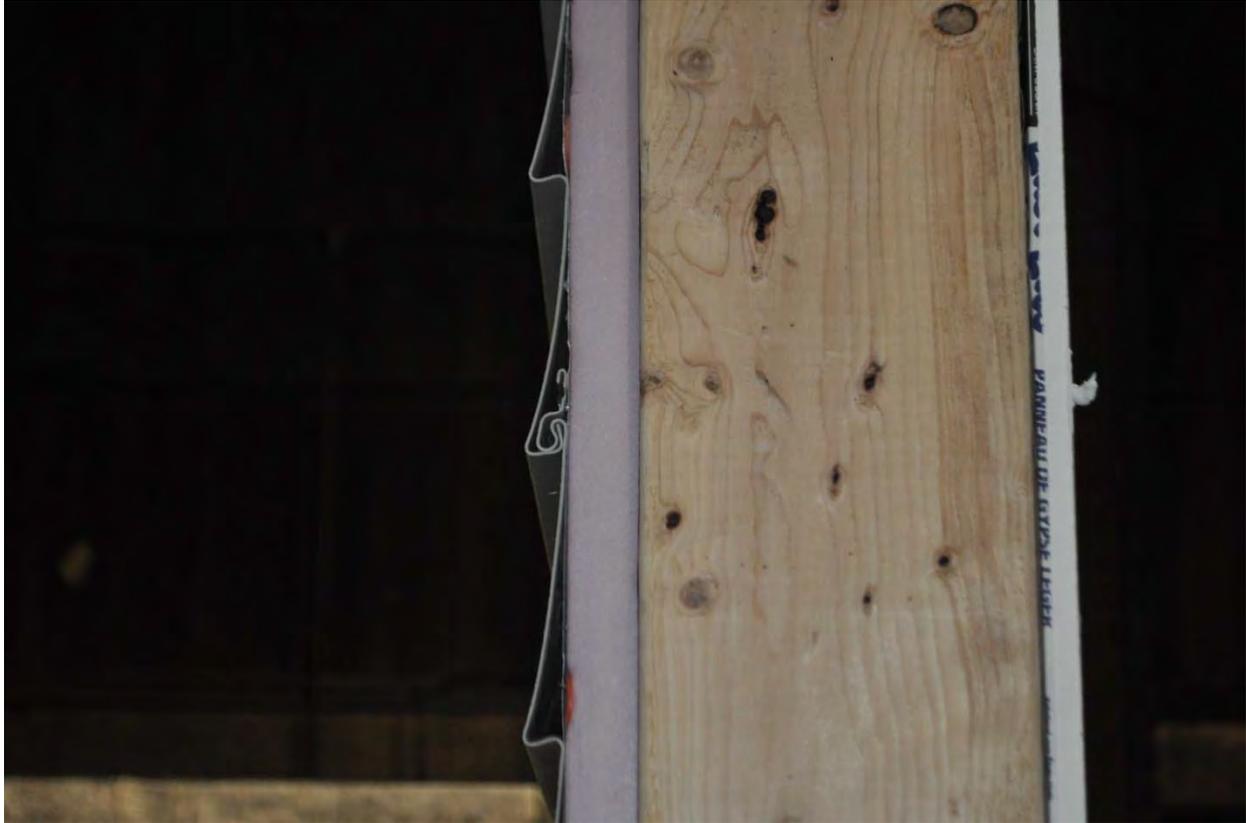
Figure 6. 12: Wall Type 8 Side View

The layout of the wall and materials used for each layer of the wall are specified in Table 6. 14. A side view of the wall is shown in Figure 6. 12. The burner heat release rate (HRR) was 100 kW for Experiment 5 while the burner was on. Photos from Experiment 5 are displayed in

Wall Type	Siding	Additional Material	Sheathing	Insulation	Back Wall
Wall 8	Double 4" Vinyl Siding	Weather-Resistant Barrier	1" R-5 EPS Insulation Board	2x6, R-19 KFI w/ IVB	1/2" Gypsum Board

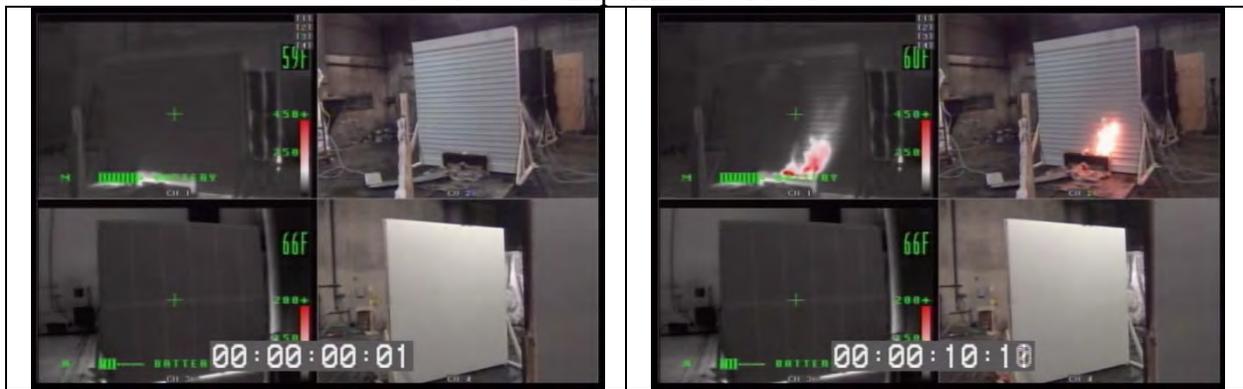
Table 6. 18: Experiment 6 Pictures

Time (mm:ss)	Description
00:00	Experiment begins
00:10	Burner is on and reaching desired 50 kW heat release rate
01:30	Vinyl siding begins to melt and burn, flames spread up the wall
02:30	Flames extend to the top of the wall and above the top of the wall
03:20	Right side of the wall has burned off all the vinyl siding
05:50	All of the vinyl siding has now burned off, pieces of vinyl siding are burning on the ground
10:05	Burner is turned off, only a small part of the wall is still burning, pieces of vinyl siding are still burning on the ground

19:55	Most of fire, except a small portion just above the burner, has self-extinguished, the experiment is over
-------	---

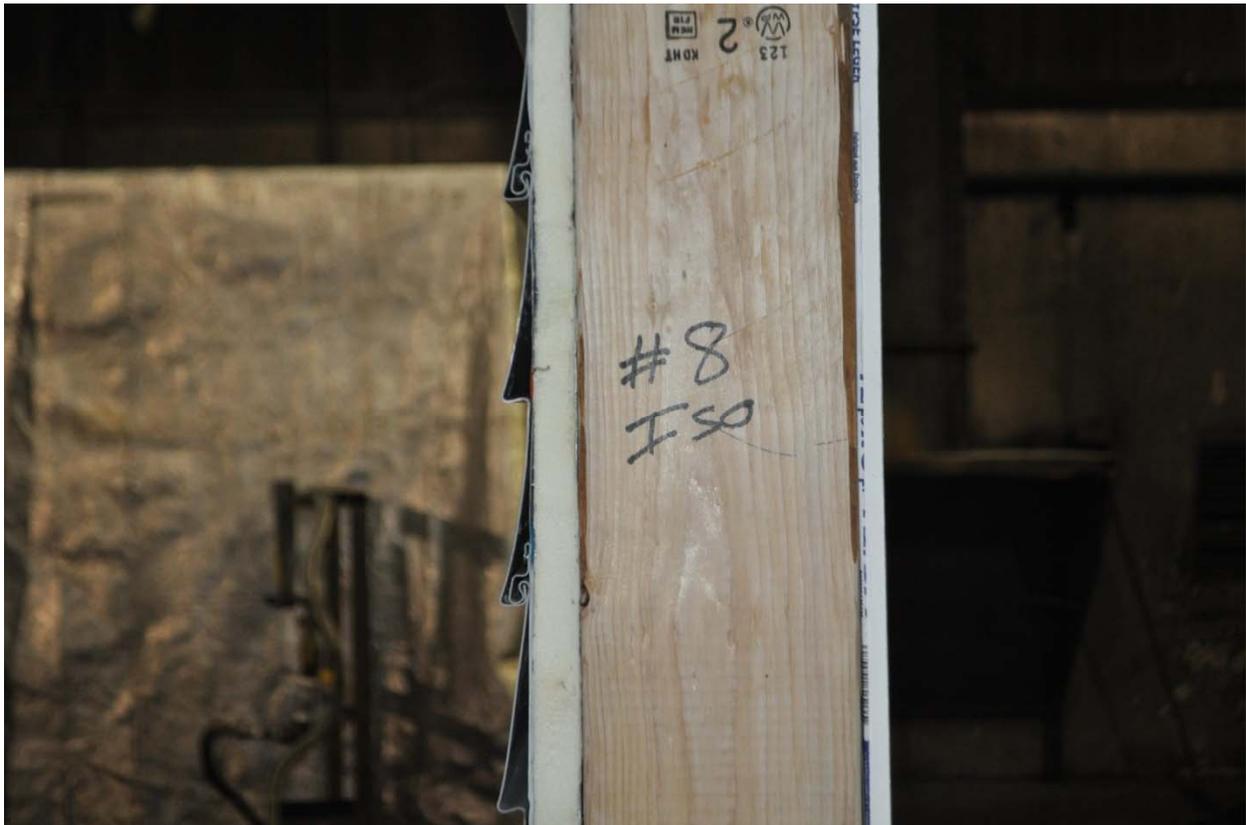
Figure 6. 14: Wall Type 8-I Side View

The layout of the wall and materials used for each layer of the wall are specified in Table 6. 20. A side view of the wall is shown in Figure 6. 14. The burner heat release rate (HRR) was 100 kW for Experiment 7 while the burner was on. Photos from Experiment 7 are displayed in

Wall Type	Siding	Additional Material	Sheathing	Insulation	Back Wall
Wall 8-I	Double 4" Vinyl Siding	Weather-Resistant Barrier	1" Polyisocyanurate Insulation Board	2x6, R-19 KFI w/ IVB	1/2" Gypsum Board

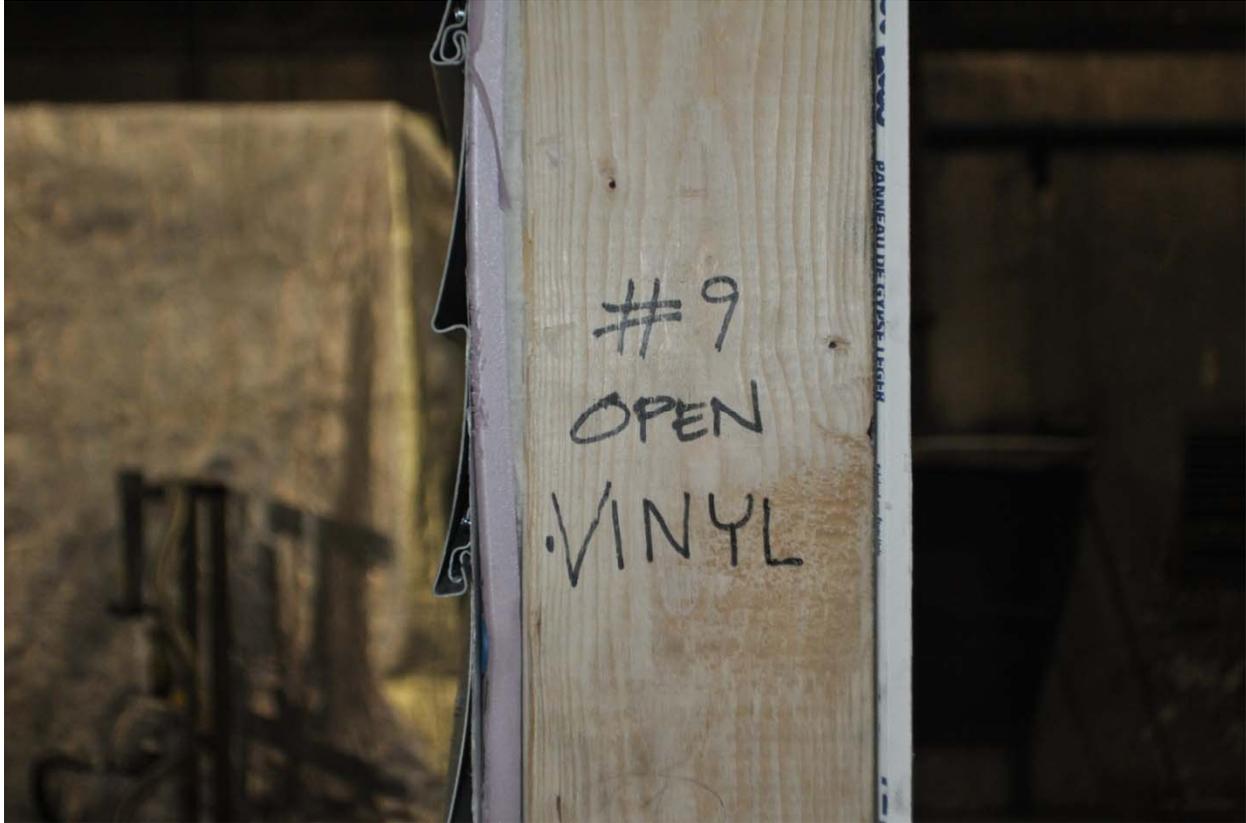
Figure 6. 15: Wall Type 9-O Side View

The layout of the wall and materials used for each layer of the wall are specified in Table 6. 23. A side view of the wall is shown in Figure 6. 15. The burner heat release rate (HRR) was 100 kW for Experiment 8 while the burner was on. Photos from Experiment 8 are displayed in

Wall Type	Siding	Additional Material	Sheathing	Insulation	Back Wall
Wall 9-O	Double 4" Vinyl Siding	Weather-Resistant Barrier	1" R-5 EPS Insulation Board	2x6, Open Cell Foam	1/2" Gypsum Board

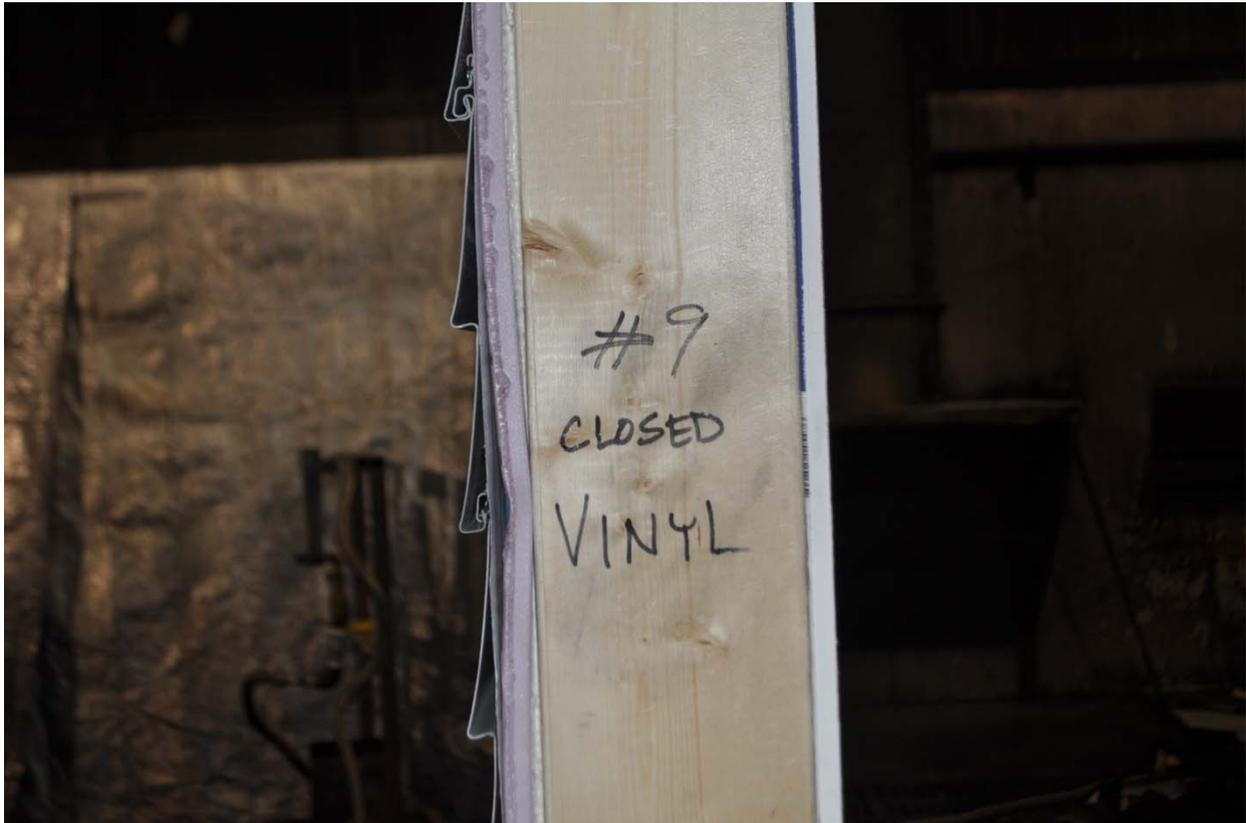
Figure 6. 16: Wall Type 9-C Side View

The layout of the wall and materials used for each layer of the wall are specified in Table 6. 26. A side view of the wall is shown in Figure 6. 16. The burner heat release rate (HRR) was 100 kW for Experiment 9 while the burner was on. Photos from Experiment 9 are displayed in Table 6. 27. A timeline of the events within Experiment 9, matching with the photos in Table 6. 27, is shown in Table 6.28. Heat release rate data, heat flux data, and temperature data from Experiment 9 are shown in appendix G, figures G.49-G.54.

Wall Type	Siding	Additional Material	Sheathing	Insulation	Back Wall
Wall 9-C	Double 4" Vinyl Siding	Weather-Resistant Barrier	1" R-5 EPS Insulation Board	2x6, Closed Cell Foam	1/2" Gypsum Board
