Study of Residential Attic Fire Mitigation Tactics and Exterior Fire Spread Hazards on Fire Fighter Safety

UL Firefighter Safety Research Institute

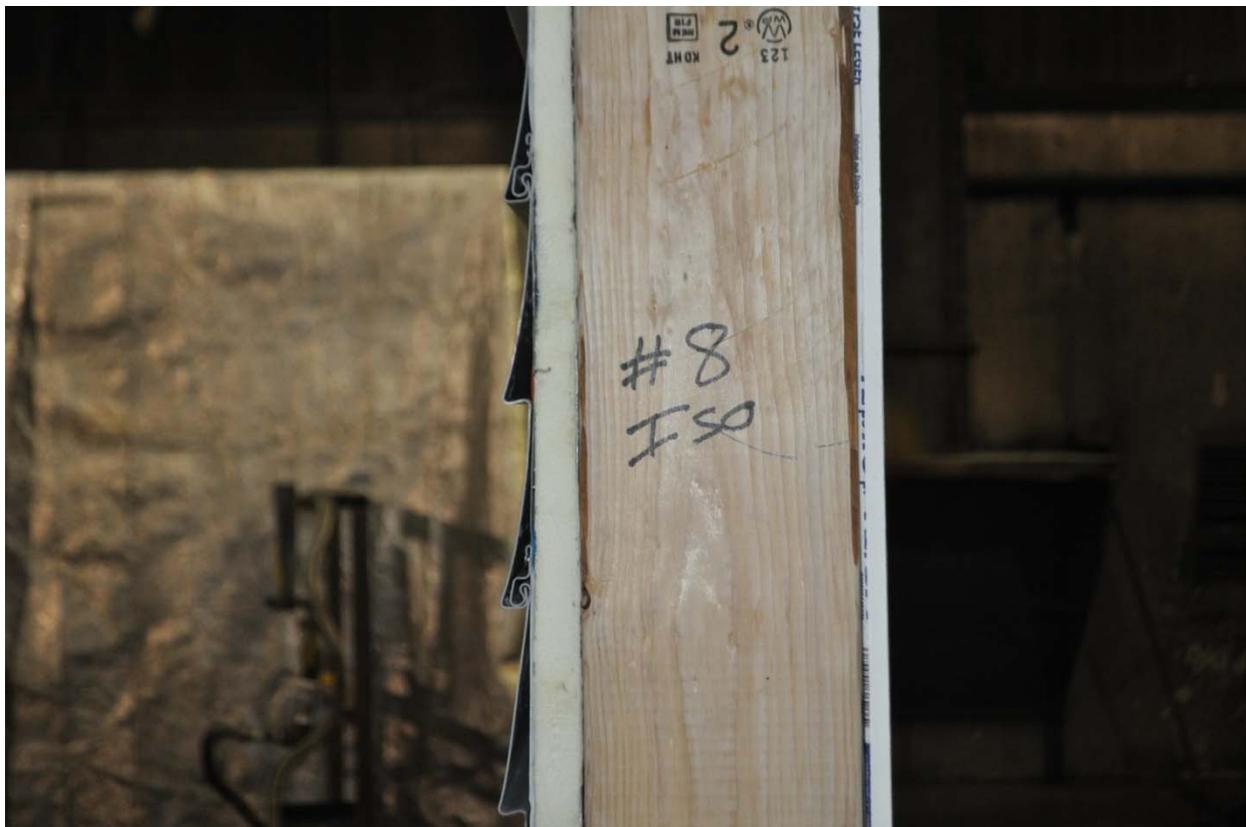
Figure 6. 17: Wall Type 9-I Side View (Side View of 8-I same as Side View of 9-I)

The layout of the wall and materials used for each layer of the wall are specified in Table 6. 29. A side view of the wall is shown in Figure 6. 17. The burner heat release rate (HRR) was 100 kW for Experiment 10 while the burner was on. Photos from Experiment 10 are displayed in Table 6. 30. A timeline of the events within Experiment 10, matching with the photos in Table 6. 30, is shown in

Wall Type	Siding	Additional Material	Sheathing	Insulation	Back Wall
Wall 9-I	Double 4" Vinyl Siding	Weather-Resistant Barrier	1/2" Polyisocyanurate Insulation Board	2x6, R-19 KFI w/ IVB	1/2" Gypsum Board

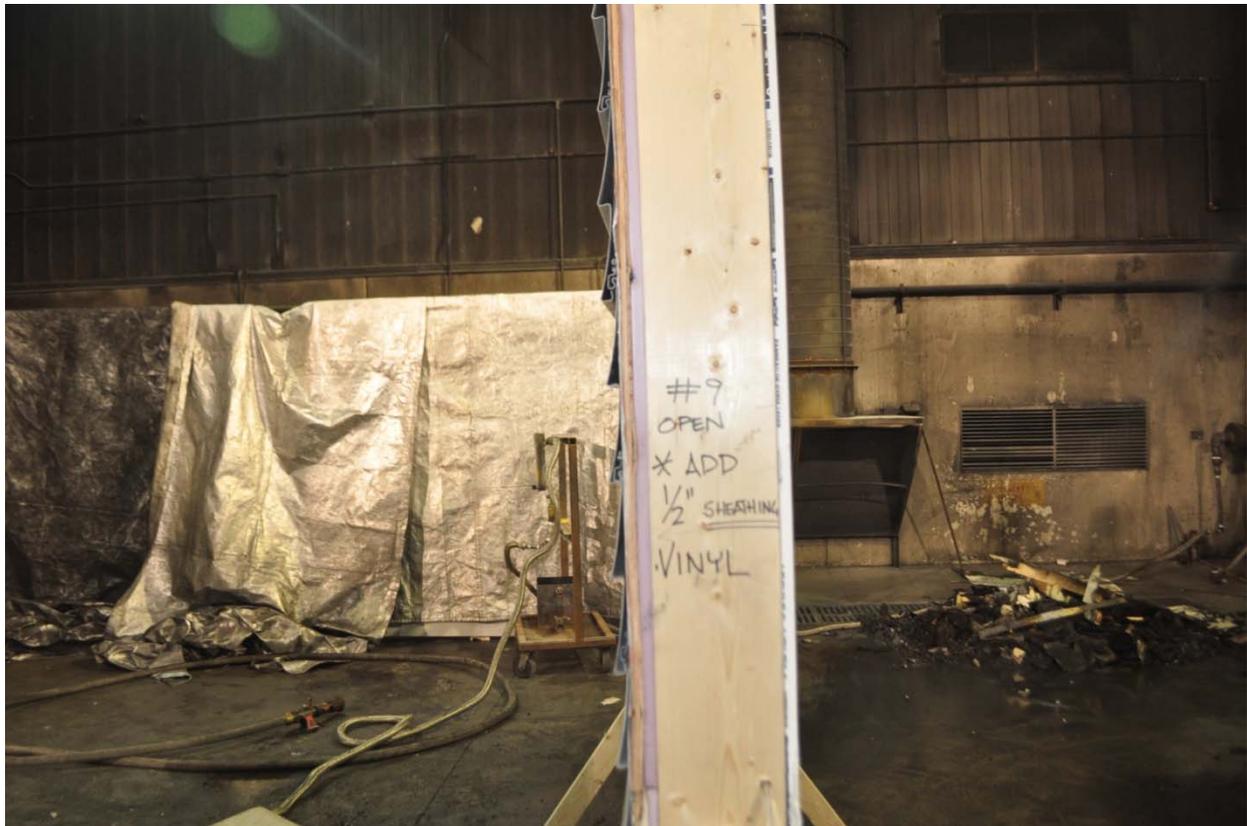
Figure 6.18: Wall Type 9-S Side View

The layout of the wall and materials used for each layer of the wall are specified in Table 6. 32. A side view of the wall is shown in Figure 6. 18. The burner heat release rate (HRR) was 100 kW for Experiment 11 while the burner was on. Photos from Experiment 11 are displayed in

Wall Type	Siding	Additional Material	Sheathing	Insulation	Back Wall
Wall 9-S	Double 4" Vinyl Siding	Weather-Resistant Barrier	1/2" Plywood followed by 1" R-5 EPS Insulation Board	2x6, Spray Polyurethane Foam	1/2" Gypsum Board

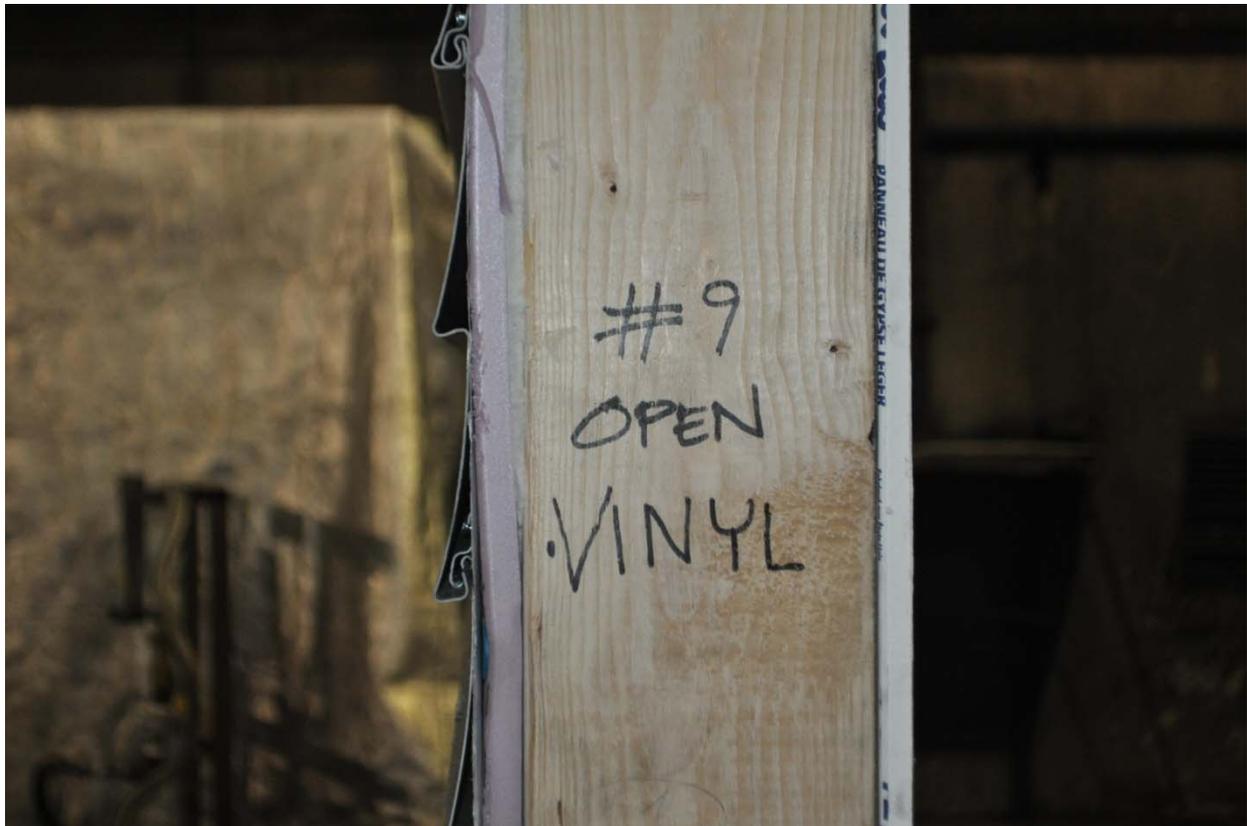
Figure 6. 19: Wall Type 9-R Side View

The layout of the wall and materials used for each layer of the wall are specified in Table 6. 35. A side view of the wall is shown in Figure 6. 19. This wall also had receptacles, which were outlets placed on the back of the wall. The burner heat release rate (HRR) was 100 kW for Experiment 12 while the burner was on. Photos from Experiment 12 are displayed in

Wall Type	Siding	Additional Material	Sheathing	Insulation	Back Wall
Wall 9-R	Double 4" Vinyl Siding	Weather-Resistant Barrier	1" R-5 EPS Insulation Board	2x6, Spray Polyurethane Foam	1/2" Gypsum Board

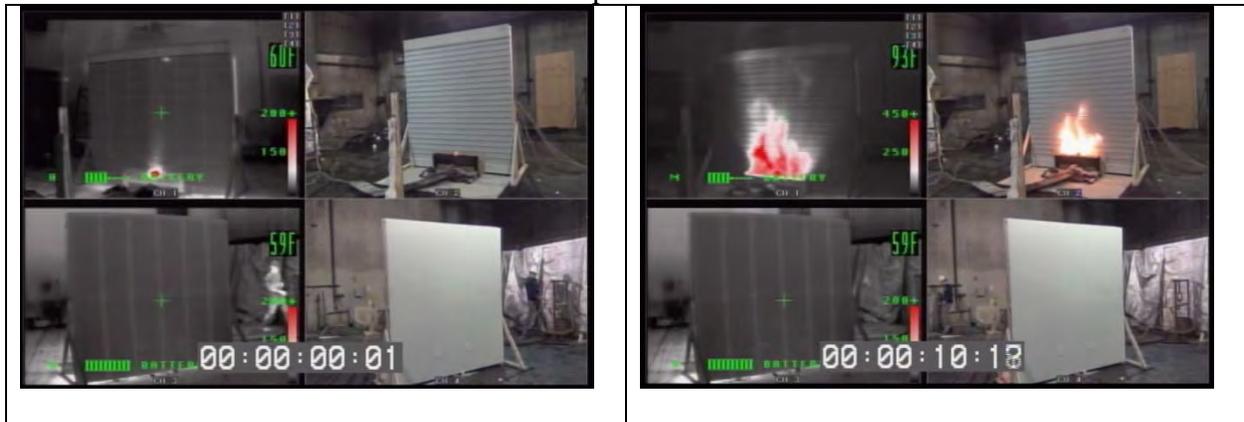
Table 6. 36: Experiment 12 Pictures

Time (mm:ss)	Description
00:00	Experiment begins
00:10	Burner is on and reaching desired 100 kW heat release rate
00:55	Vinyl siding begins to melt and burn, flames spread up the wall

01:45	Flames reach top of the wall and extend above the wall
03:40	Large amounts of smoke and flame extending from the wall, also large amount of burning occurring on the ground

07:30	Flames still present in the studs and insulation, burning still occurring on the ground
10:05	Burner turned off, flames still near the top of the wall, above the burner, and on the ground

13:02	Much of the flame has reduced, only remaining above the burner and on the ground, back of the wall has been burned through at the receptacle, smoke rising out of the hole in the back of the wall

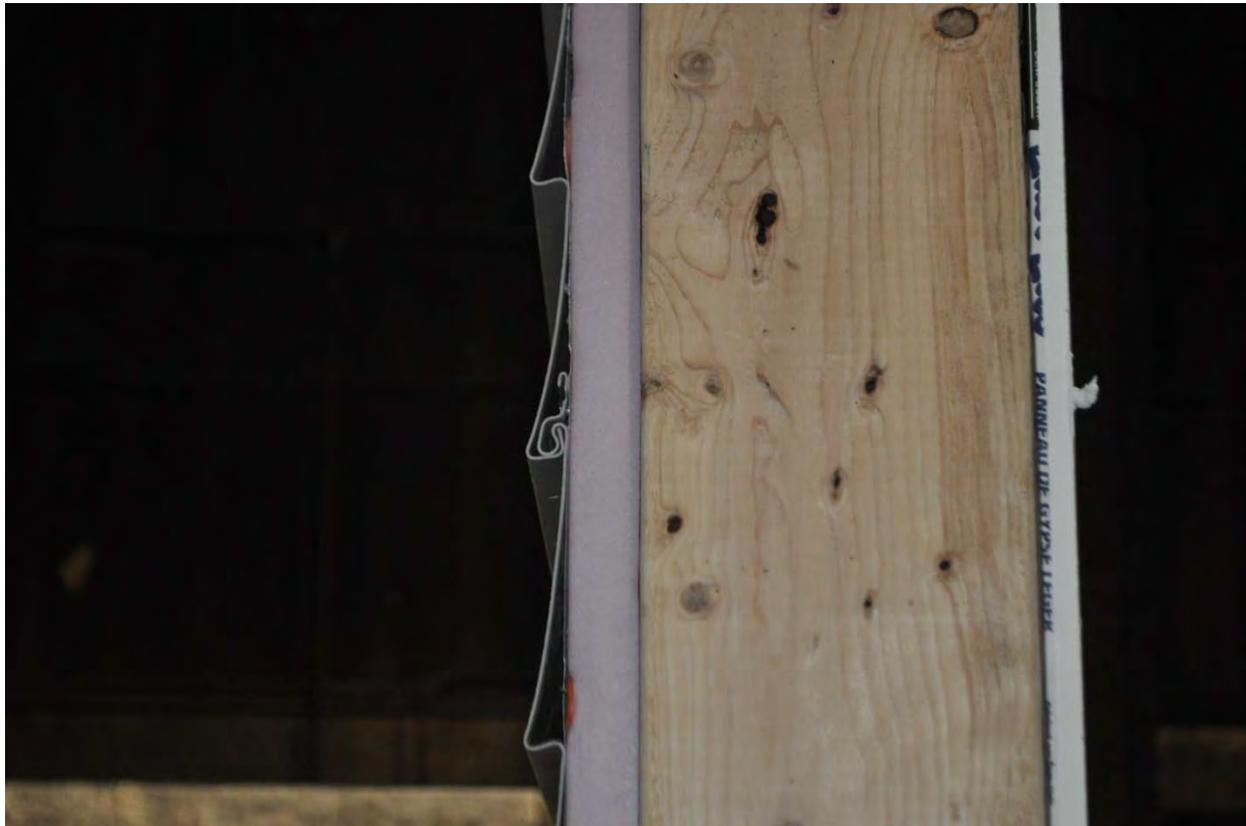
Figure 6. 20: Wall Type 8-R Side View

The layout of the wall and materials used for each layer of the wall are specified in Table 6. 38. A side view of the wall is shown in Figure 6. 20. This wall also had receptacles on the back wall. The burner heat release rate (HRR) was 100 kW for Experiment 13 while the burner was on. Photos from Experiment 13 are displayed in Table 6. 39. A timeline of the events within Experiment 13, matching with the photos in Table 6. 39, is shown in Table 6. 40. Heat release rate data, heat flux data, and temperature data from Experiment 13 are shown in appendix G, figures G.73-G.78.

Wall Type	Siding	Additional Material	Sheathing	Insulation	Back Wall
Wall 8-R	Double 4" Vinyl Siding	Weather-Resistant Barrier	1" R-5 EPS Insulation Board	2x6, R-19 KFI w/ IVB	1/2" Gypsum Board

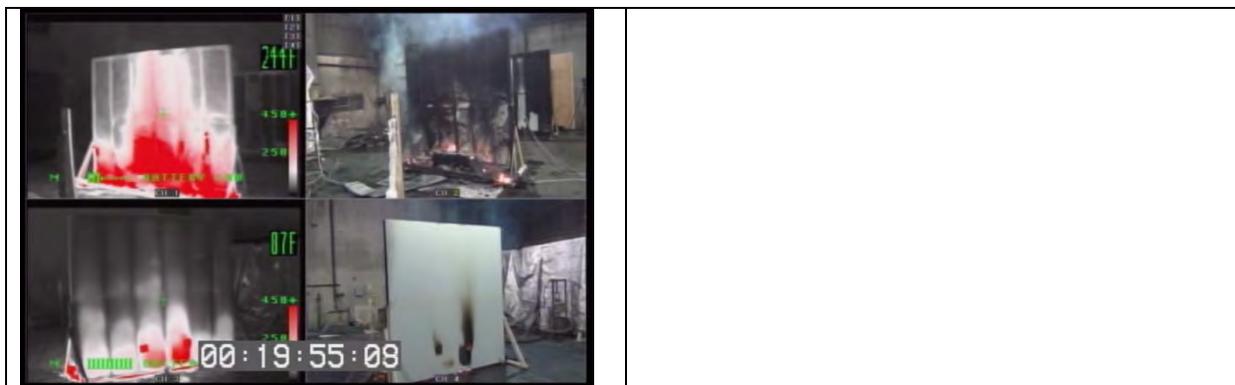
Table 6. 39: Experiment 13 Pictures

Time (mm:ss)	Description
00:00	Experiment begins
00:10	Burner is on and reaching desired 100 kW heat release rate
00:50	Vinyl siding begins to melt and burn, flames spread up the wall
01:30	Flames reach top of the wall and extend above the wall
03:45	Most of the vinyl siding has burned off, still large amounts flame originating on the ground and right side of the wall
05:00	Burning still occurring on the ground in front of the wall
10:05	Burner turned off, flames still on the ground and above the burner, discoloration seen on back of the wall
14:25	Two holes on back of the wall, flames coming from one of the receptacle holes
19:55	The fire has self-extinguished, large amount of charring on the back wall, experiment is over

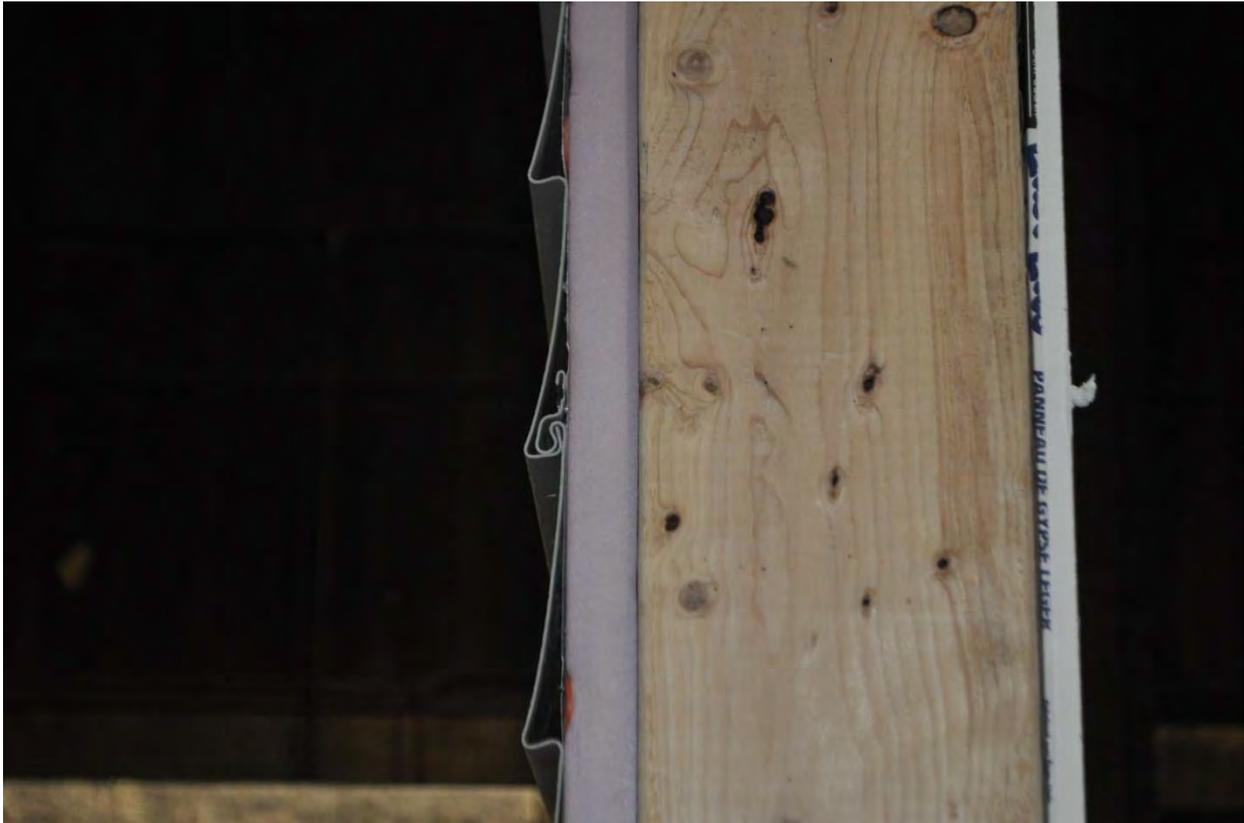
Figure 6. 22: Wall Type 8 Side View

Wall Type	Siding	Additional Material	Sheathing	Insulation	Back Wall
Wall 8	Double 4" Vinyl Siding	Weather-Resistant Barrier	1" R-5 EPS Insulation Board	2x6, R-19 KFI w/ IVB	1/2" Gypsum Board

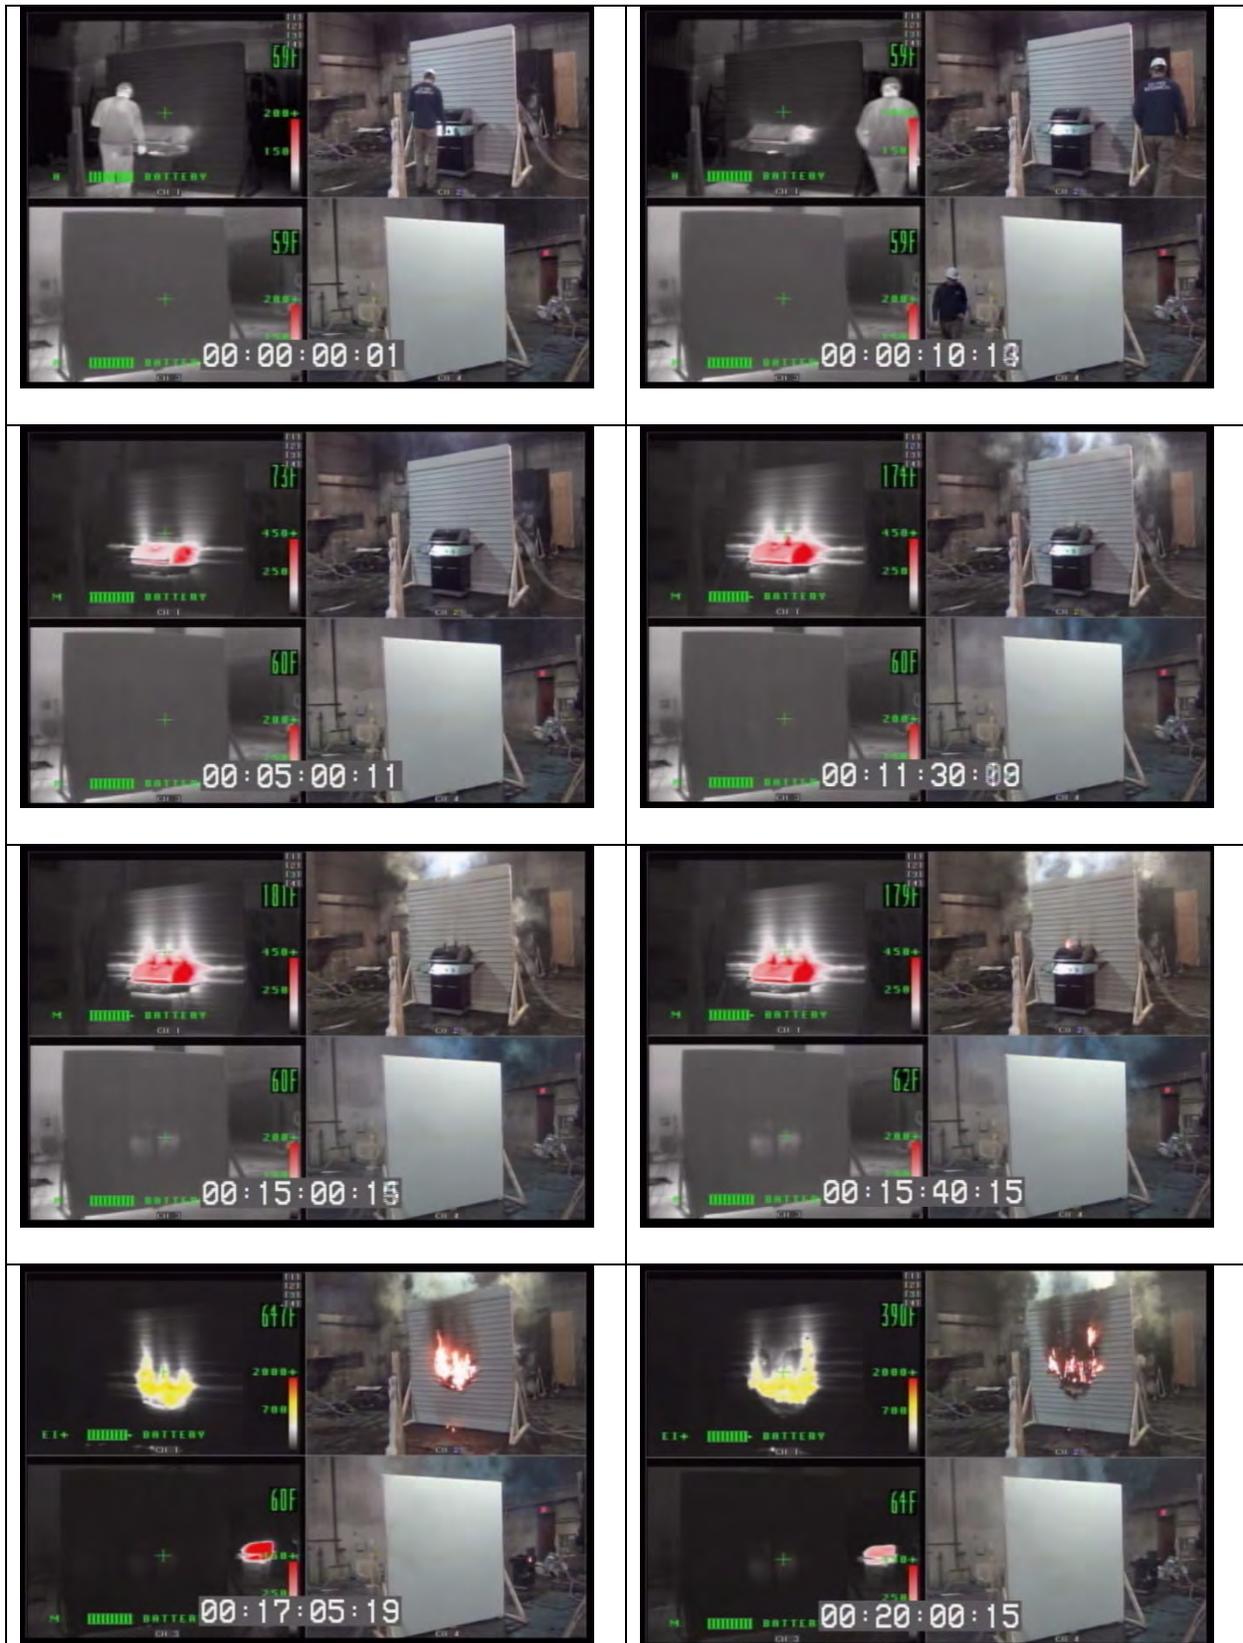
Table 6. 48: Experiment 16 Pictures

Time (mm:ss)	Description
00:00	Experiment begins
00:10	Grill is on and heating up
05:00	Only a very small amount of melting of the vinyl siding
11:30	First separating of vinyl siding is seen just above the grill
15:00	Another separation point of the vinyl siding is seen above the grill
15:40	Flames are seen for first time
17:05	Fire begins to grow, grill is removed
20:00	Fire begins to die down, does not reach top of the wall
29:55	Some fire still remains but it has not grown, soot and charring is seen on some of the wall, experiment is over

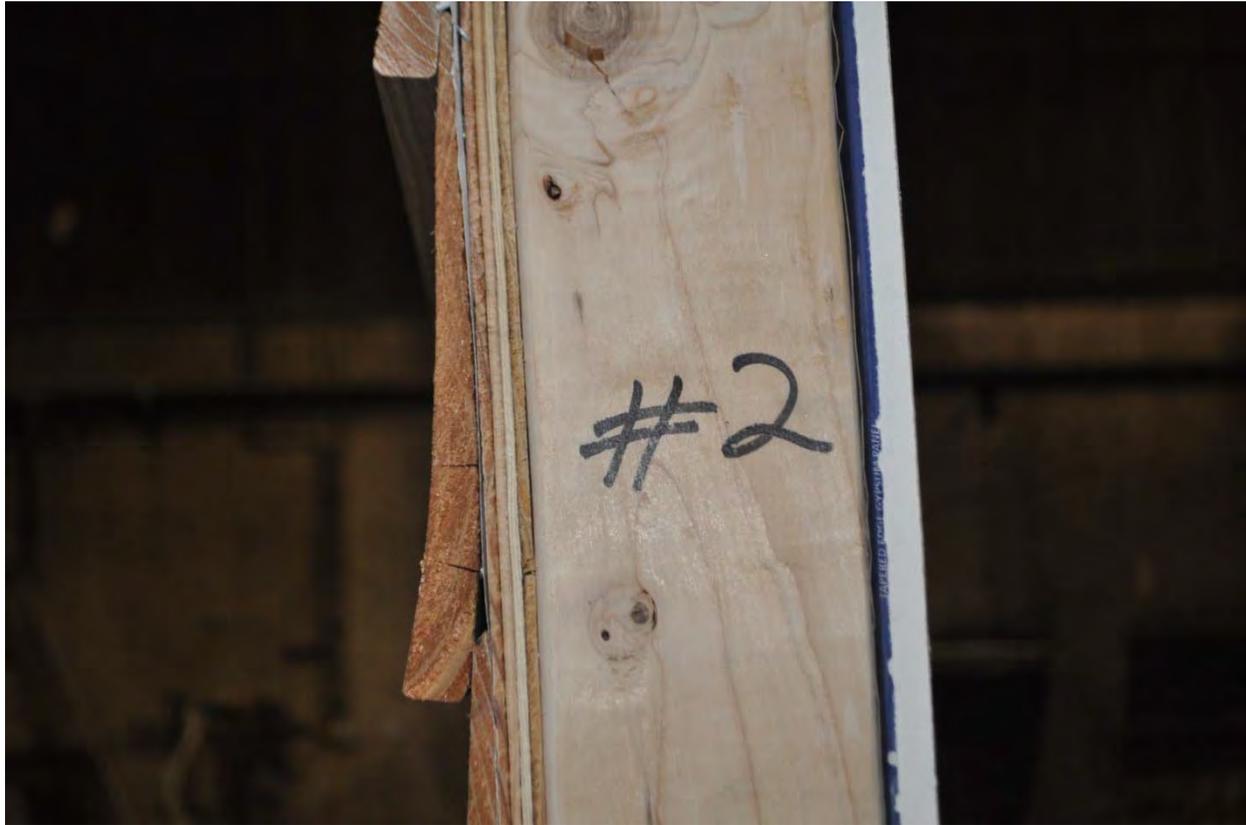
Figure 6. 24: Wall Type 2 Side View

The layout of the wall and materials used for each layer of the wall are specified in Table 6. 50. A side view of the wall is shown in Figure 6. 24. The burner heat release rate (HRR) was 100 kW for Experiment 17 while the burner was on. Photos from Experiment 17 are displayed in Table 6. 51. A timeline of the events within Experiment 17, matching with the photos in Table 6. 51, is shown in Table 6. 52. Heat release rate data, heat flux data, and temperature data from Experiment 17 are shown in appendix G, figures G.97-G.102.

Wall Type	Siding	Additional Material	Sheathing	Insulation	Back Wall
Wall 2	8" Wood Lap Siding	Weather-Resistant Barrier	1/2" Plywood Sheathing	2x4, R-13 KFI w/ IVB	1/2" Gypsum Board

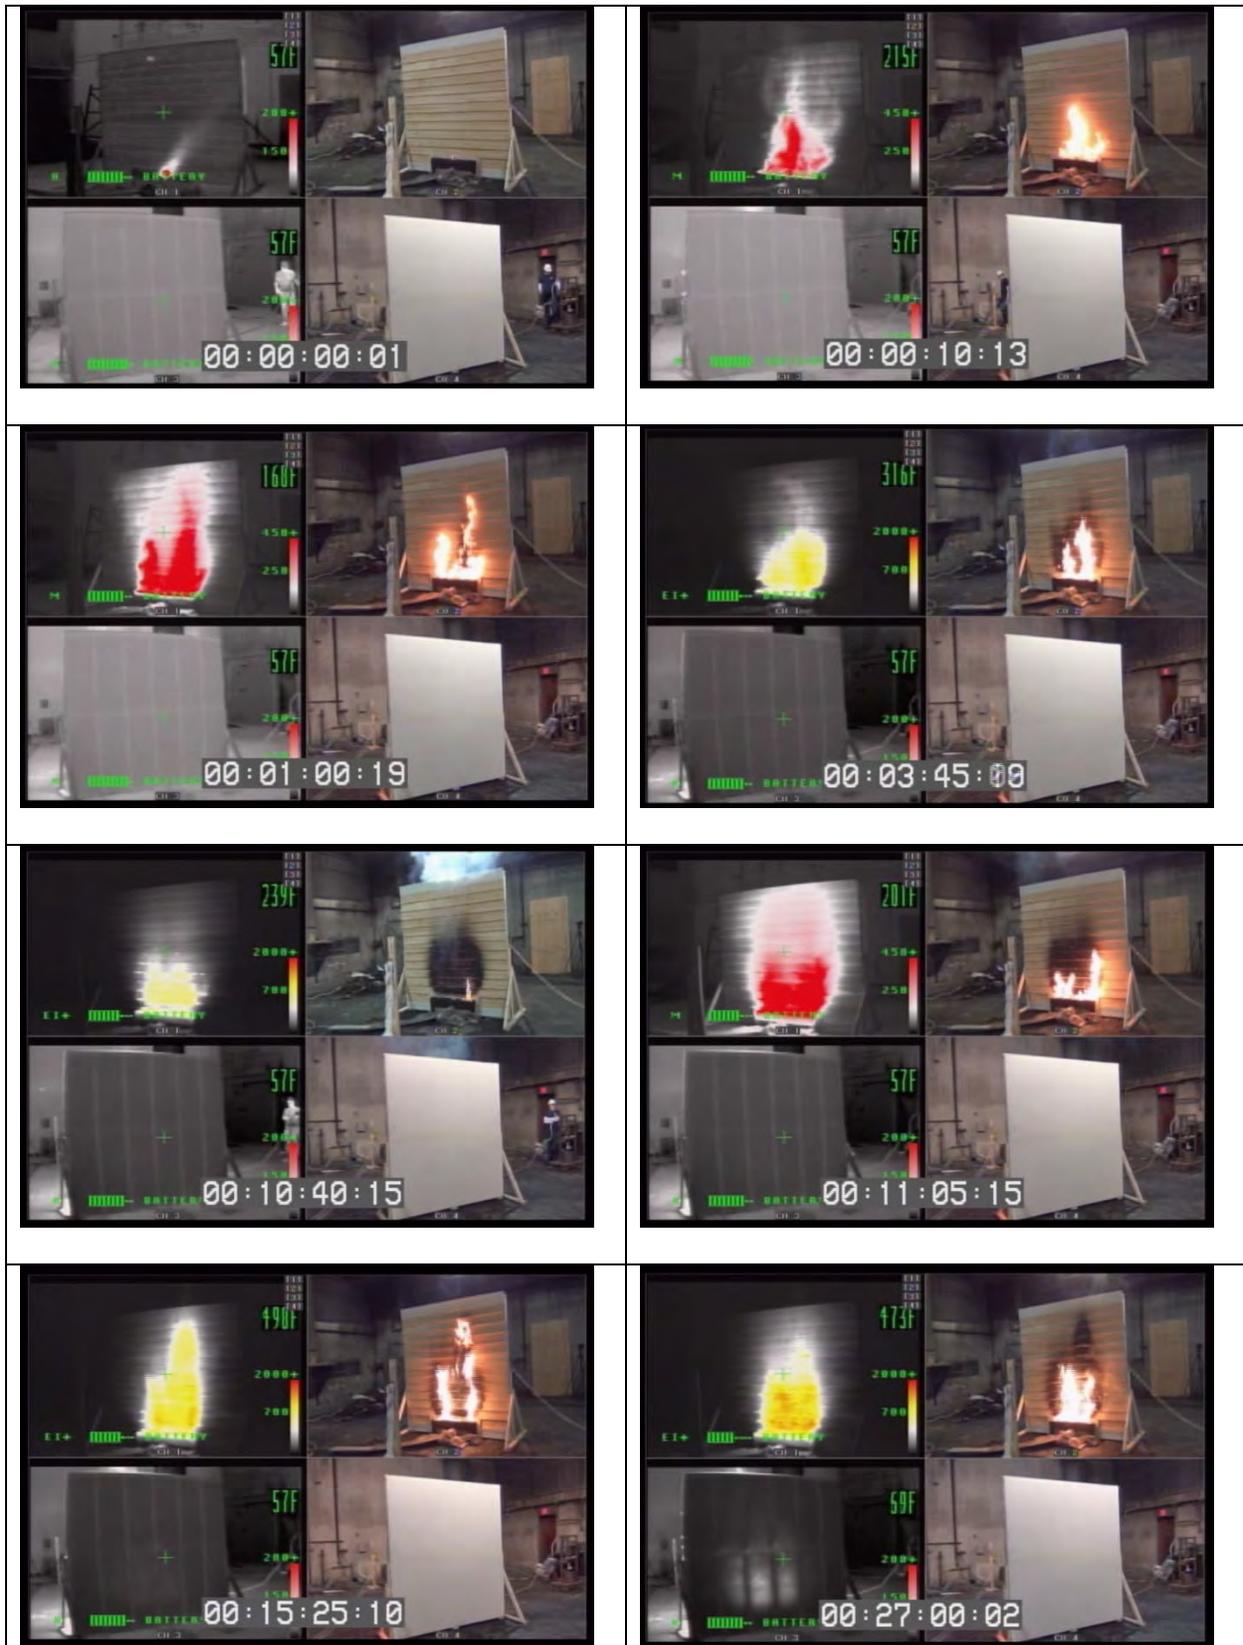
Table 6. 51: Experiment 17 Pictures

Time (mm:ss)	Description
00:00	Experiment begins
00:10	Burner is on and reaching desired 100 kW heat release rate
01:00	Charring is visible but most the flame is from the burner
03:45	Charring has increased along the surface of the siding but still most of the flame is from the burner
10:40	Burner is turned off, no flame remains on the wall
11:05	Burner is turned back on
15:25	Charring increases up along the wall, reaching the top
27:00	Flame is again reduced to mostly just the burner
29:25	Flame spread up the wall, again reaching the top
30:05	Burner is turned off, some flame remains just above the burner in the center of the wall
34:50	Some fire still remains on the lower center part of the wall, experiment is over

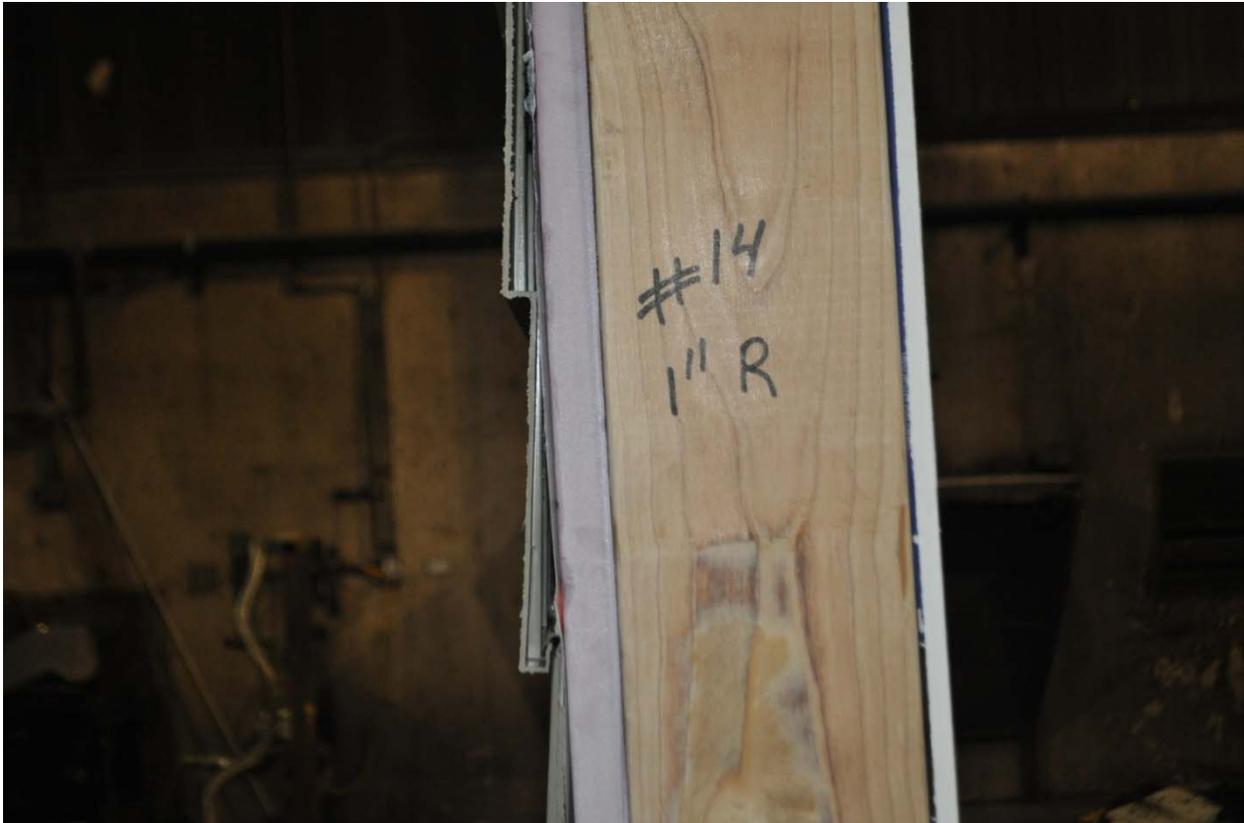
Figure 6. 25: Wall Type 14 Side View

Wall Type	Siding	Additional Material	Sheathing	Insulation	Back Wall
Wall 14	Double 7" Polypropylene Shingle Siding	Weather-Resistant Barrier	1" R-5 EPS Insulation Board	2x6, R-19 KFI w/ IVB	1/2" Gypsum Board

The layout of the wall and materials used for each layer of the wall are specified in Table 6. 53. A side view of the wall is shown in Figure 6. 25. The burner heat release rate (HRR) was 100 kW for Experiment 18 while the burner was on. Photos from Experiment 18 are displayed in Table 6. 54. A timeline of the events within Experiment 18, matching with the photos in Table 6. 54, is shown in

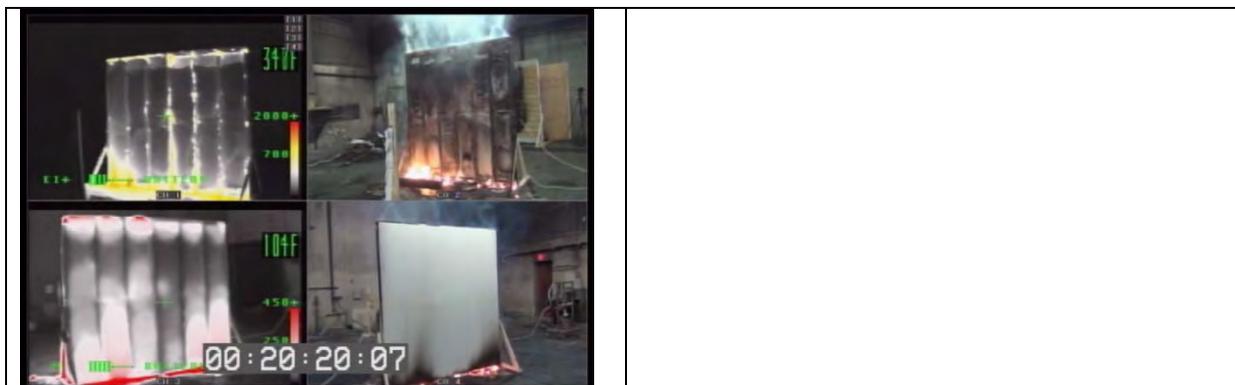
Table 6. 54: Experiment 18 Pictures

Time (mm:ss)	Description
00:00	Experiment begins
00:10	Burner is on and reaching desired 100 kW heat release rate
01:00	Some of the siding begins to melt and burn

02:00	Flames have spread up the wall, not yet reaching the top
02:20	Flames have reached the top of the wall, extending well above it
02:40	The most intense burning of the siding is seen

03:20	The centerline of the wall seems to have decreased burning, the outer edges of the flame region are still burning
05:00	Flames have reached the top corners of the wall

06:40	The siding has burned off, larger flames are rising up from the ground in front of the wall due to the siding that fell from the wall onto the ground

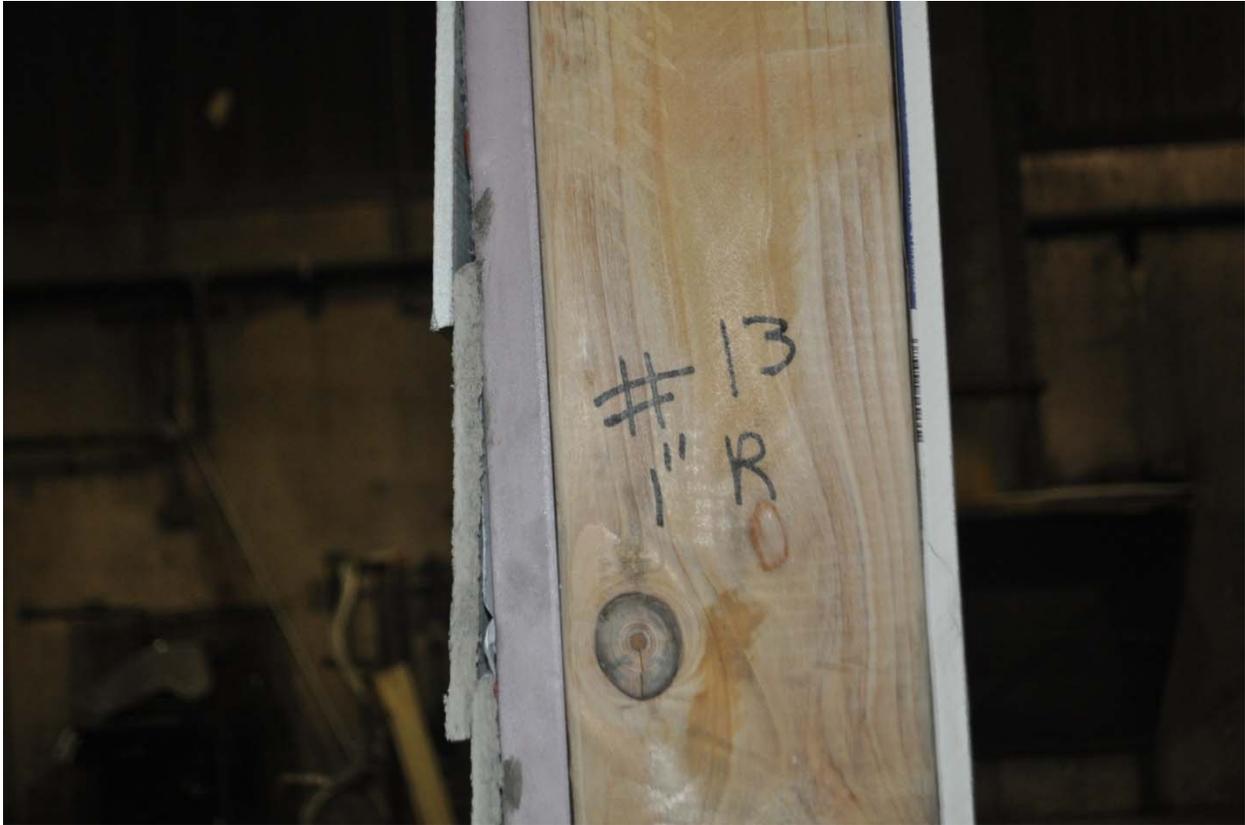
Figure 6. 26: Wall Type 13 Side View

Wall Type	Siding	Additional Material	Sheathing	Insulation	Back Wall
Wall 13	8" Fiber Cement Siding	Weather-Resistant Barrier	1" R-5 EPS Insulation Board	2x6, R-19 KFI w/ IVB	1/2" Gypsum Board

The layout of the wall and materials used for each layer of the wall are specified in Table 6. 56. A side view of the wall is shown in Figure 6. 26. The burner heat release rate (HRR) was 100 kW for Experiment 19 while the burner was on. Photos from Experiment 19 are displayed in

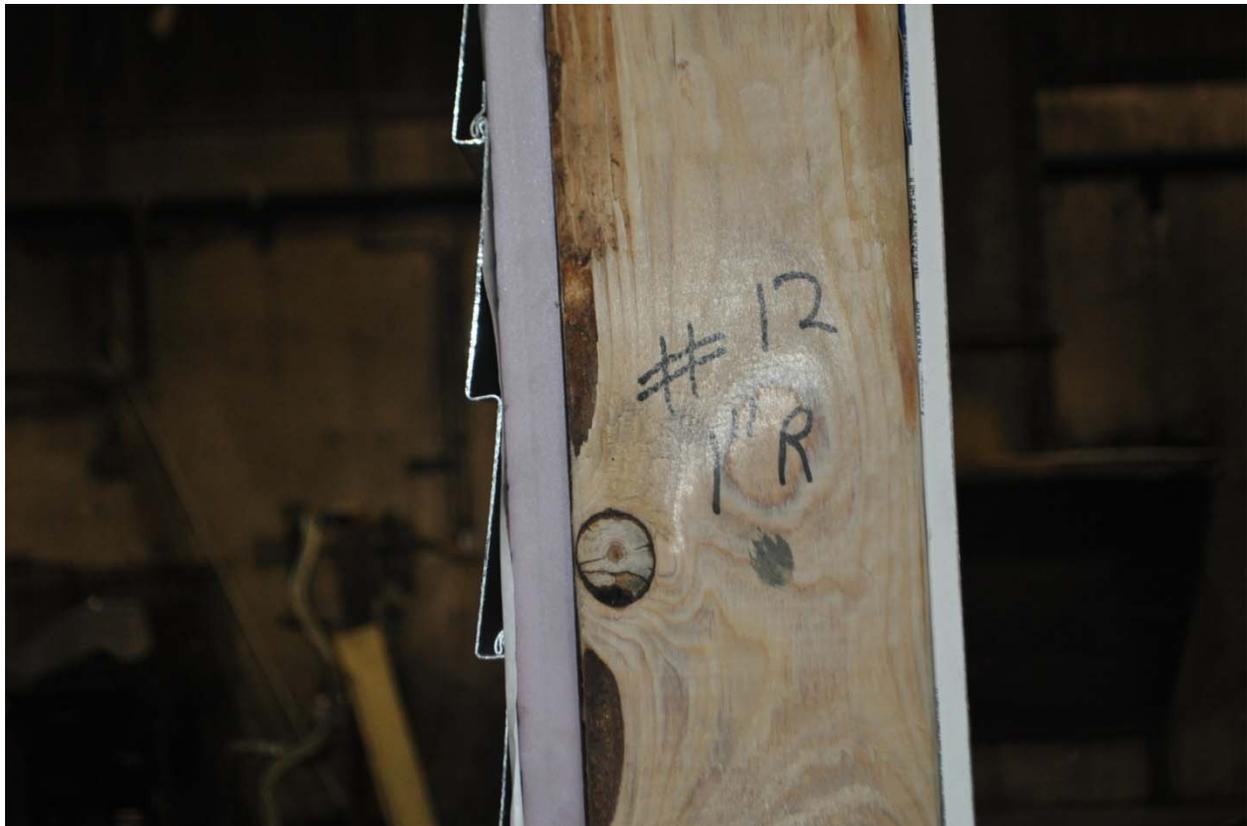
Figure 6. 27: Wall Type 12 Side View

Wall Type	Siding	Additional Material	Sheathing	Insulation	Back Wall
Wall 14	Double 4" Aluminum Siding	Weather-Resistant Barrier	1" R-5 EPS Insulation Board	2x6, R-19 KFI w/ IVB	1/2" Gypsum Board

The layout of the wall and materials used for each layer of the wall are specified in Table 6. 59. A side view of the wall is shown in Figure 6. 27. The burner heat release rate (HRR) was 100 kW for Experiment 20 while the burner was on. Photos from Experiment 20 are displayed in

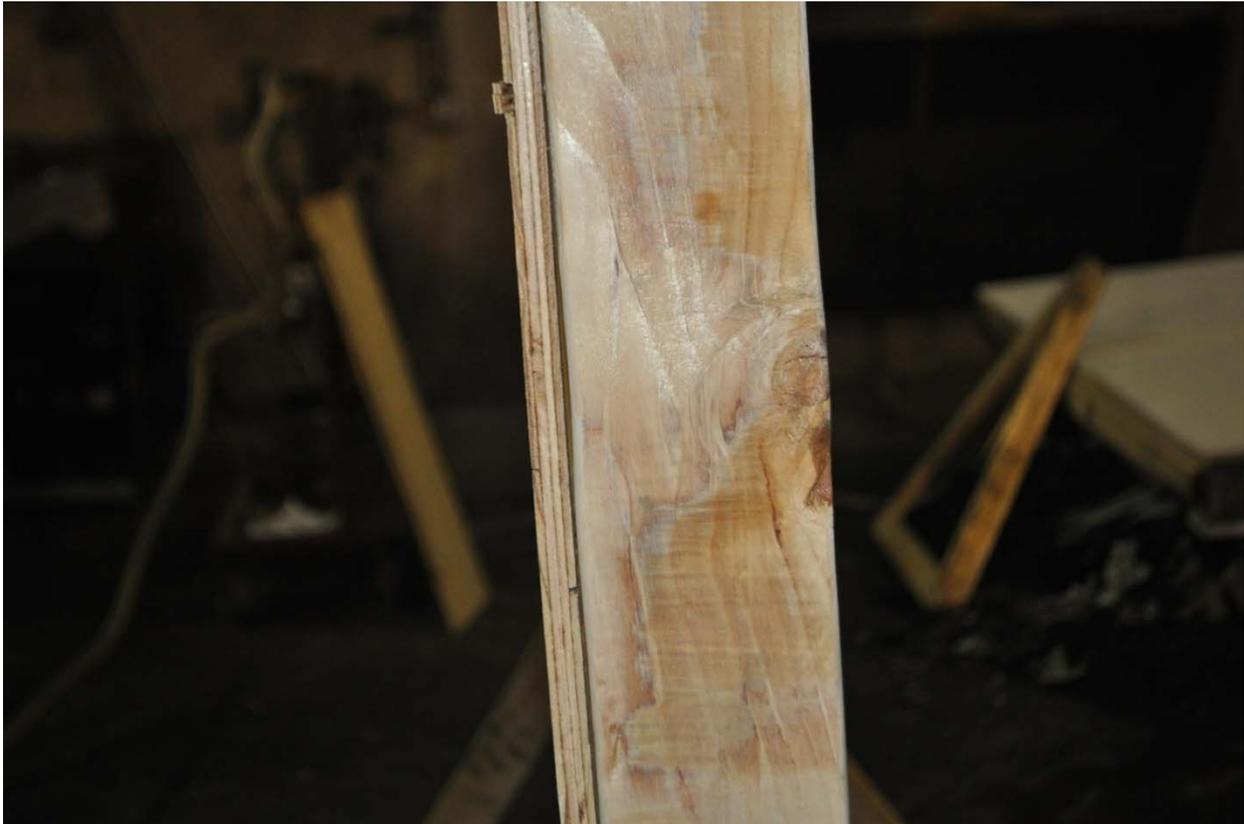
Figure 6. 29: Experiment 22 Side View

Wall Type	Siding	Additional Material	Sheathing	Insulation	Back Wall
N/A	None	None	1/2" Plywood	2x4 Studs w/ Open Space	None

The layout of the wall and materials used for each layer of the wall are specified in Table 6. 65. A side view of the wall is shown in Figure 6. 29. The burner heat release rate (HRR) was 100 kW for Experiment 22 while the burner was on. Photos from Experiment 22 are displayed in Table 6. 66. A timeline of the events within Experiment 22, matching with the photos in Table 6. 66, is shown in Table 6. 67. Heat release rate data from Experiment 22 is shown in appendix G, figure G.123.

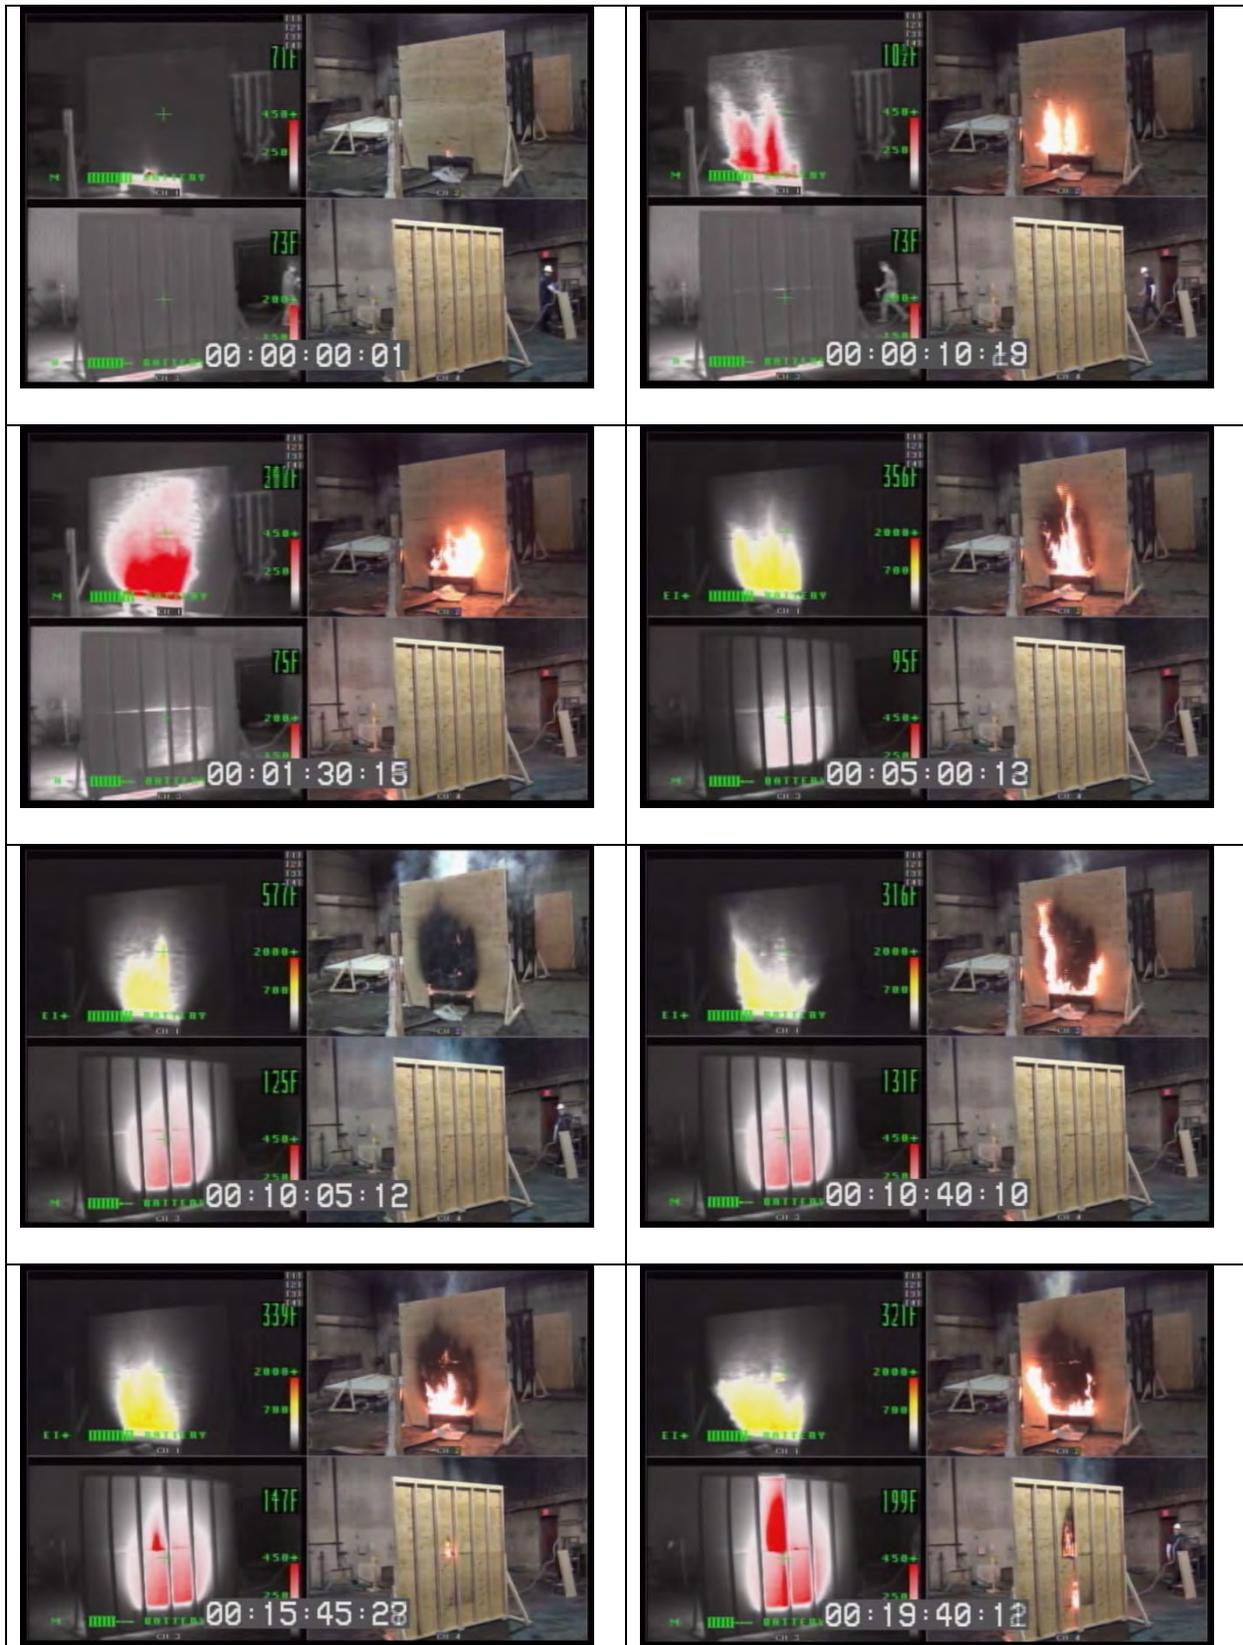
Table 6. 66: Experiment 22 Pictures

Time (mm:ss)	Description
00:00	Experiment begins
00:10	Burner is on and reaching desired 100 kW heat release rate
01:30	Some initial charring of the plywood
05:00	Charred area on the surface increases
10:05	Burner is turned off, no flame remains
10:40	Burner is turned back on
15:45	Flame breaks through plywood and burns out the other side
19:40	Flame breaks through plywood in an additional location
20:05	Burner is turned off, still some flame remains mostly on the back side of the plywood
25:00	Flame has grown on the back side and spread on both sides of the plywood, extending above the wall, experiment is over

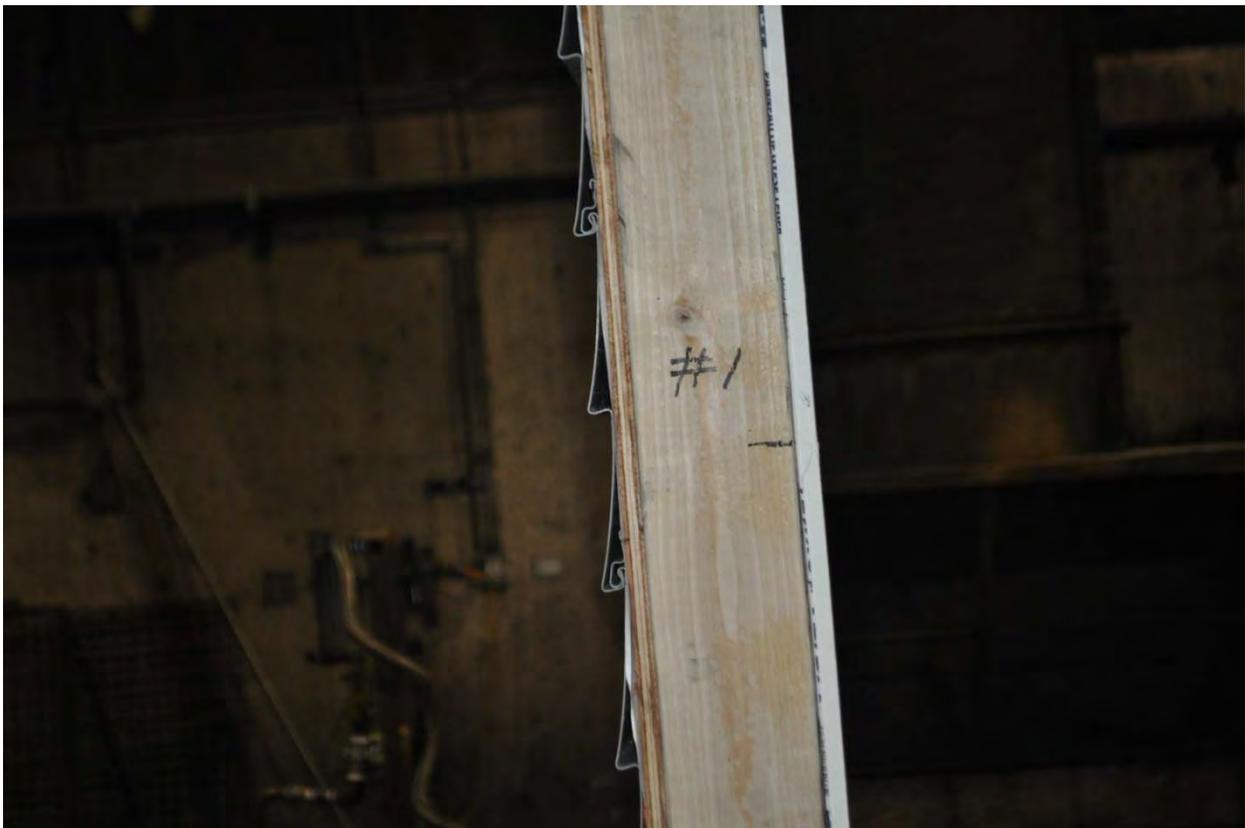
Figure 6. 30: Wall Type 1 Side View

Wall Type	Siding	Additional Material	Sheathing	Insulation	Back Wall
Wall 1	Double 4" Vinyl Siding	Weather-Resistant Barrier	1/2" Plywood Sheathing	2x4, R-13 KFI w/ IVB	1/2" Gypsum Board

The layout of the wall and materials used for each layer of the wall are specified in Table 6. 68. A side view of the wall is shown in Figure 6. 30. The burner heat release rate (HRR) was 25 kW for Experiment 23 while the burner was on. Photos from Experiment 23 are displayed in Table 6. 69. A timeline of the events within Experiment 23, matching with the photos in Table 6. 69, is shown in Table 6. 70. Heat release rate data, heat flux data, and temperature data from Experiment 23 are shown in appendix G, figure G.124-G.129.
