Study of Residential Attic Fire Mitigation Tactics and Exterior Fire Spread Hazards on Fire Fighter Safety

UL Firefighter Safety Research Institute

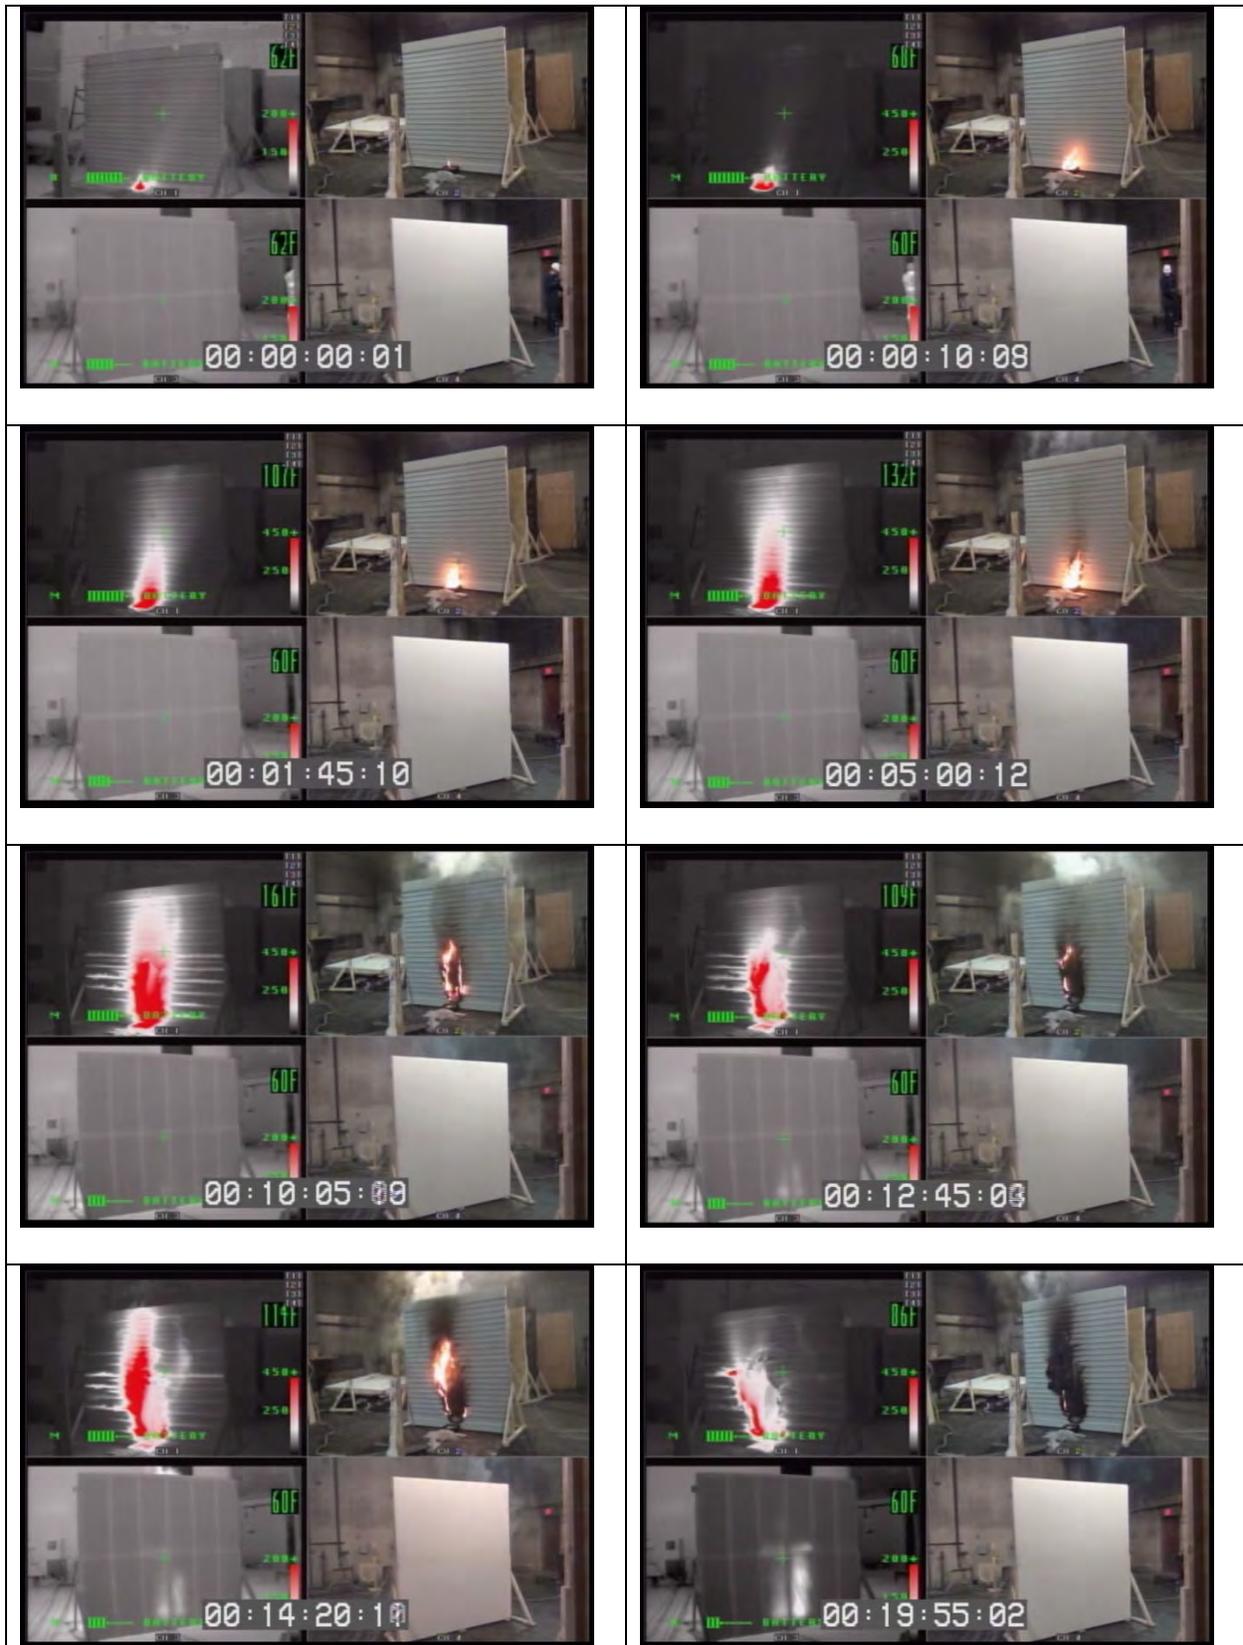
Table 6. 69: Experiment 23 Pictures

Time (mm:ss)	Description
00:00	Experiment begins
00:10	Burner is on and reaching desired 25 kW heat release rate
01:45	Some charring on the siding
05:00	Fire begins to grow, rising slightly up the wall
10:05	Burner is turned off, only the outer edge of the burnt region is flaming
12:45	Flame is dying out, has not gotten any higher
14:20	Left side of burnt region continues to burn
19:55	Fire has self-extinguished, never reached the top of the wall, experiment is complete

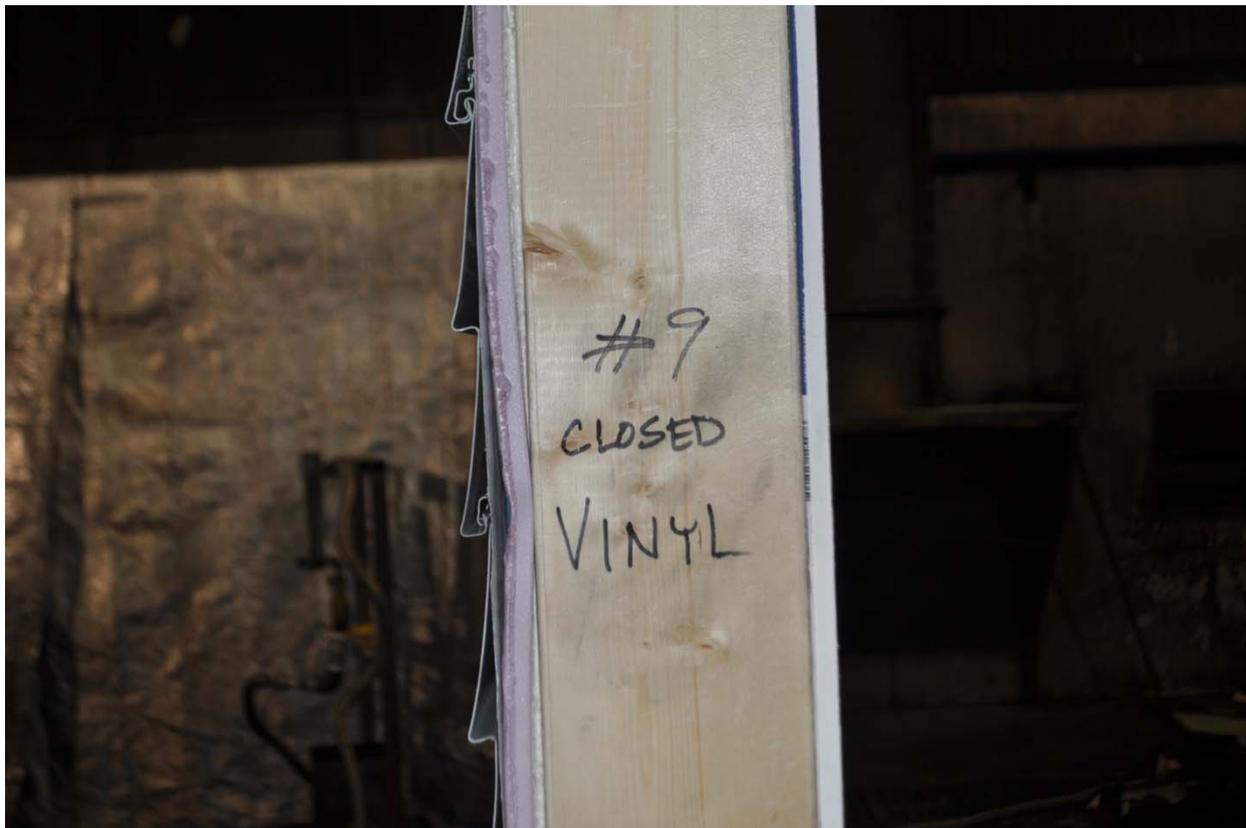
Figure 6. 31: Wall Type 9-C Side View

Wall Type	Siding	Additional Material	Sheathing	Insulation	Back Wall
Wall 9-C	Double 4" Vinyl Siding	Weather-Resistant Barrier	1" R-5 EPS Insulation Board	2x6, Closed Cell Foam	1/2" Gypsum Board

The layout of the wall and materials used for each layer of the wall are specified in Table 6. 71. A side view of the wall is shown in Figure 6. 31. The burner heat release rate (HRR) was 25 kW for Experiment 24 while the burner was on. Photos from Experiment 24 are displayed in Table 6. 72. A timeline of the events within Experiment 24, matching with the photos in Table 6. 72, is shown in Table 6. 73. Heat release rate data, heat flux data, and temperature data from Experiment 24 are shown in appendix G, figures G.130-G.135.

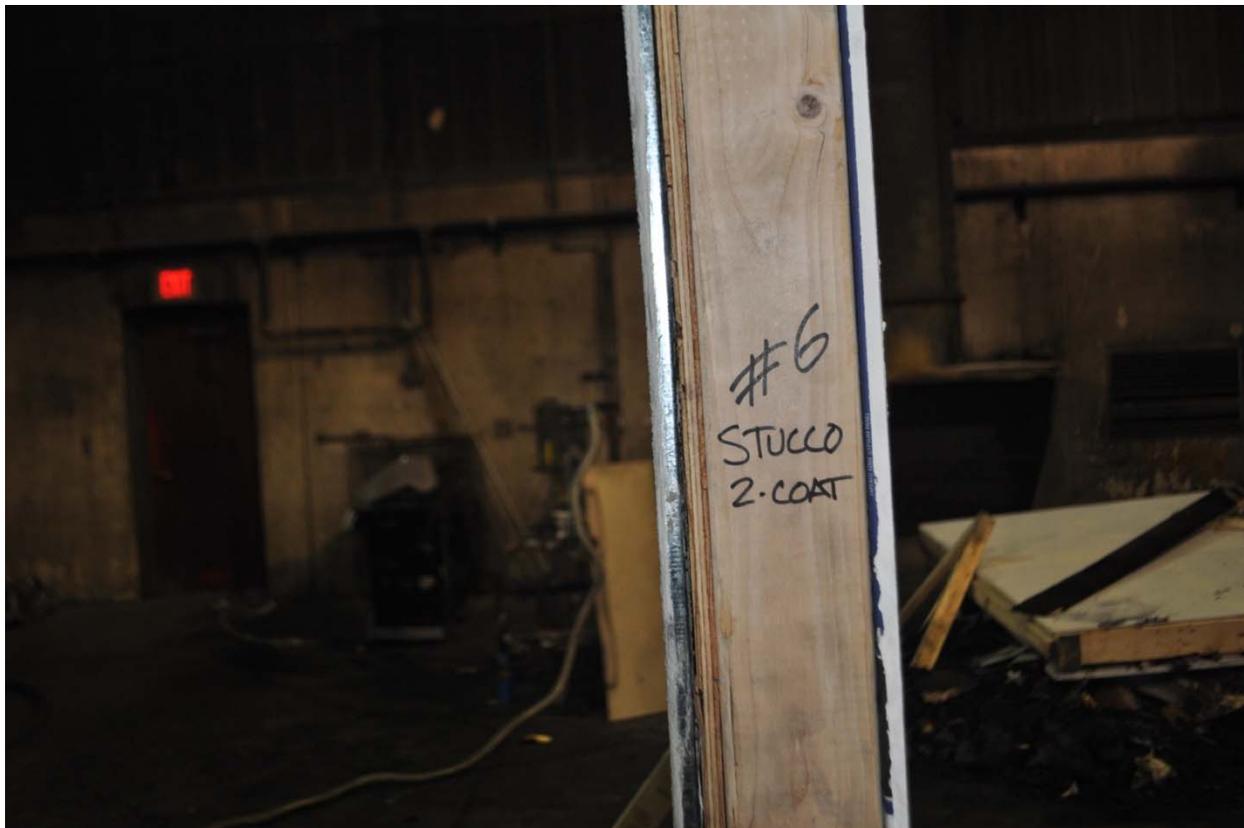
Figure 6. 32: Wall Type 6 Side View

Wall Type	Siding	Additional Material	Sheathing	Insulation	Back Wall
Wall 6	3/8" Elastomeric Base Coat (Stucco)	Weather resistant barrier	1/2" Plywood Sheathing	2x4, R-13 KFI w/ IVB	1/2" Gypsum Board

The layout of the wall and materials used for each layer of the wall are specified in Table 6. 74. A side view of the wall is shown in Figure 6. 32. The burner heat release rate (HRR) was initially 100 kW for Experiment 25 and then raised to 200 kW after 20 minutes passed. Photos from Experiment 25 are displayed in Table 6. 75. A timeline of the events within Experiment 25, matching with the photos in Table 6. 75, is shown in Table 6. 76. Heat release rate data, heat flux data, and temperature data from Experiment 25 are shown in appendix G, figures G.136-G.141.

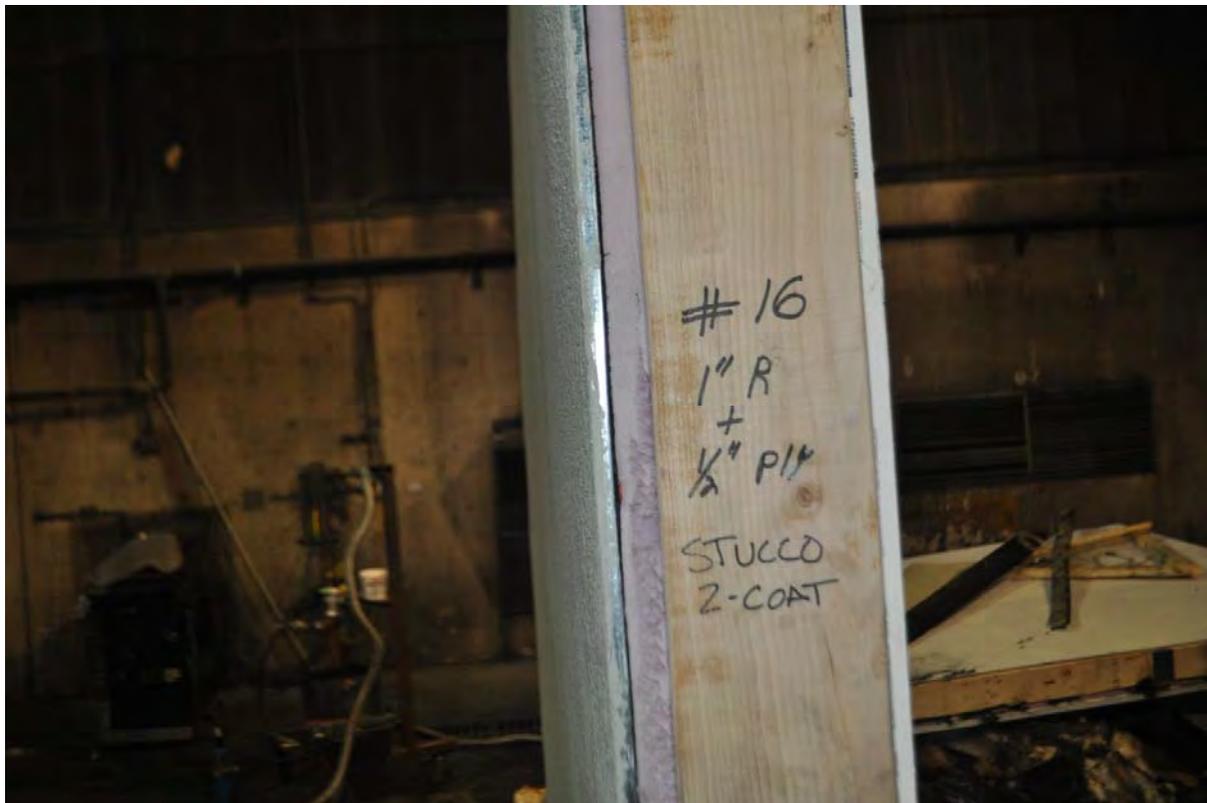
Figure 6. 33: Wall Type 16 Side View

Wall Type	Siding	Additional Material	Sheathing	Insulation	Back Wall
Wall 16	3/8" Elastomeric Base Coat (Stucco)	Layer of W.R.B.	1" R-5 EPS followed by 1/2" Plywood Sheathing	2x6, R-19 KFI w/ IVB	1/2" Gypsum Board

The layout of the wall and materials used for each layer of the wall are specified in Table 6. 77. A side view of the wall is shown in Figure 6. 33. The burner heat release rate (HRR) was initially 100 kW for Experiment 26 and then raised to 200 kW after 20 minutes passed. Photos from Experiment 26 are displayed in Table 6. 78. A timeline of the events within Experiment 26, matching with the photos in Table 6. 78, is shown in Table 6. 79. Heat release rate data, heat flux data, and temperature data from Experiment 26 are shown in appendix G, figures G.142-G.147.

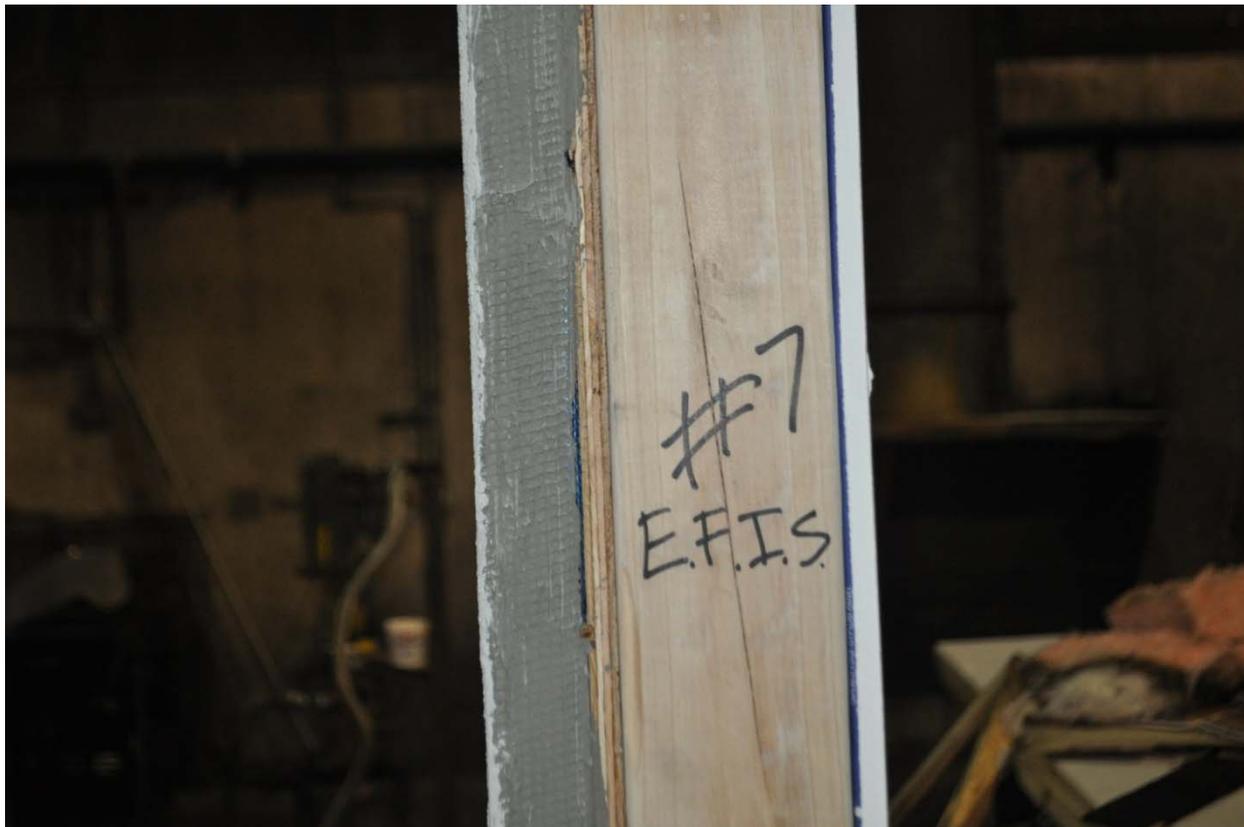
Figure 6. 34: Wall Type 7 Side View

Wall Type	Siding	Additional Material	Sheathing	Insulation	Back Wall
Wall 7	3/16" Base Coat on fiberglass mesh w/ Acrylic Finish (E.I.F.S.)	Weather-Resistant Barrier	1.5" EPS followed by 1/2" Plywood Sheathing	2x4, R-13 KFI w/ IVB	1/2" Gypsum Board

The layout of the wall and materials used for each layer of the wall are specified in Table 6. 80. A side view of the wall is shown in Figure 6. 34. The burner heat release rate (HRR) was initially 100 kW for Experiment 27 and then raised to 200 kW after 20 minutes passed. Photos from Experiment 27 are displayed in Table 6. 81. A timeline of the events within Experiment 27, matching with the photos in Table 6. 81, is shown in Table 6. 82. Heat release rate data, heat flux data, and temperature data from Experiment 27 are shown in appendix G, figures G.148-G.153.

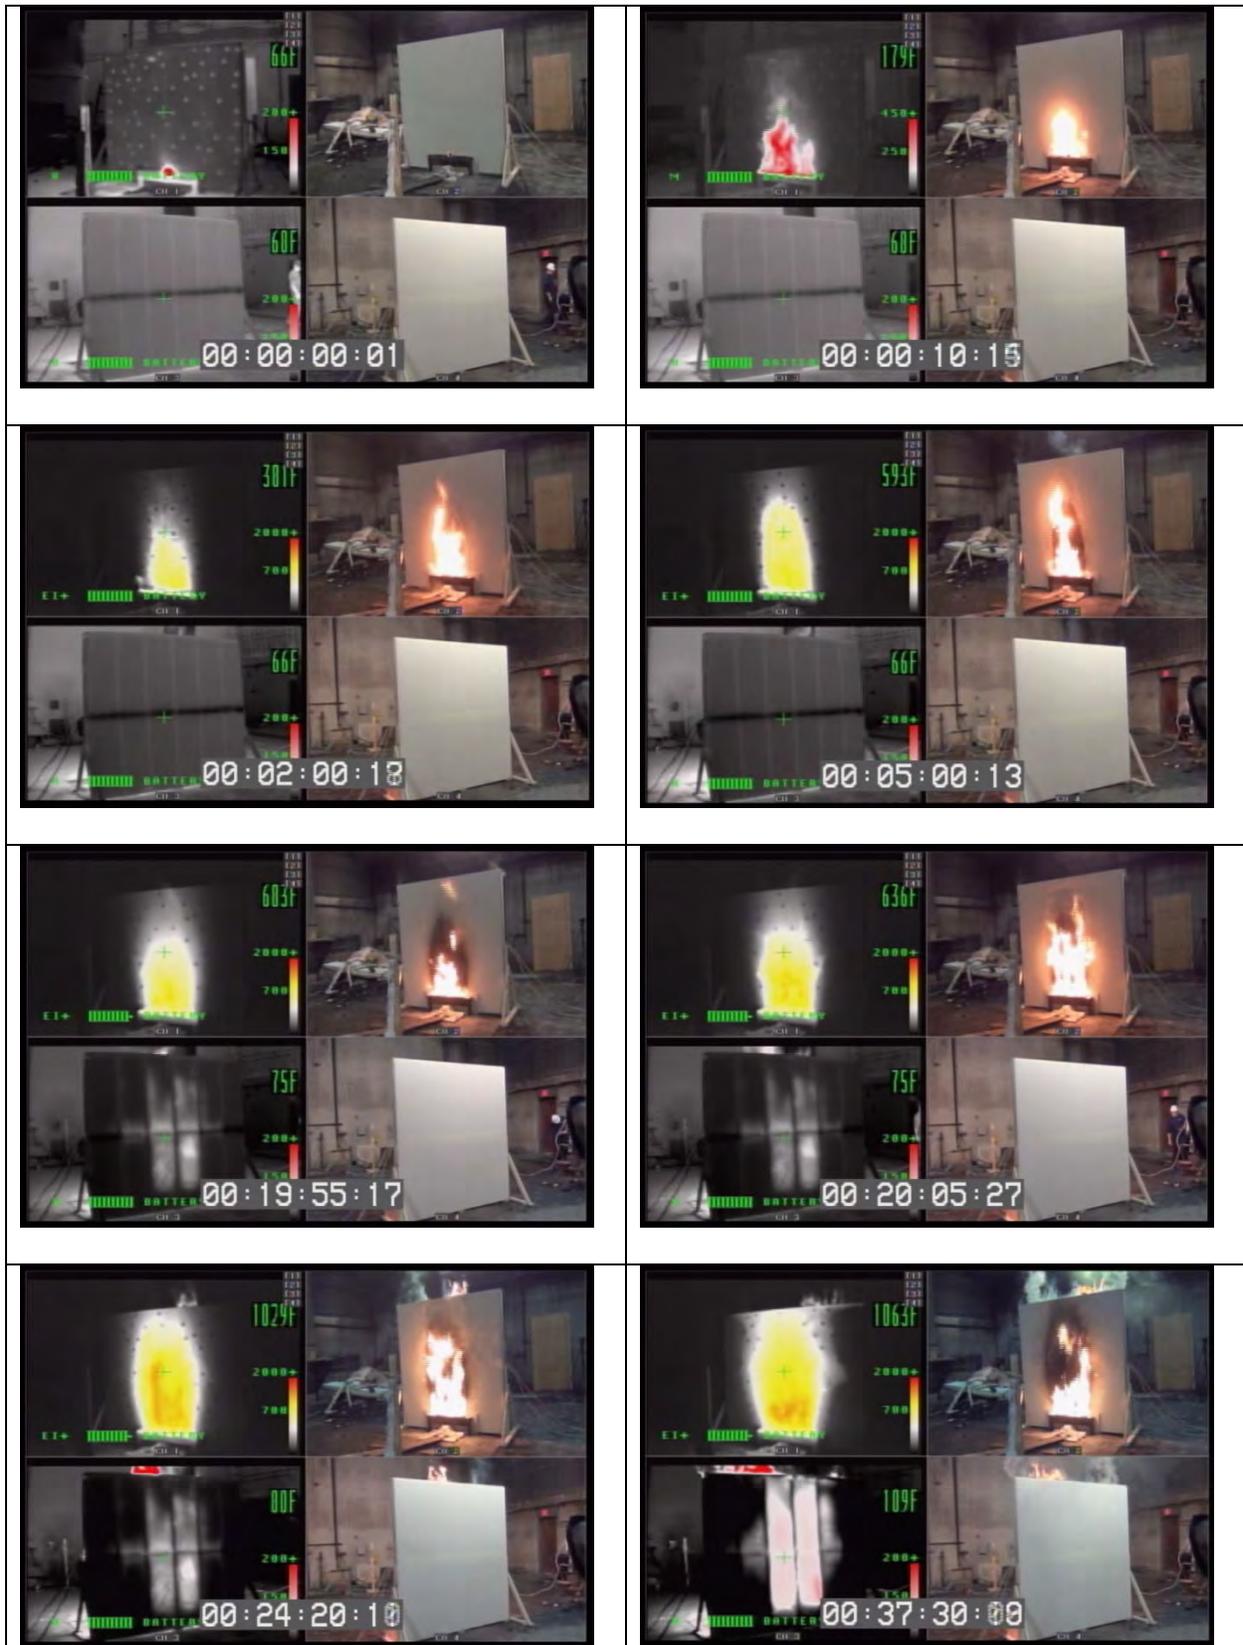
Table 6. 81: Experiment 27 Pictures

Time (mm:ss)	Description
00:00	Ignition
00:10	Burner is on and reaching desired 100 kW heat release rate
02:00	Some initial charring on the siding
05:00	The charred area has increased, the siding is still not involved
19:55	Siding still not involved, some smoke is coming out the top of the wall
20:05	The burner HRR is increased
24:20	Flame is seen exiting out the top of the wall

37:30	Flame and large amounts of smoke exiting out the top of the wall, siding still not involved
50:15	Burner is turned off, hole is punched in the siding to expose the wall materials underneath, small amount of flame exits out one of the holes
53:20	Larger hole is made again and more flame is now visible from burning materials underneath the siding
55:45	Another large hole is made and the fire grows larger
57:00	Flames reach top of the wall and extend above the wall
59:55	Still some flame is visible, the damage to the siding is from holes made during the experiment, experiment is over

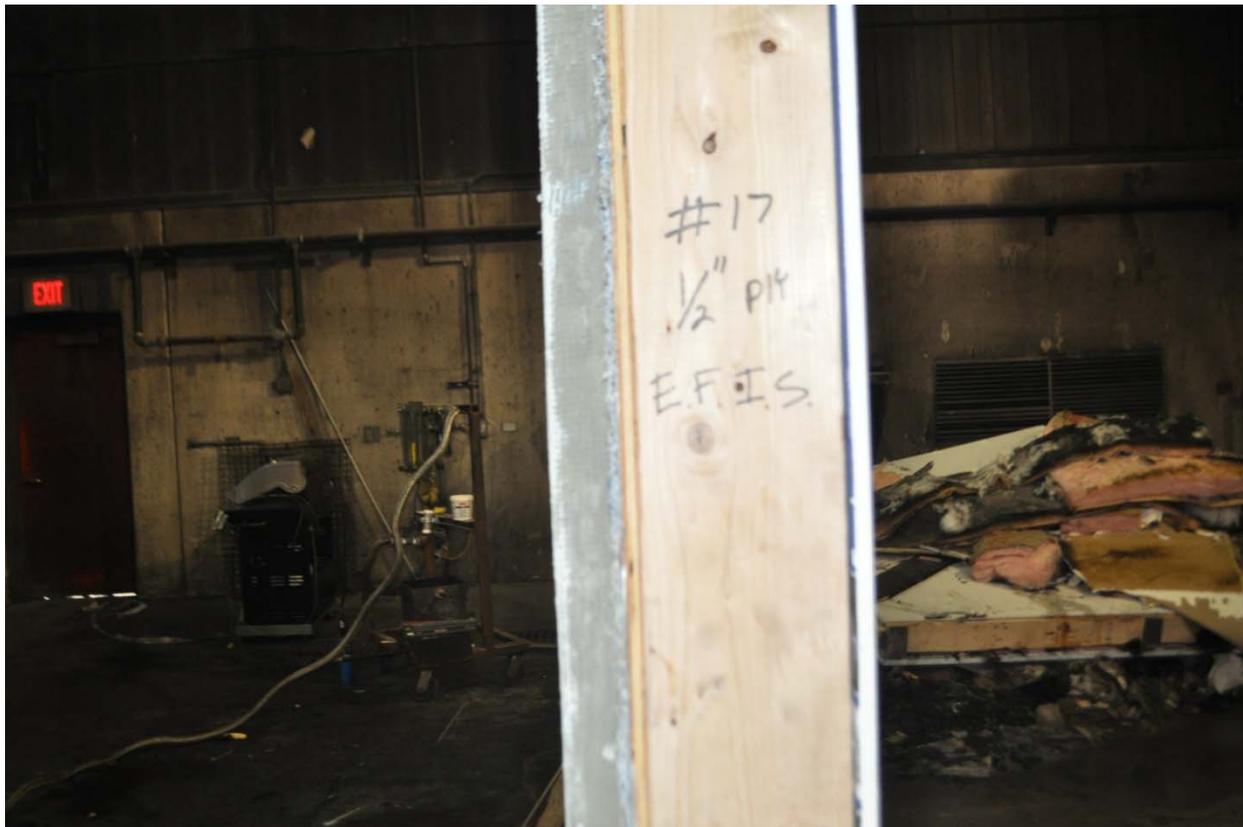
Figure 6. 35: Wall Type 17 Side View

Wall Type	Siding	Additional Material	Sheathing	Insulation	Back Wall
Wall 17	3/16" Base Coat on fiberglass mesh w/ Acrylic Finish (E.I.F.S.)	Weather-Resistant Barrier	1.5" EPS followed by 1/2" Sheathing	2x6, R-19 KFI w/ IVB	1/2" Gypsum Board

The layout of the wall and materials used for each layer of the wall are specified in Table 6. 83. A side view of the wall is shown in Figure 6. 35. The burner heat release rate (HRR) was initially 100 kW for Experiment 28 and then raised to 300 kW after 10 minutes passed. Photos from Experiment 28 are displayed in Table 6. 84. A timeline of the events within Experiment 28, matching with the photos in Table 6. 84, is shown in Table 6. 85. Heat release rate data, heat flux data, and temperature data from Experiment 28 are shown in Appendix G, figures G.154-G.159.

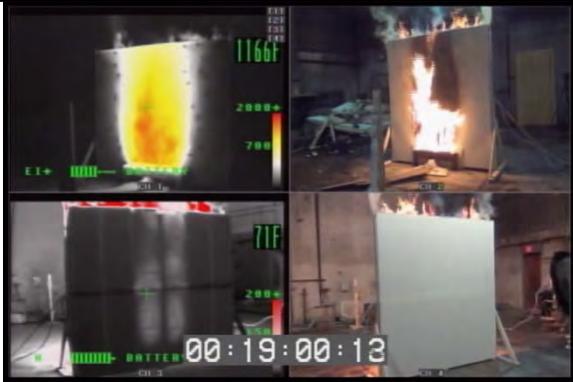
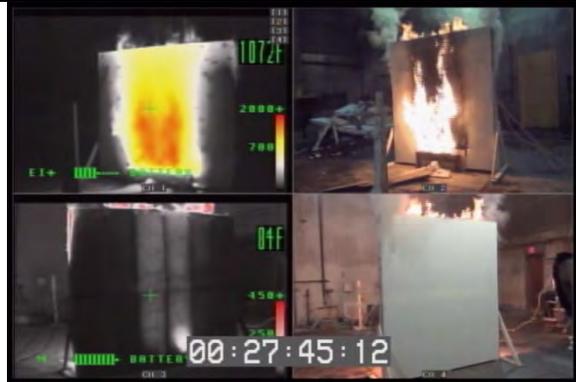
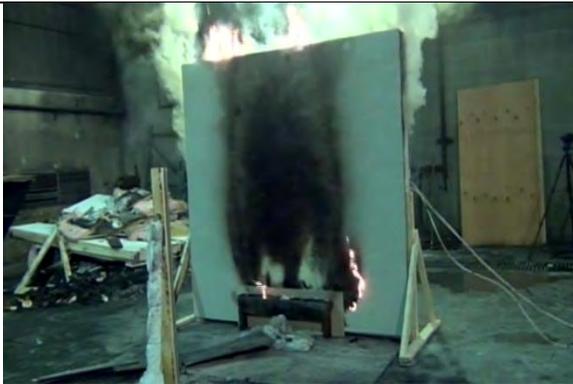
Table 6. 84: Experiment 28 Pictures

Time (mm:ss)	Description
00:00	Experiment begins
00:10	Burner is on and reaching desired 100 kW heat release rate
02:00	Some initial charring of the siding

06:00	The charred area on the wall has increased, siding is still not involved, smoke is exiting out the top of the wall
10:15	Burner HRR is increased
12:45	Charring has reached the top of the wall, some flame is exiting out the top of the wall

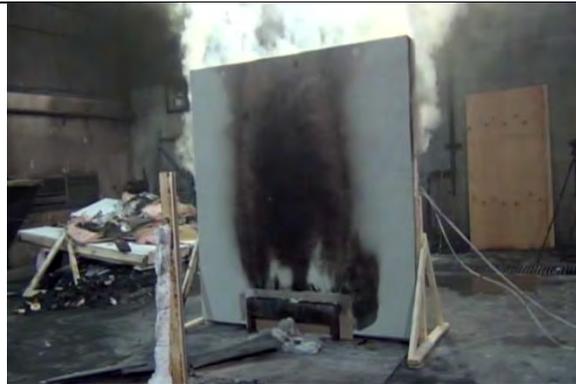
Front View at 30:05

19:00	Flame is exiting out the entire width of the top wall, siding is still not involved
27:45	Conditions mostly unchanged from 19:00, video ends
30:05	Burner is turned off, flames still exiting out the top of the wall, siding is no longer burning except for a small portion near the bottom right of the wall

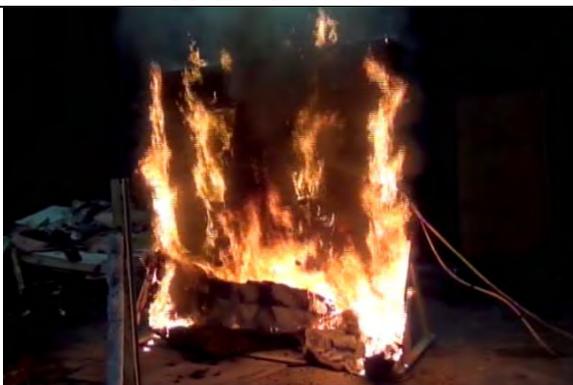
Back View at 39:05

39:05	Initial charring on the back of the wall
40:00	Materials under siding still involved, heaviest burning is on the outside of the wall where the supports of the wall have gotten involved in the fire

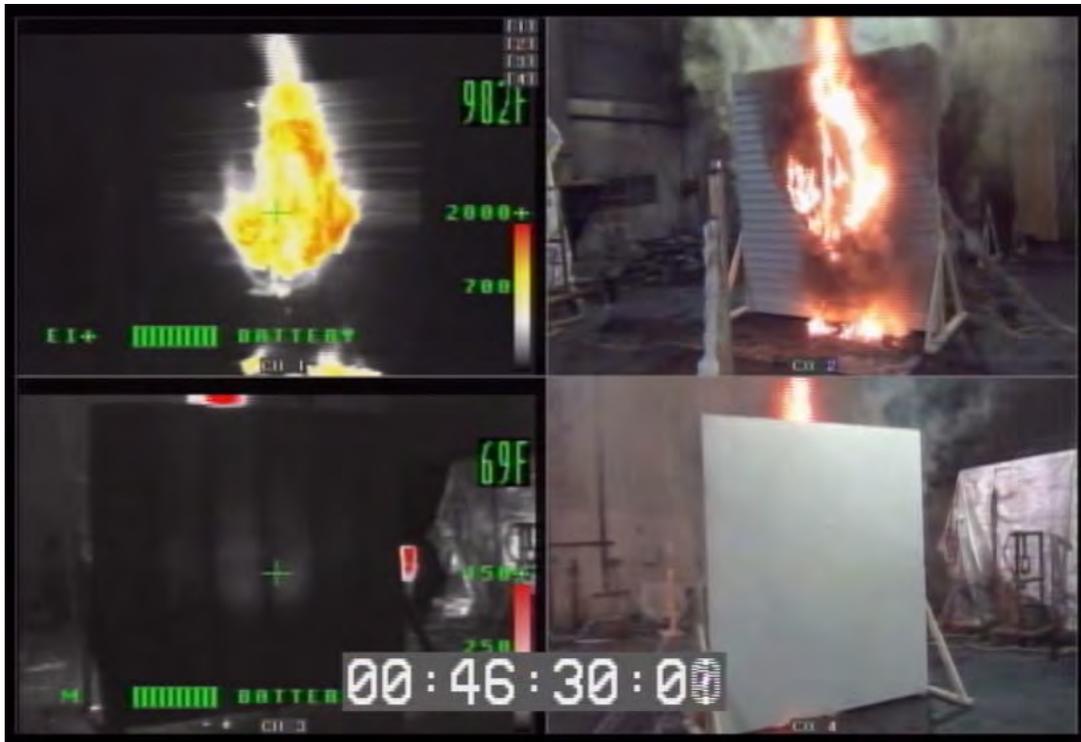
Figure 6. 44: Picture of Peak Heat Release Rate for Wall Type 8 Grill Fire

The grill source was a low hazard with wall type 1 as ignition took on the order of tens of minutes the fire self-extinguished when the grill was removed. It was only able to generate a small area of flame as seen in Figure 6. 45 For wall type 8 with the polystyrene sheathing the fire spread up the wall surface and would have exposed a potential eave line indicating the grill source would have a been a hazard for that wall type for this configuration see Figure 6. 44.

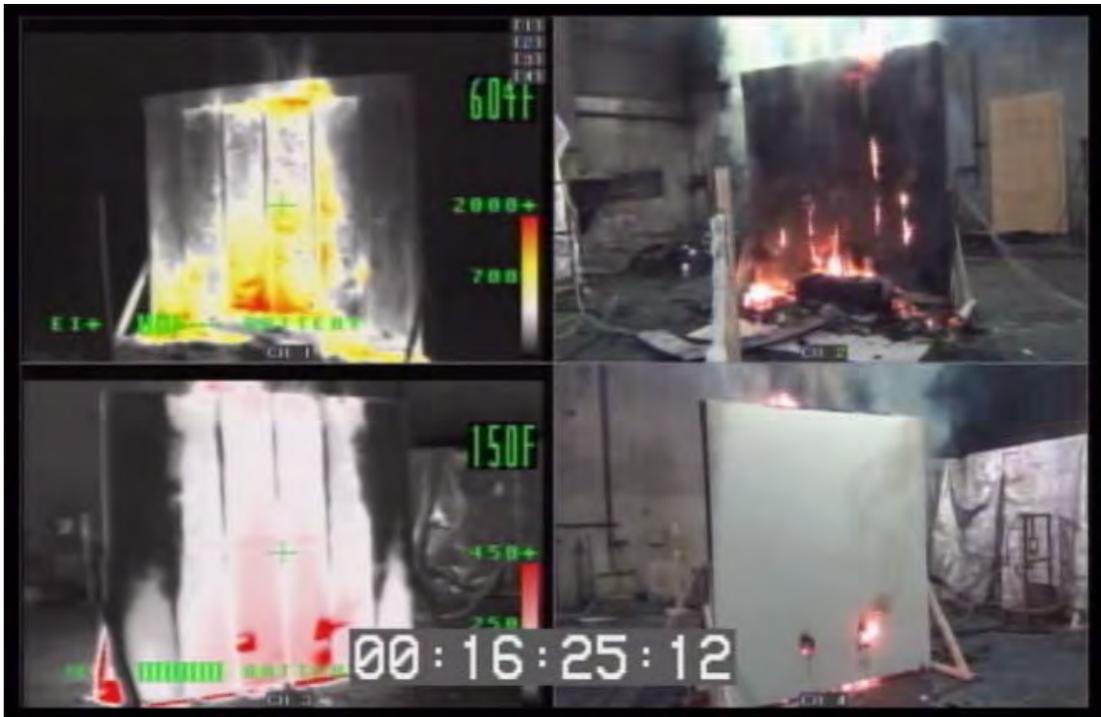
Figure 6. 46: Image of Fire out of Back Wall of Experiment 12

To evaluate the effect of electrical receptacles experiment 12 and experiment 13 had receptacles, i.e. outlets, on the back wall. In Figure 6. 46 and Figure 6.47 fire can be seen exiting out of the back wall through the receptacles. This suggests that the receptacles can contribute to the penetration of an exterior fire to the interior. These two experiments were the only two experiments with significant flaming exiting out of the back wall. There were other experiments with large areas of discoloration indicating heat damage, but the flame did not penetrate through, since there was no hole in the wall for the flame to exit. The gypsum board provides an effective fire barrier when not compromised by penetrations for purposes such as electrical or plumbing. Therefore the walls themselves are unlikely to be the method of penetration from the exterior. Instead, other parts of the wall that make the wall more vulnerable to penetration, such as receptacles or possibly windows, are likely to be the cause of exterior to interior fire spread.

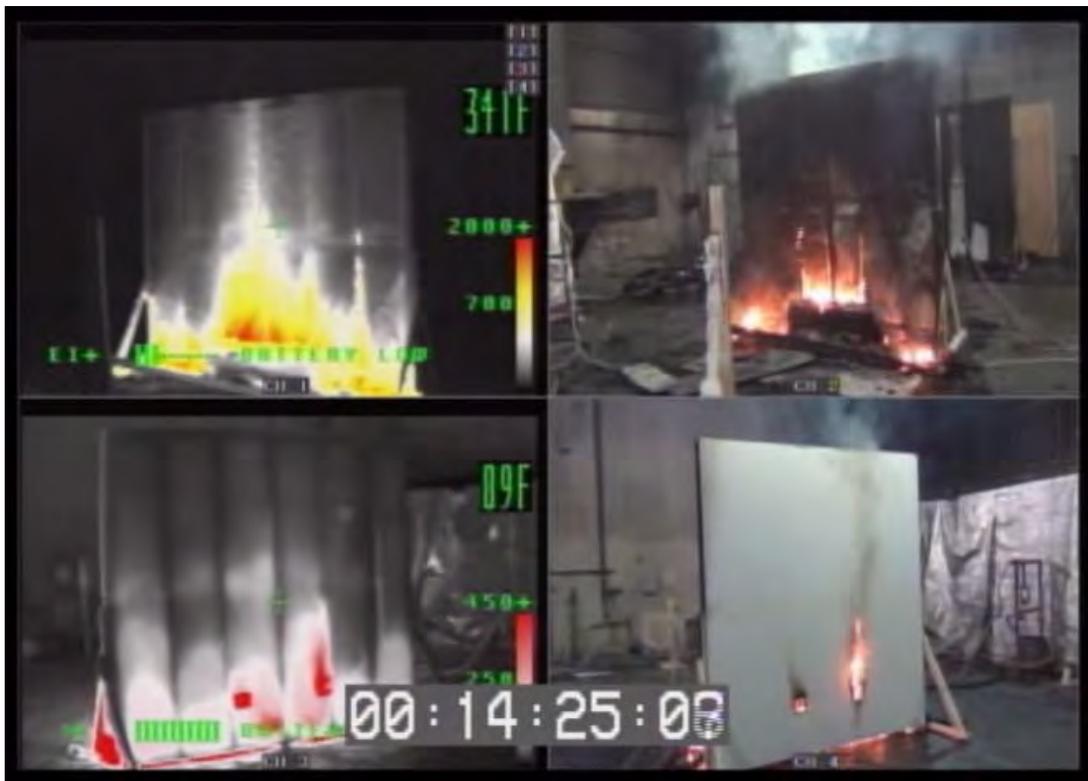
Figure 6. 47: Image of Fire out of Back Wall of Experiment 13

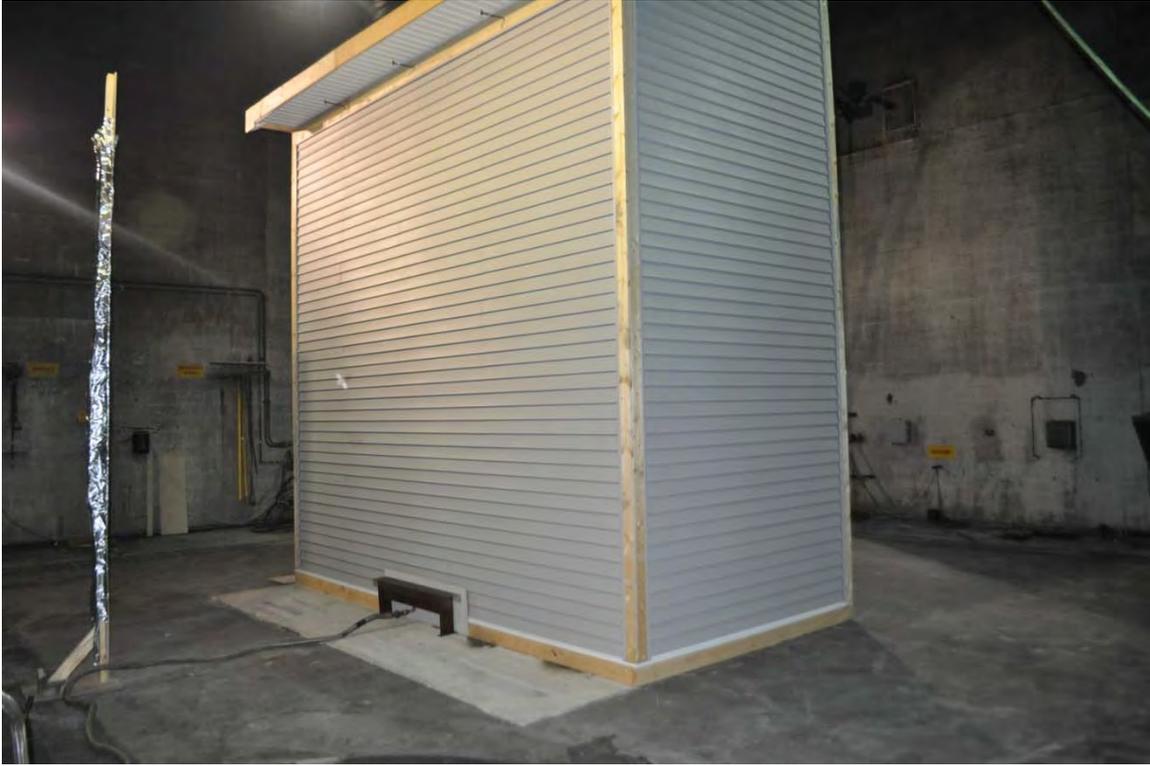
Figure 7. 2: Front View of Eave Structure for Experiment 1

The layout of the wall and materials used for each layer of the exterior wall are specified in Table 7. 1. The attic insulation is the same as the wall insulation and lies on the ceiling in the attic. A front view and rear view of the wall and attic structure is shown in Figure 7. 2 and Figure 7. 3. The burner heat release rate (HRR) was 100 kW for Experiment 1 while the burner was on. Photos from Experiment 1 are displayed in Table 7. 2. A timeline of the events within Experiment 1, matching with the photos in Table 7. 2, is shown in Table 7. 3. Heat release rate data, heat flux data, temperature, and flow velocity data from Experiment 1 are shown in appendix H figures H.1-H.13.

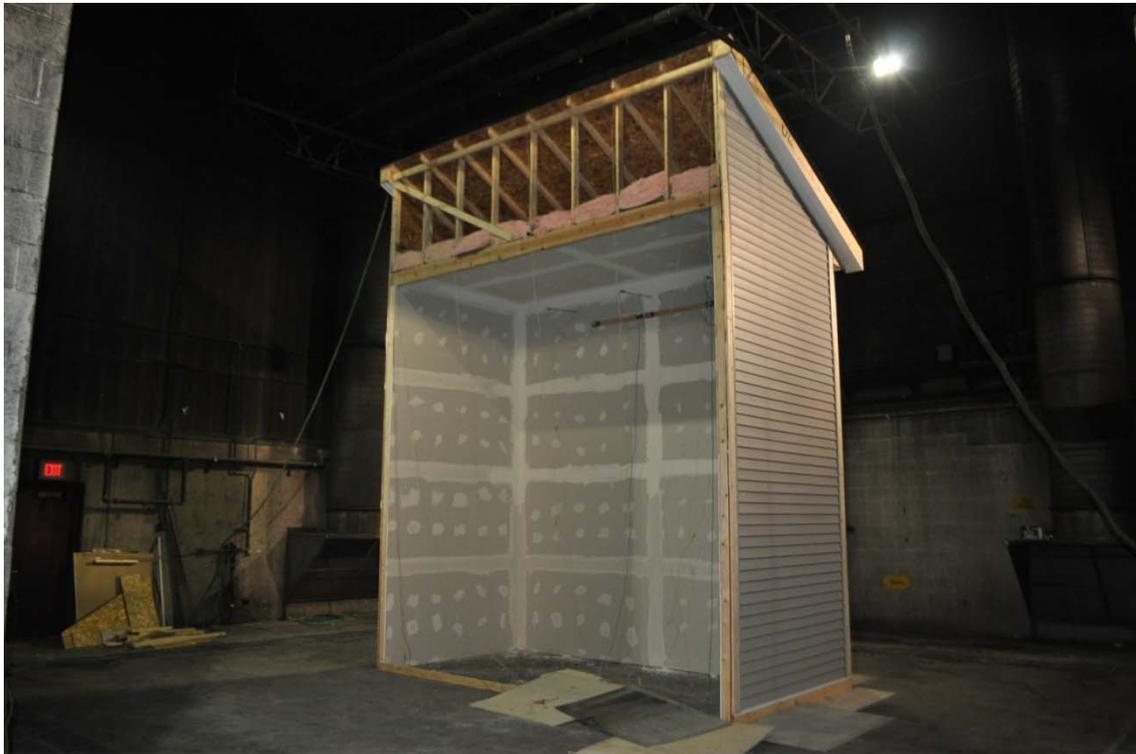
Figure 7. 3: Rear View of Eave Structure for Experiment 1

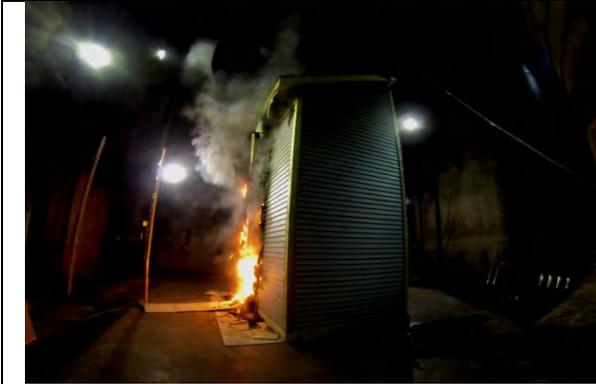
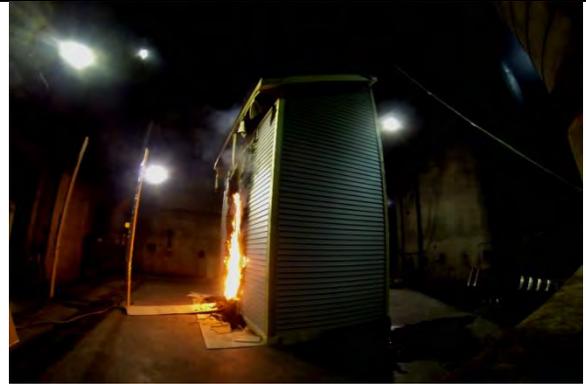
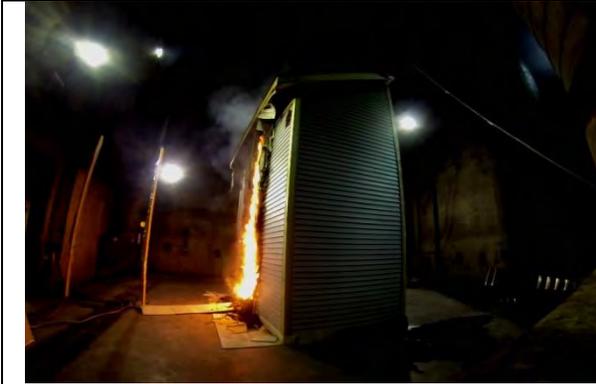
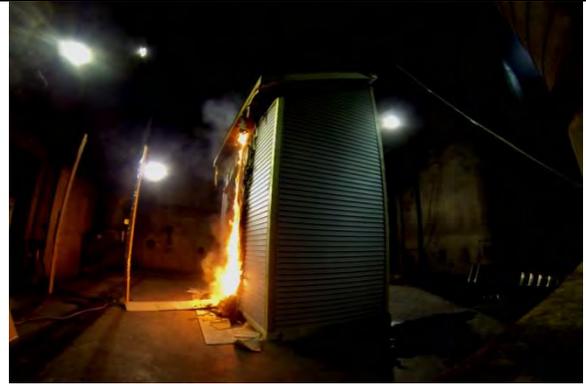
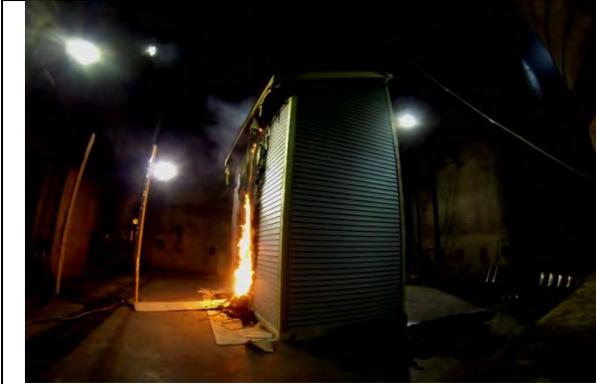
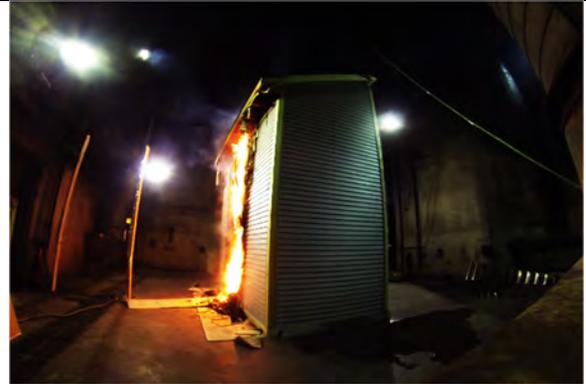
Table 7. 2: Eave Experiment 1 Pictures

07:00	Fire recedes back down, only the outer parts of the vinyl siding are burning
15:00	Fire starts to grow again vertically along the plywood sheathing

19:00	Fire dies back down again, burning in the eave is almost completely diminished
24:40	Flames visible in attic space
26:00	Fire again spreads to the top of the wall from the plywood sheathing

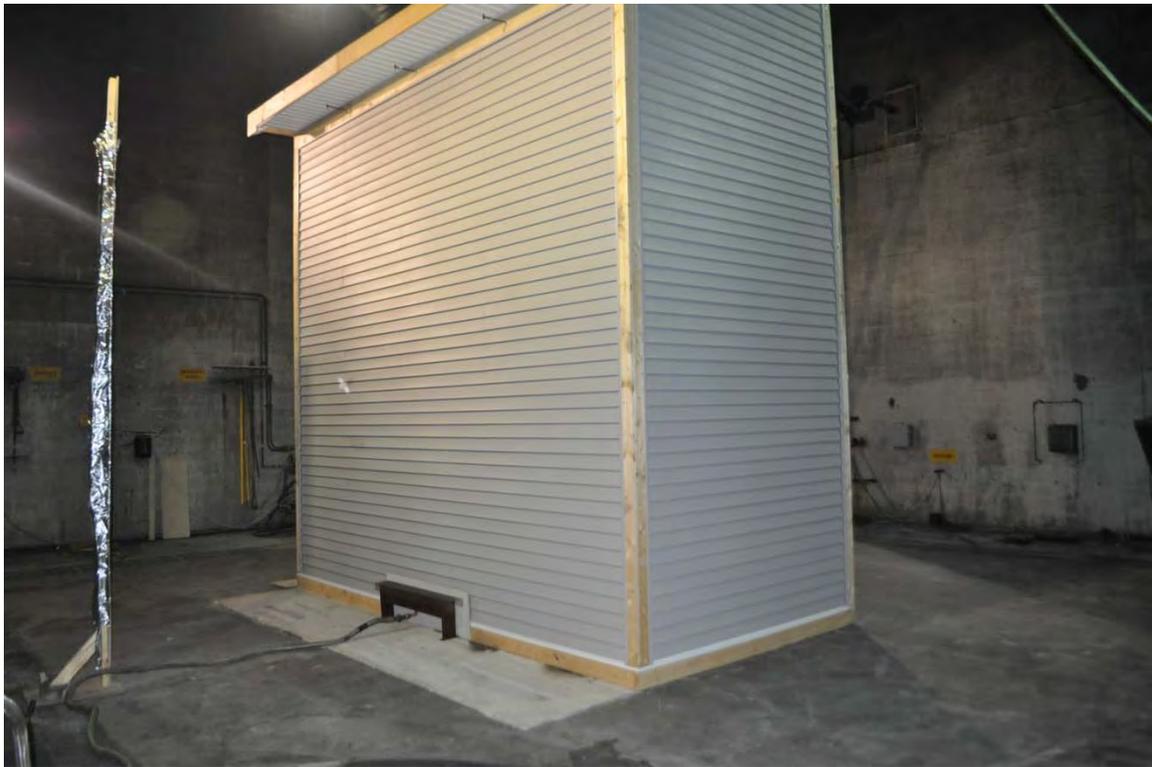
Figure 7. 4: Front View of Eave Structure for Experiment 2

The layout of the wall and materials used for each layer of the exterior wall are specified in Table 7. 4. The attic insulation is the same as the wall insulation and lies on the ceiling in the attic. A front view and rear view of the wall and attic structure is shown in Figure 7. 4 and Figure 7. 5. The burner heat release rate (HRR) was 100 kW for Experiment 2 while the burner was on. Photos from Experiment 2 are displayed in Table 7. 4. A timeline of the events within Experiment 2, matching with the photos in Table 7. 4, is shown in Table 7. 6. Heat release rate data, heat flux data, temperature, and flow velocity data from Eave Experiment 2 are shown in appendix H figures H.14-H26.

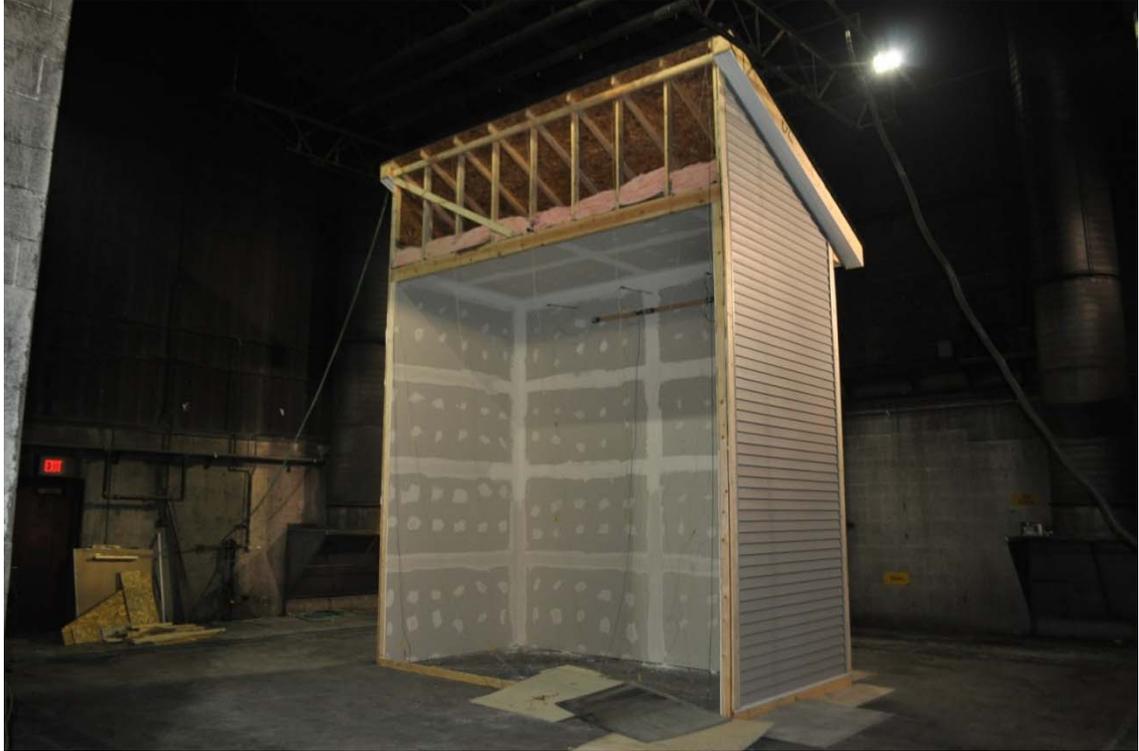
Figure 7. 5: Rear View of Eave Structure for Experiment 2

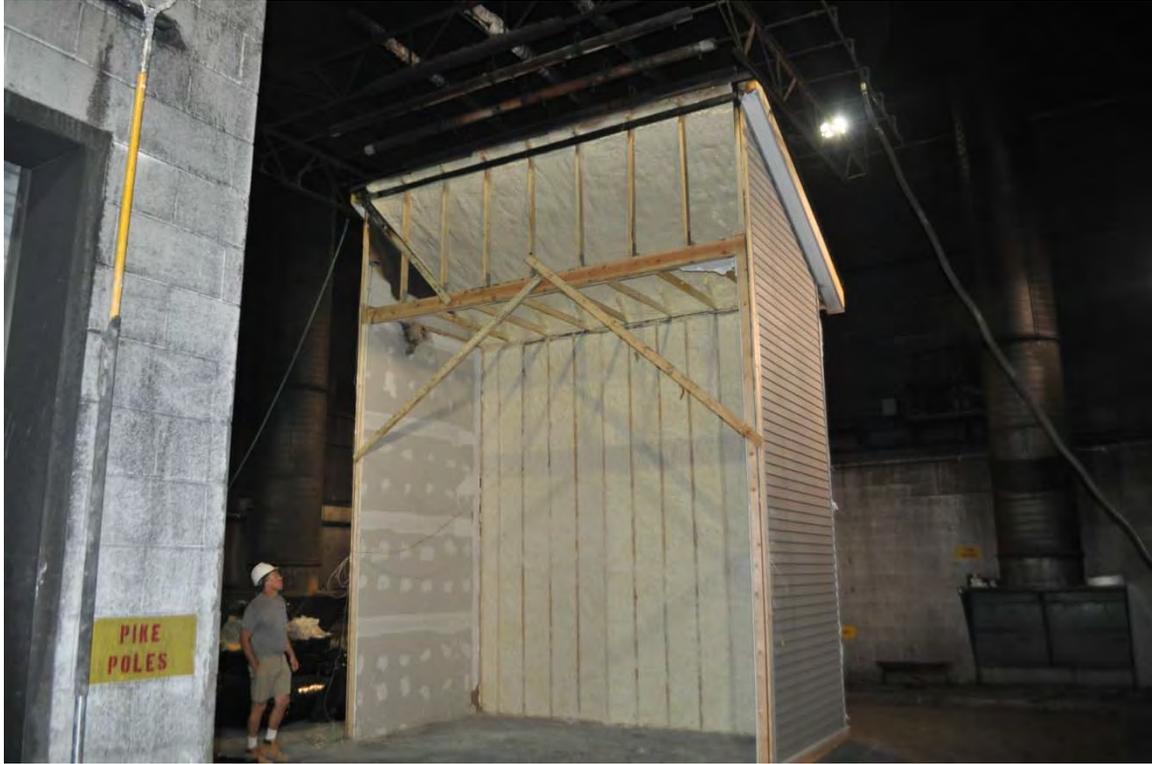
Figure 7. 7: Rear View of Eave Structure for Experiment 3 before drywall application

The layout of the wall and materials used for each layer of the exterior wall are specified in Table 7. 7. The attic insulation is the same as the wall insulation, and, in this case, is applied to the underside of the roof. A front view and rear view of the wall and attic structure is shown in Figure 7.6 and Figure 7. 7. The burner heat release rate (HRR) was 100 kW for Experiment 3 while the burner was on. Photos from Experiment 3 are displayed in Table 7. 8. A timeline of the events within Experiment 3, matching with the photos in Table 7. 8, is shown in Table 7. 9. Heat release rate data, heat flux data, temperature, and flow velocity data from Eave Experiment 3 are shown in appendix H, figures H.27-H.39.
