Study of Residential Attic Fire Mitigation Tactics and Exterior Fire Spread Hazards on Fire Fighter Safety

UL Firefighter Safety Research Institute

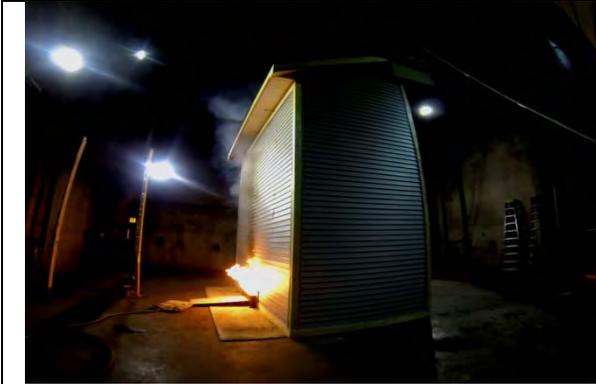
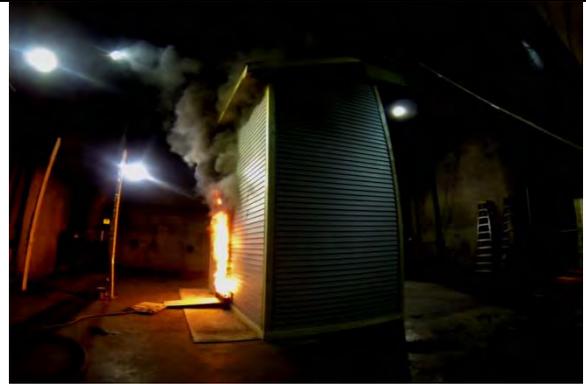
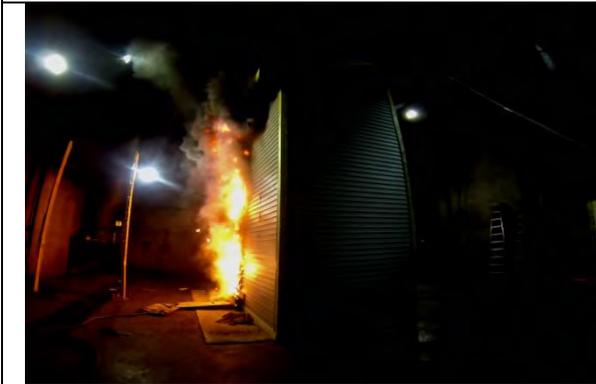
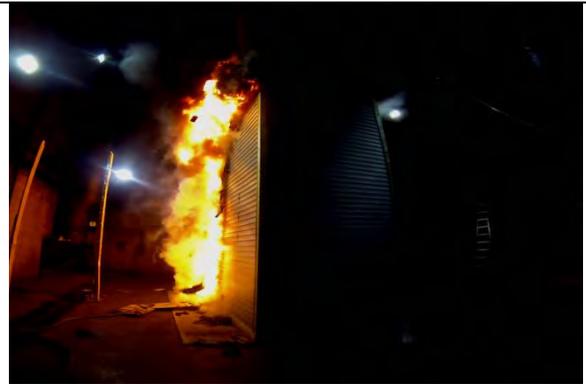
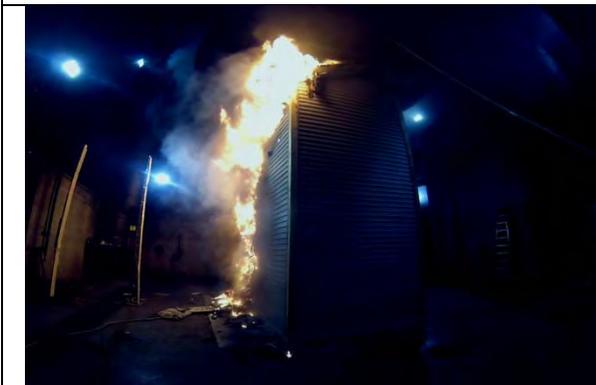
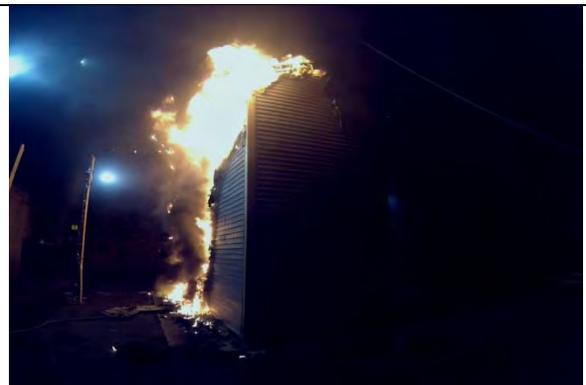
Table 7. 8: Eave Experiment 3 Pictures

Time (mm:ss)	Description
00:00	Start of the Experiment
00:10	Burner is turned on and set to a heat release rate of 100 kW
01:00	Smoke is visible, vinyl siding begins to burn

06:00	Eaves are still fully involved, parts of the wall in the center have burned up, the fire on the wall is spreading horizontally outwards from the center

08:00	Eaves still fully involved, flames have spread farther out and are nearing the edge of the wall, flame from the wall has diminished
10:00	Eaves still fully involved, clear damage to vinyl siding at the top of the side of the structure

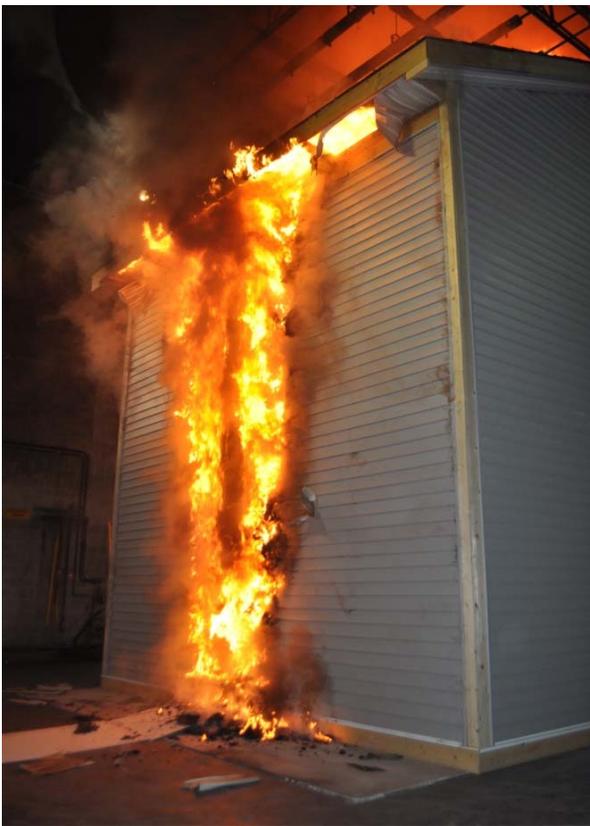
Figure 7. 8: Eave Experiment 2 Fire

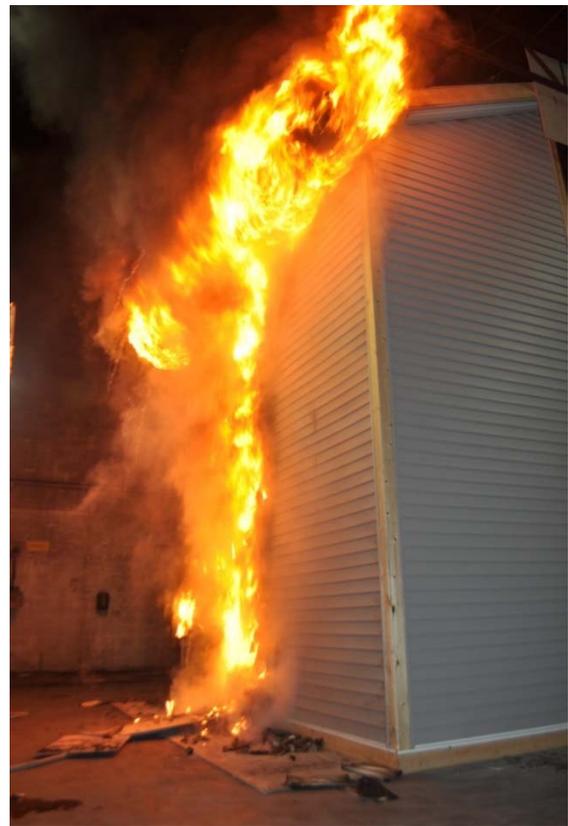
Figure 7. 9: Eave Experiment 3 Fire

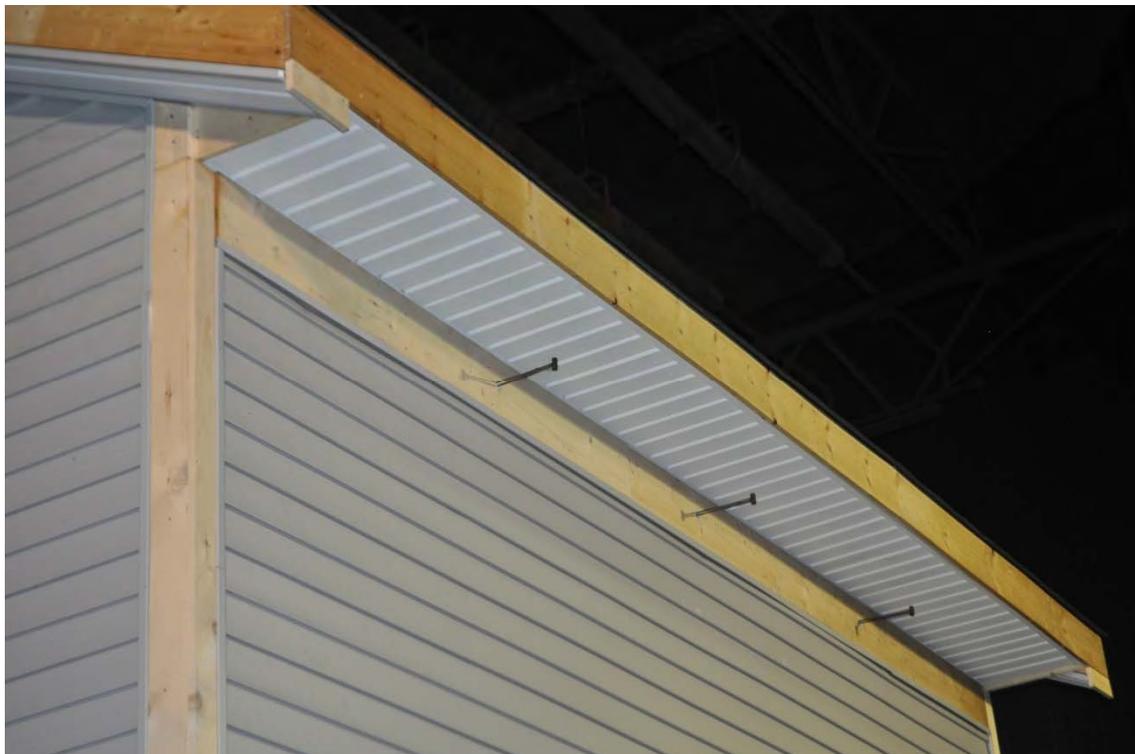
Figure 7. 10: Vinyl Eave Vents

Flames entered the attic space in eave experiment 2 occurred at 1:51 into the experiment due to the rapid flame spread up the surface of the wall. The present of vinyl eaves (Figure 7. 10) and plastic baffles (Figure 7. 11) which melted out quickly due to the heat from below provided no resistance to the spread of flames into the attic space. The additional fuel from the polystyrene insulation board and direct flame impingement on the sheathing of the roof resulted in the attic space becoming fully involved in under 20 seconds. Figure 7. 12 through Figure 7. 16 show the rapid progression of flames in the attic space.

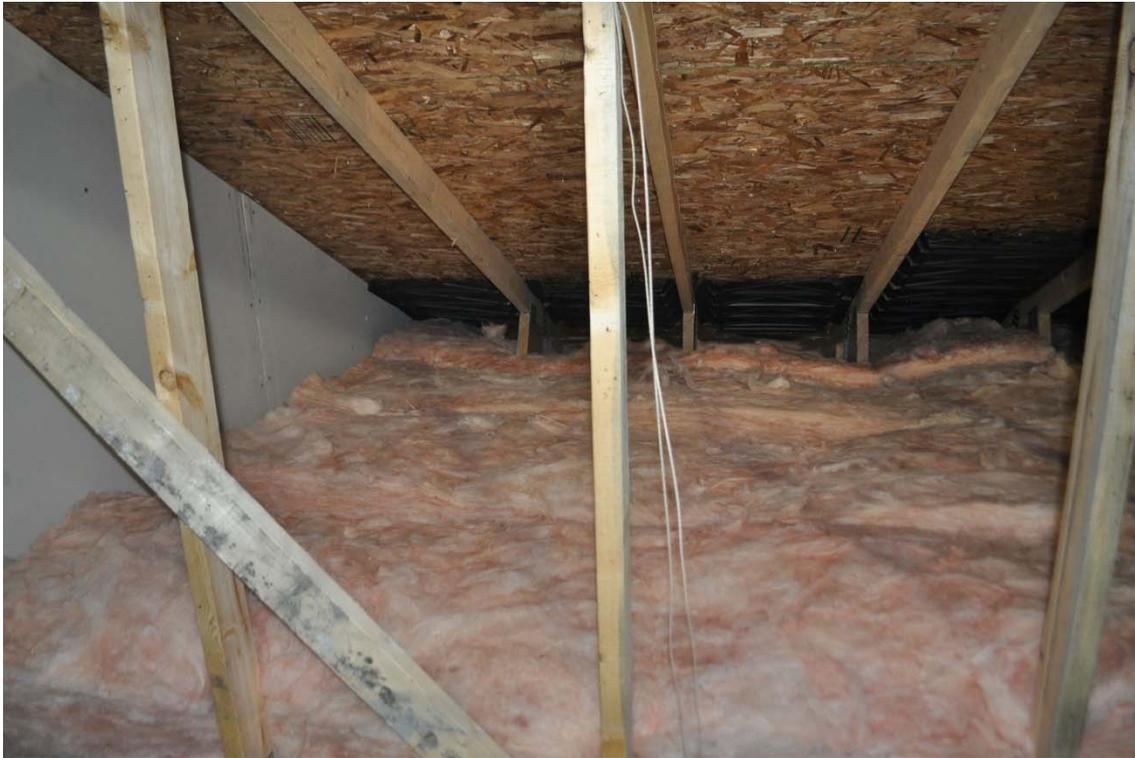
Figure 7. 11: Plastic Ventilation Baffles

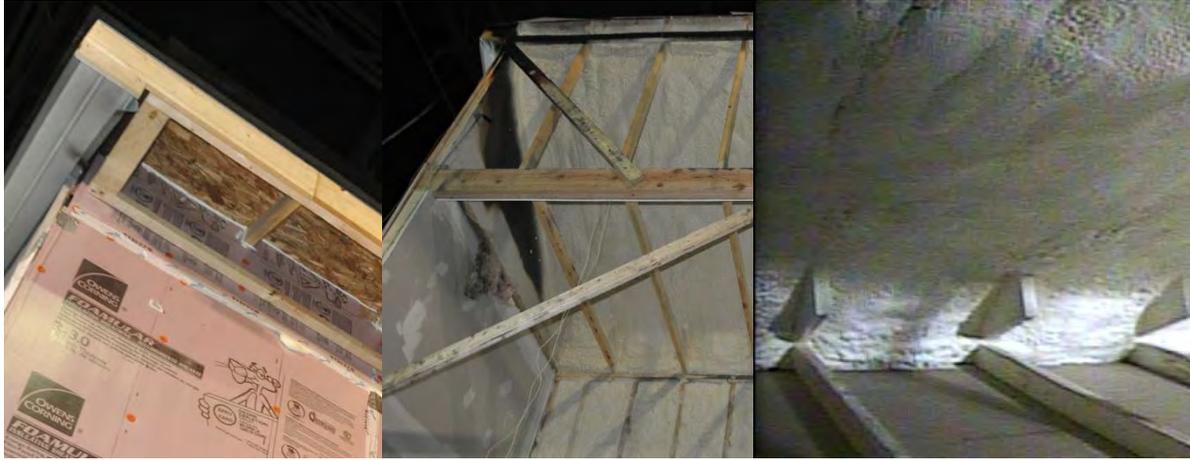
Figure 7. 17: Spray Foam Insulation in Eave Line

The transition to structure fire in experiment 3 took significantly longer than eave experiment 2 but not as long as eave experiment 1. This occurred due to the construction of the eave and attic space. Unlike experiment 2 the attic space in experiment 3 was part of the conditioned space of the structure with the spray foam providing the insulation barrier in the exterior wall and on the roof of the attic. To ensure energy efficiency the spray foam was also placed in the eaves to provide a continuous insulation system (Figure 7. 17). Flames entered the attic space at 10:23 only after they had spread vertically up the wall and the spray foam in burned away.

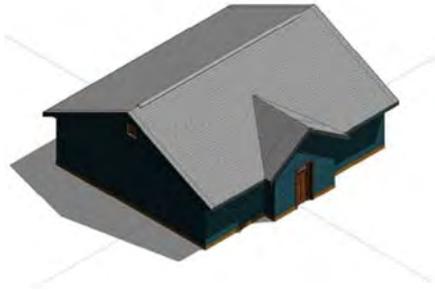
Figure 8. 1: Rendering of experimental fixture

The four full scale attics test structures incorporated a light weight truss roof system with an 8 ft. space below simulating the living space in a home. The structures measured 30 ft. by 36 ft. with 6-12 pitched roofs constructed with wood plywood sheathing, ridge vent, gable vents and eave vents (Figure 8. 1 through Figure 8. 8). Shingles were provided on the ridge vent and 4 ft. down each side of the peak for all fixtures with the exception of the test fixture used in experiment 1. The attic was separated from the space below with a layer of ½ in. gypsum wall board and two layers of 6” fiberglass bat insulation. Attic access hatches measuring 2 ft. by 4 ft. were used to gain access to the attic space for instrumentation however were closed off with a ½ in. sheet of gypsum wall board and no insulation during tests. The space below was finished with ½ in. gypsum wall board to provide an enclosure finished with tape and plaster. A single door provided access for suppression tactics and instrumentation. Each structured was used to evaluate the effectiveness of one or more fire suppression tactics for a total of 7 experiments. Construction drawings for the test fixtures can be found in Appendix C, Figures C.1-C.4.

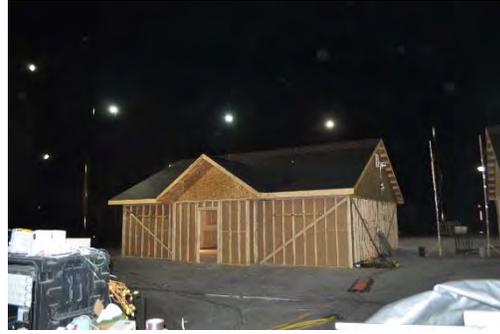
Figure 8. 2: Front of structure

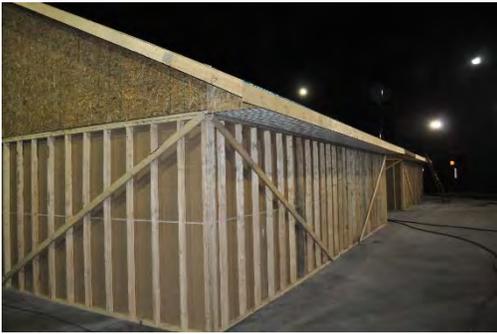
Figure 8. 3: Rear of structure

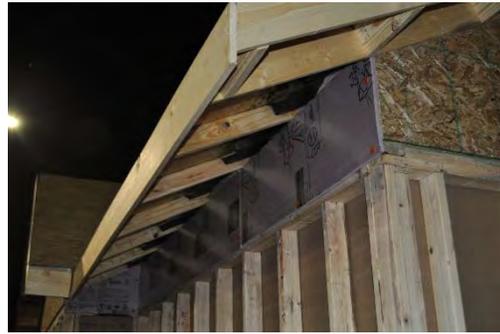
Figure 8. 4: Eave construction detail (before soffit was added)

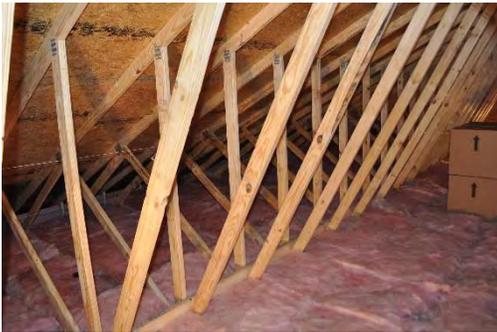
Figure 8. 5: Attic construction

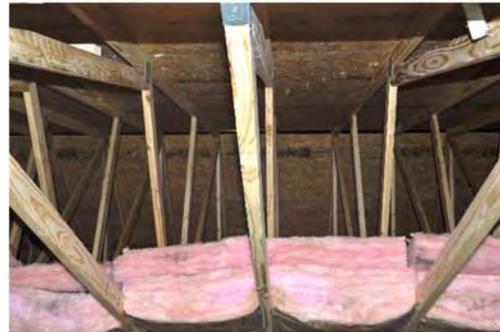
Figure 8. 6: Attic insulation

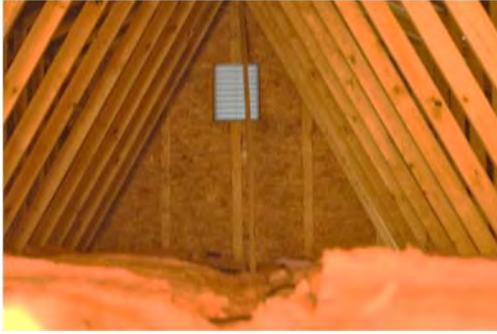
Figure 8. 7: Center of attic and gable vent

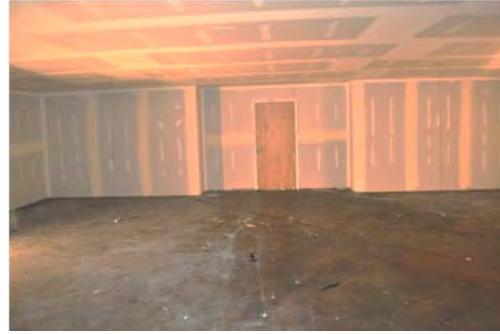
Figure 8. 8: Interior of structure

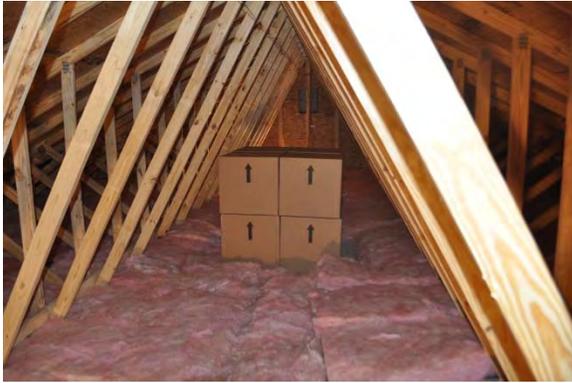
Figure 8. 9: Attic Experiment 1 Fuel Load

This experiment was intended to evaluate the fire dynamics and suppression effectiveness of an attic fire where interior operations were conducted. The suppression tactic evaluated involved breaching the attic ceiling just enough to provide access to the space with a nozzle. Eight (8) type IV commodity boxes (cardboard boxes with plastic cups) were placed on a 4 ft. x 4 ft. cement board located centered in the attic space. This experiment was the only experiment conducted without shingles over the ridge vent and 4 ft. down the roof slope. Ignition was provided by an electric match located at the center of the boxes covered with shredded paper to ensure fire spread to the commodity boxes. Figure 8. 9 and Figure 8. 10 below show the fuel load in the attic and a sample of the electric match used for ignition.

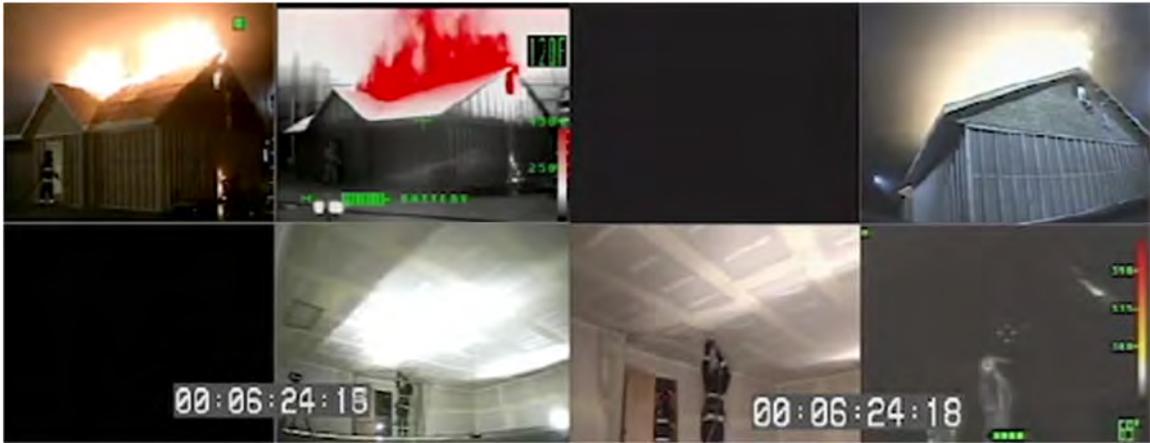
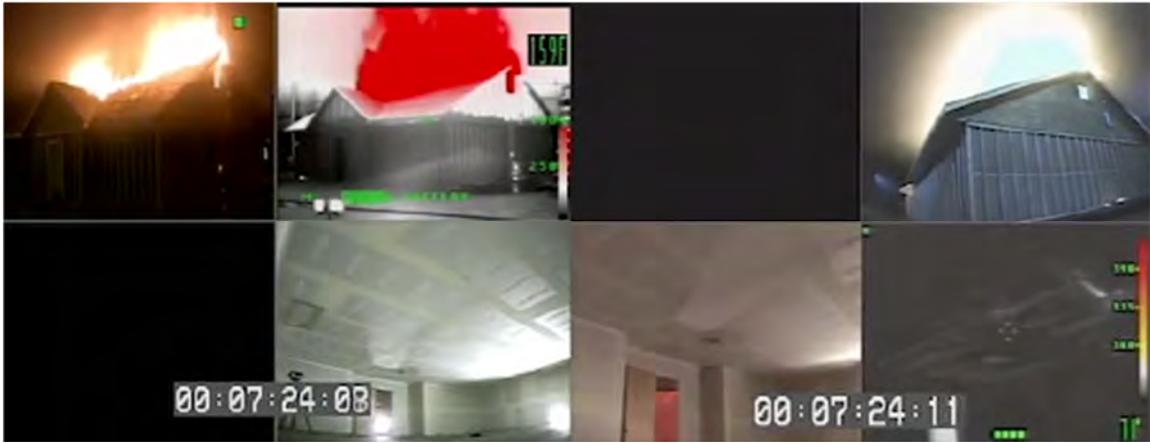
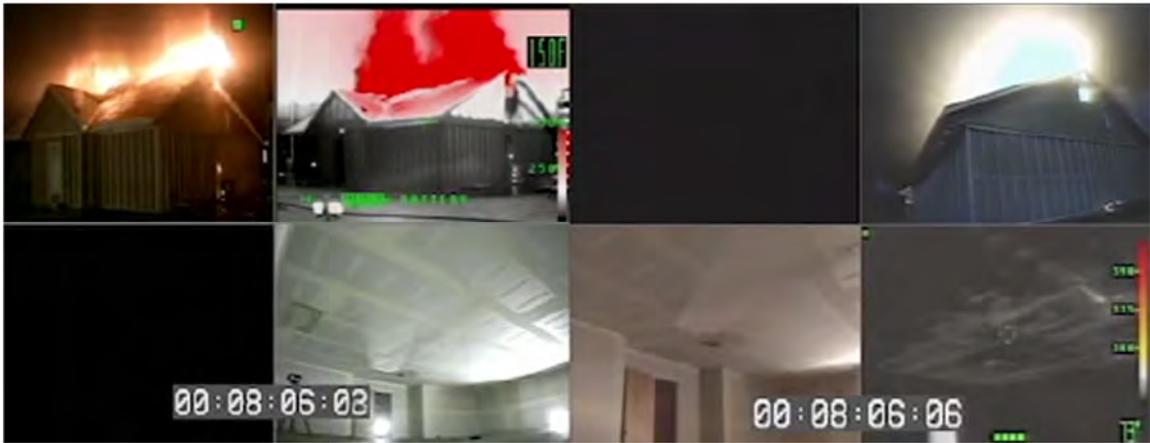
Table 8. 2: Experiment 1 - Chronological Images

<u>Event</u>	<u>Time</u>
Ignition	00:00
Fog Stream through Small Hole Below - On	05:46
Fog Stream through Small Hole Below - Off	06:24
1 Minute Following Water Application	07:24
Straight Stream East Gable	08:06
Eaves Pulled	08:53
Water Applied through Eaves – Side A East	09:06
Water Applied through Eaves – Side A West	09:33
Water Applied through Eaves – Side C	11:31
Ceiling Collapse	11:47

The front door to the test set up was closed and ignition takes place at 00:00. After the fire grows to a relatively steady state a simulated engine crew opens the front door and uses a pike pole to punch a small hole is put in ceiling just inside the door just large enough for an automatic nozzle to fit through. An automatic nozzle set to a wide fog and supplied with 100psi flowing approximately 150gpm is placed in the hole created and turned on at 05:46. Water flows for 38 seconds or a total of approximately 95 gallons and the nozzle is removed at 06:24. The crew backs out and leaves the front door open. The crew repositions to the east gable and at 08:06 uses a straight stream for 24 seconds through the east gable with the same flow rate. At 08:53 the front eaves are pulled starting on the west side of the door and working toward the east side. Water is applied through the eaves at 09:06 starting in the same location and working west using a straight stream at 100psi flowing 150gpm. While water is flowing through the front east eaves the west eaves are removed at 09:15. At 09:33 the line is repositioned to the west eaves and water is applied using the straight stream pattern at the same flow rate. Water is applied through the rear eaves at 11:31 using a safety line for which pressure/flow were not monitored. The ceiling collapses at 11:47. After 12:00 the majority of the flames have been extinguished, video and data continue until 12:45. Table 8. 2 shows images of the experiment at each of the events steps described in Table 8. 1. All data gathered during the experiment can be found in Appendix I, Figures I.1-I.11.

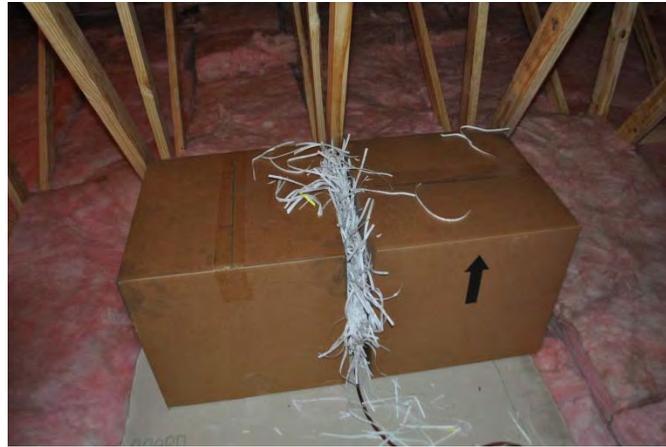
Figure 8. 11: Attic Experiment Two Box Fuel Load

This experiment was intended to study the fire dynamics and suppression effectiveness when a large is created below the fire to apply water while the attic is intact. Two (2) type IV commodity boxes were placed on a 4 ft. x 4 ft. cement board located centered in the attic space. Ignition was provided by an electric match located at the center of the boxes covered with shredded paper to ensure fire spread to the commodity boxes. Figure 8. 11 shows the fuel load for this experiment.

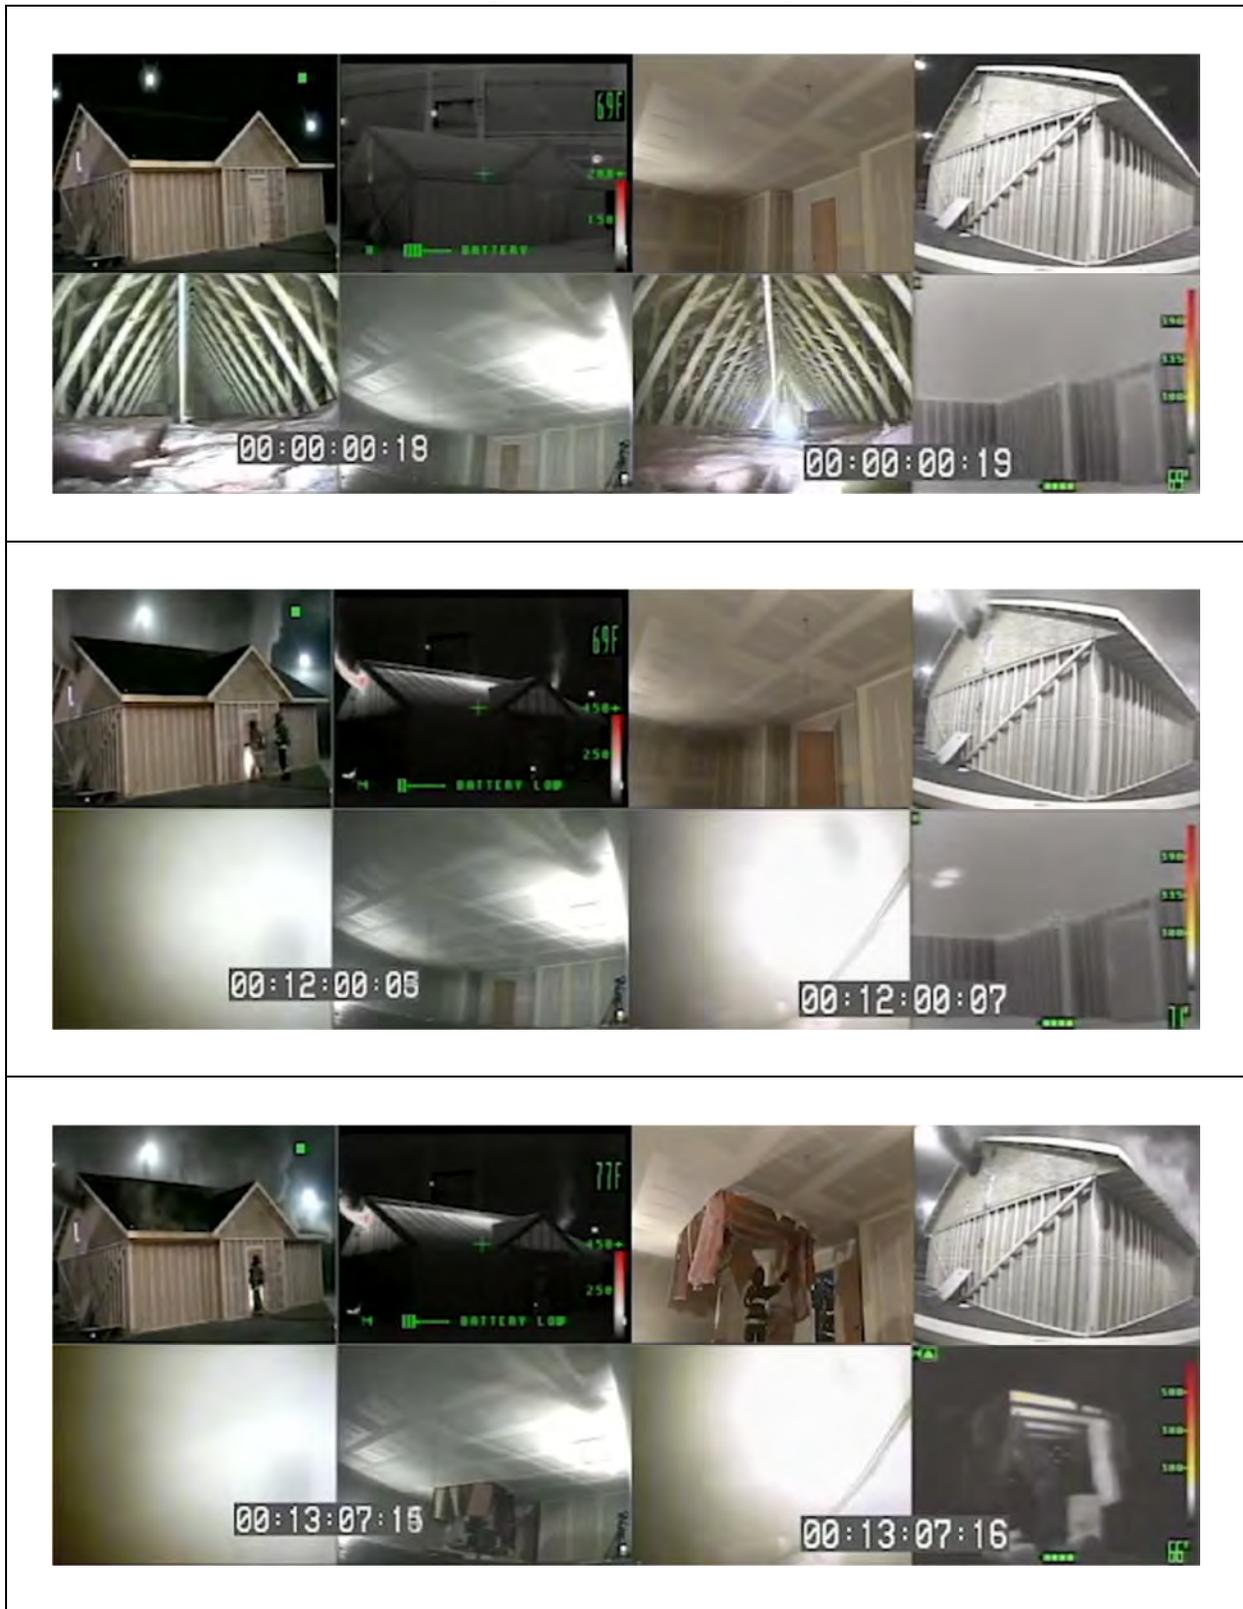
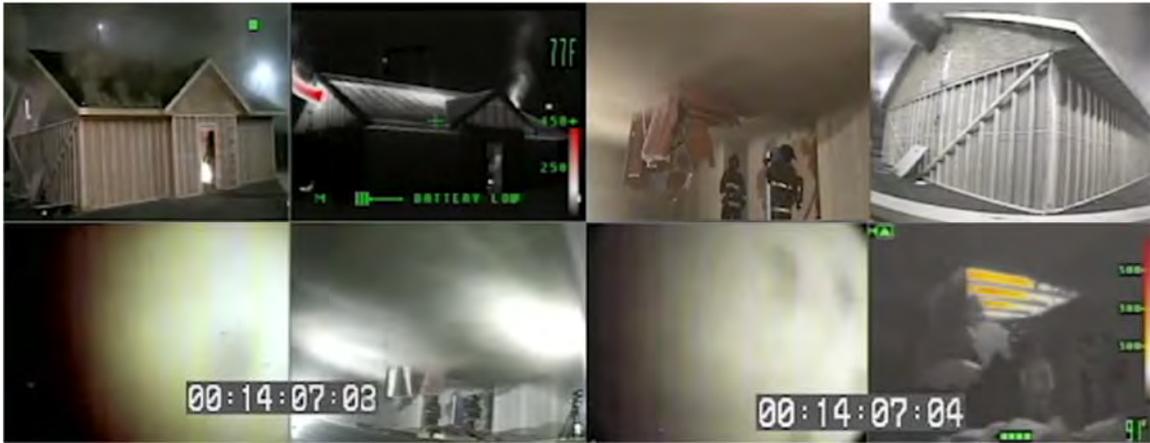
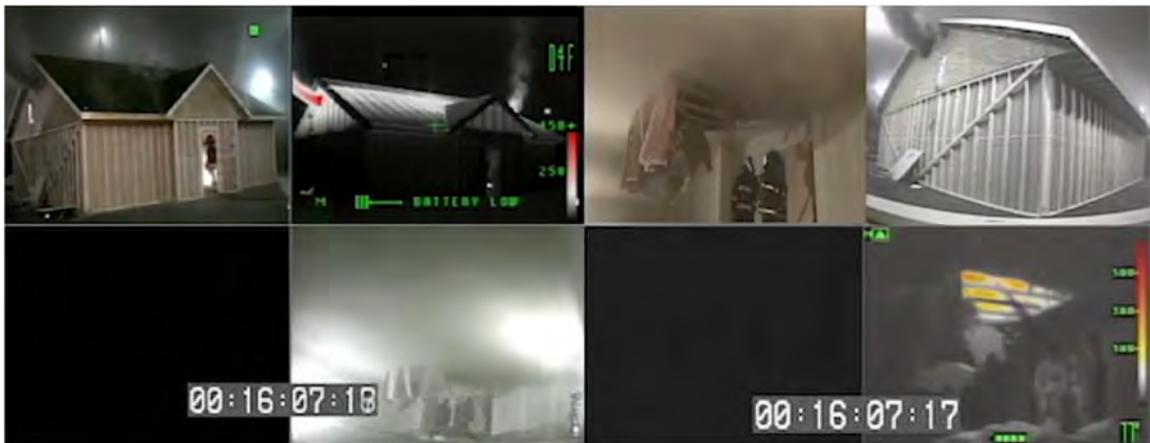
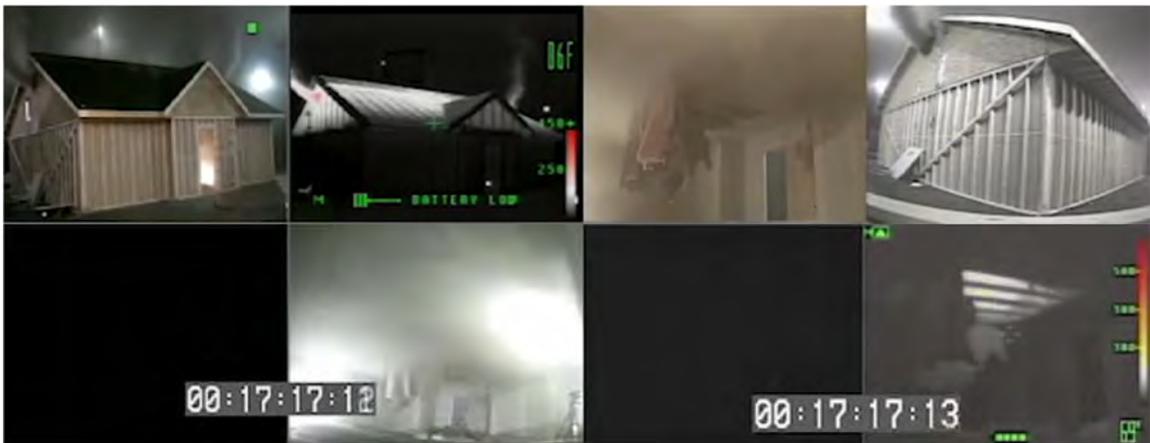
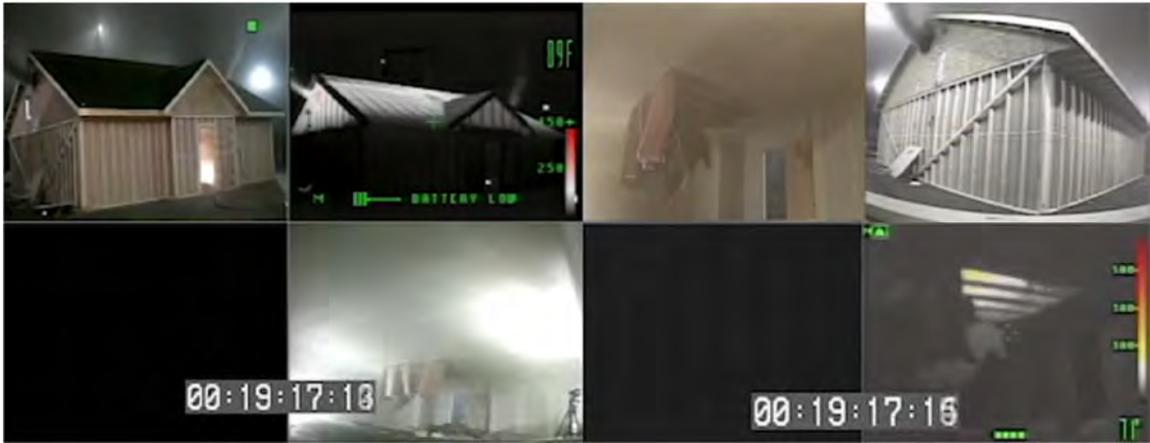
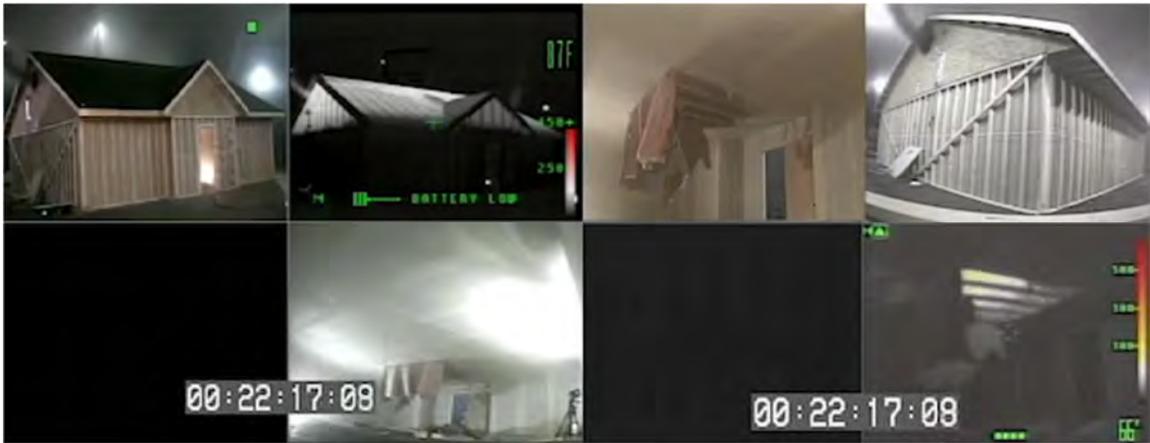
Table 8. 4: Experiment 2A Chronological Images

<u>Event</u>	<u>Time</u>
Ignition	00:00
Door Opened & 8ft. x 8ft. Attic Access Hole	12:00
1 Minute after access hole	13:07
2 Minutes after access hole	14:07
10 Seconds water from below (Straight Stream & Fog)	16:07
1 Minute after water application	17:17
2 Minutes after water application	19:17
5 Minutes after water application	22:17
9 Minutes after water application	26:17

At 00:00 ignition occurred. The fire was permitted to grow to a ventilation-limited state. At 12:00 a simulated engine crew opened the front door and made an approximately 8 ft. x 8 ft. attic access hole just inside the door to the structure. The conditions were monitored for two minutes. Water was applied at 15:07 for 20 seconds using a straight stream followed by a fog stream. The nozzle was supplied with 100psi flowing approximately 150gpm. After the application of water conditions were monitored and after 30 minutes the temperatures were steadily decreasing and the experiment ended. Table 8. 4 shows images of the experiment at each of the events described in Table 8. 3. All data gathered during this experiment can be found in Appendix I, Figures I.12-I.26.

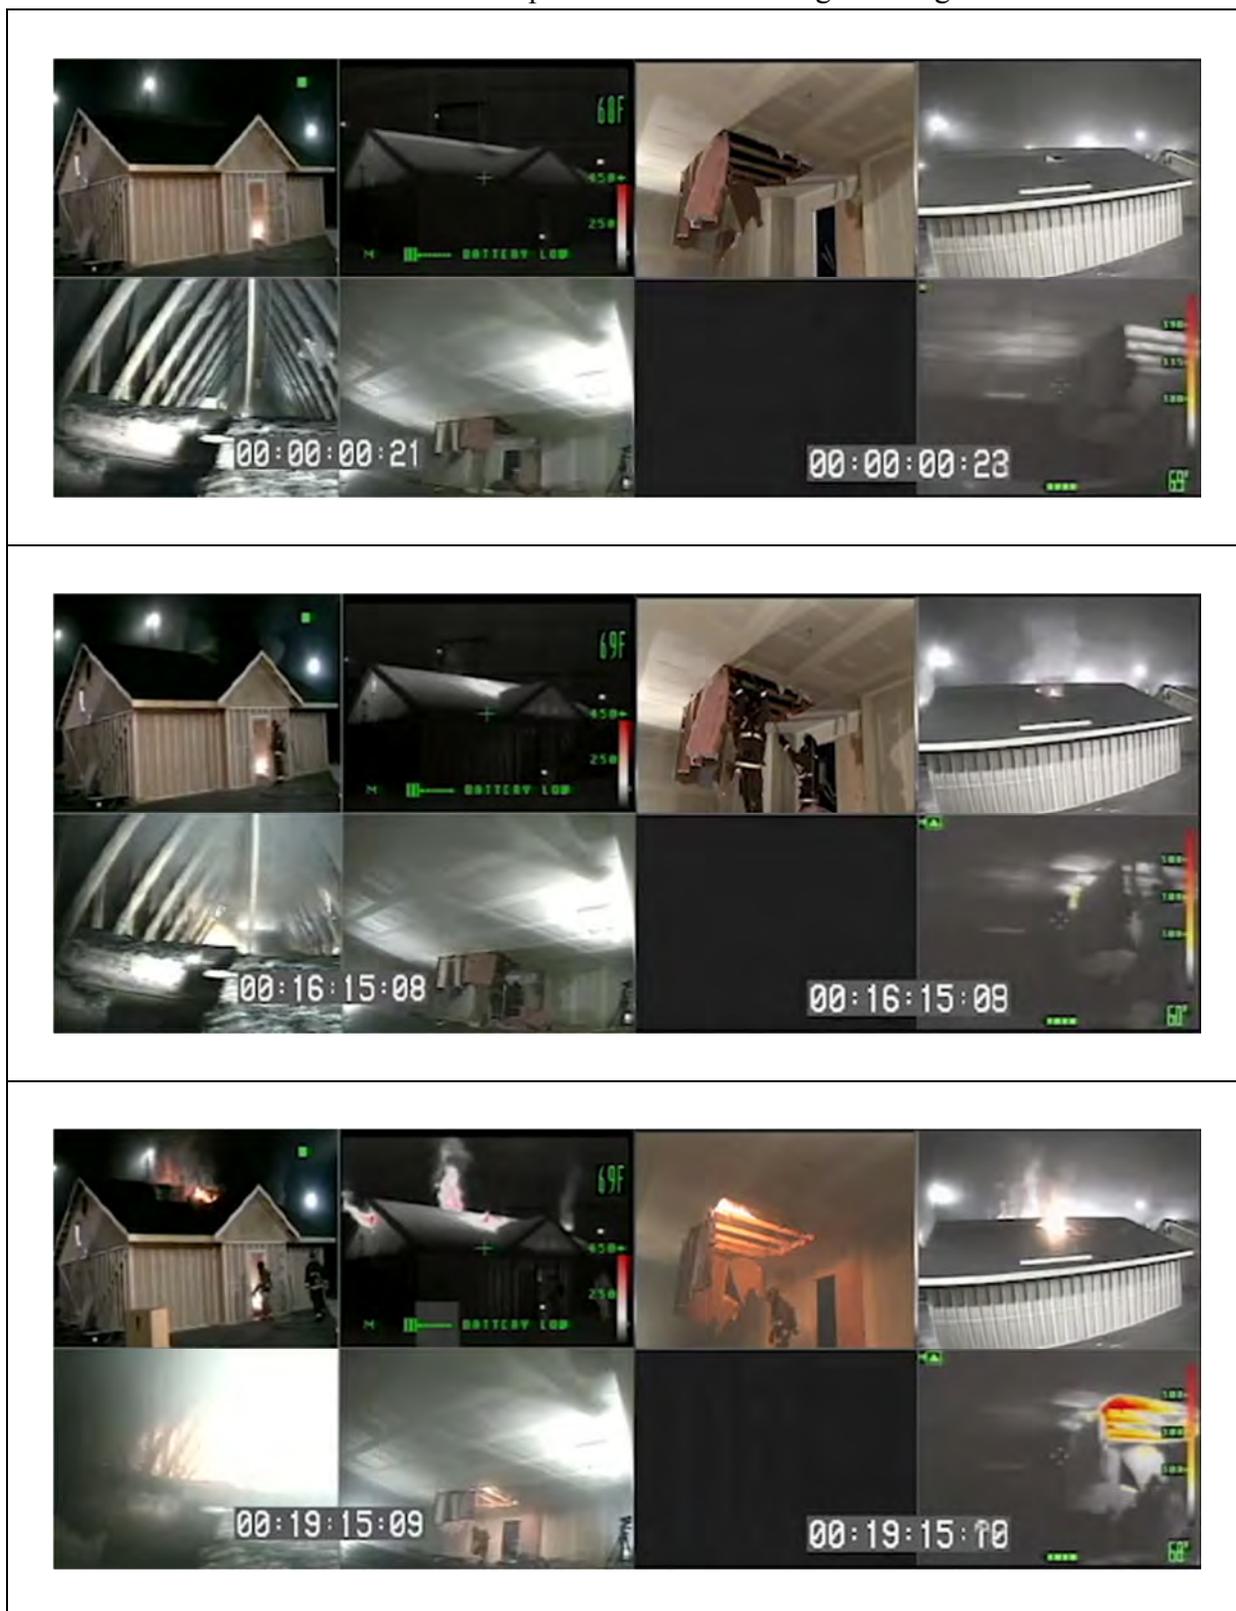
Table 8. 6: Attic Experiment 2B Chronological Images

<u>Event</u>	<u>Time</u>
Ignition	00:00
2 Commodity Boxes Added	16:15
3 Minutes After Boxes Added	19:15
Attic space approaches Flashover	19:30
15 Seconds of Fog	20:35
1 Minute after water application	21:50
23 Seconds of Straight Stream	22:32
1 Minute after water application	23:55
Water through Front Soffits (Extinguishment)	25:10

A continuation of experiment 2A this experiment was intended to evaluate the fire dynamics and suppression effectiveness of interior operations where a large hole is made below and water applied into a vented or burned through attic. Two (2) type IV commodity boxes placed just inside the 8ft. x 8ft. attic access hole and an approximate 4ft. x 4ft. ventilation hole was opened centerline on the side ‘C’ roof to simulate a ventilated or burned through attic. Ignition was provided with an electronic match shown in Figure 8. 11 placed between the commodity boxes and covered with shredded paper. Ignition occurred at 00:00 and the fire was permitted to grow. Due to the moisture from the earlier water application two (2) additional commodity boxes were added at 16:15 to provide the required fuel load to dry out the wood surfaces and permit flashover of the attic space. The attic approached flashover at 19:30. Water was applied with a fog nozzle supplied with 100 psi flowing 150gpm for 15 seconds at 20:35. The effect was evaluated and followed up with 23 seconds of straight stream supplied with 100psi at 150gpm at 22:32. Extinguishment was initiated at 25:10 via the eaves. Table 8. 6 shows the experiment images at each of the events described in Table 8. 5. All data for this experiment is shown in Appendix I.

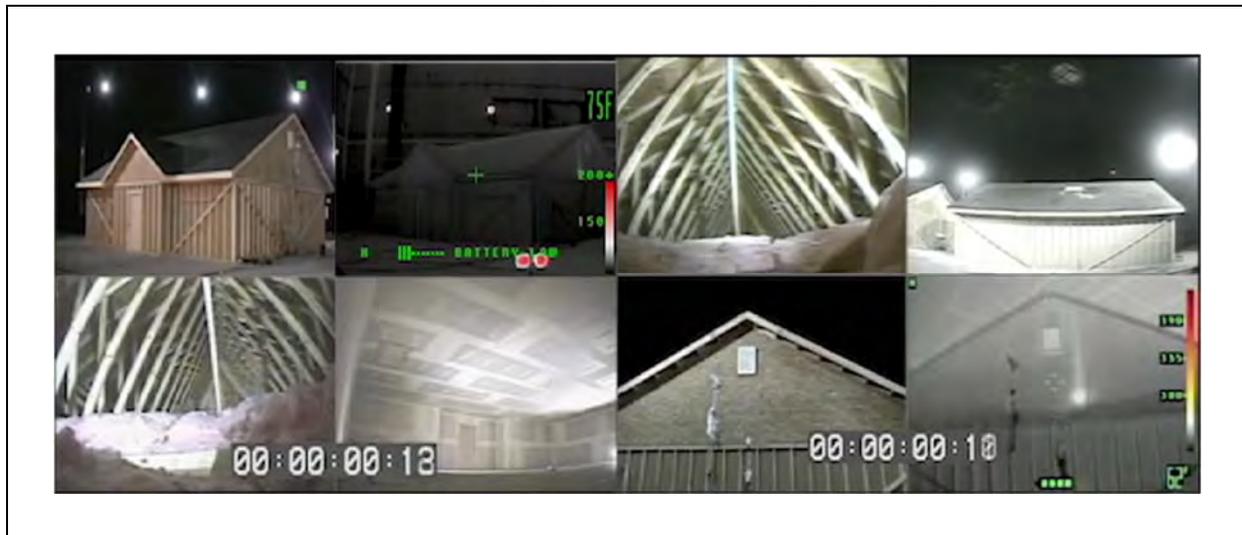
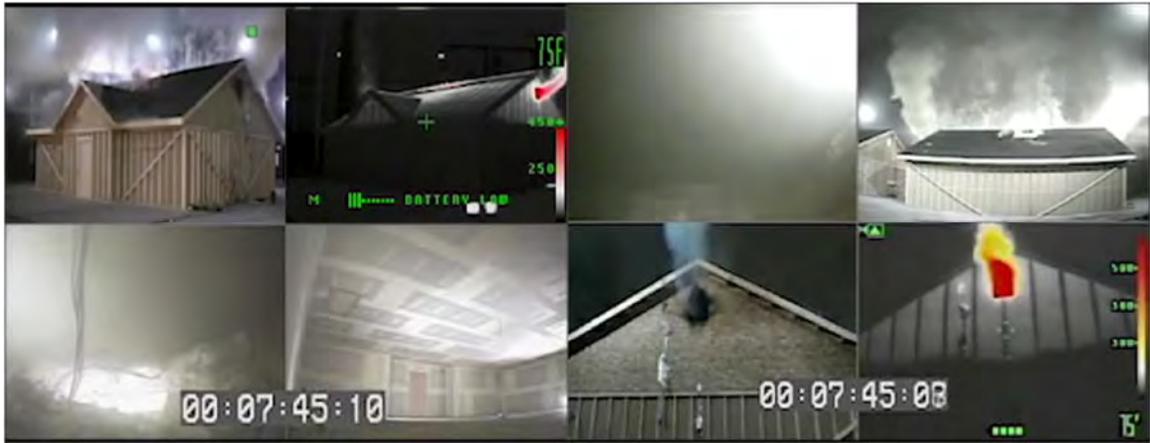
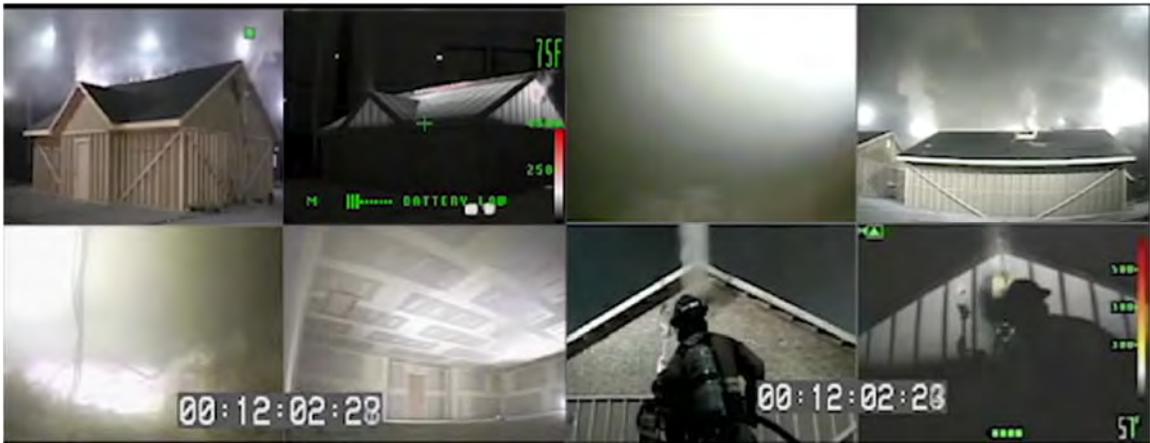
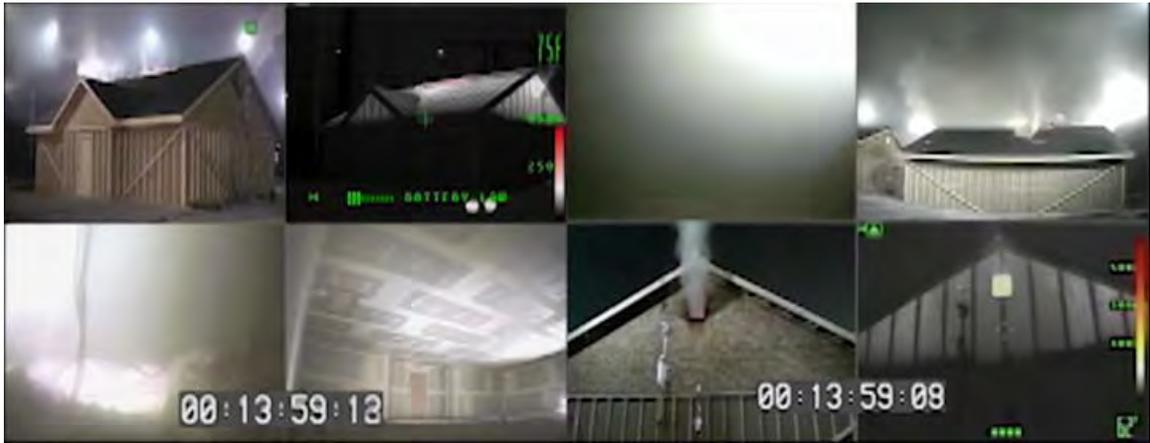
Table 8. 8: Attic Experiment 3 Chronological Images

This experiment was intended to evaluate the fire dynamics and suppression effectiveness of an exterior water application through the gable vent on an intact attic. Two (2) type IV commodity boxes were placed on a 4 ft. x 4 ft. cement board located centered in the attic space. Ignition was provided by an electric match located at the center of the boxes covered with shredded paper to ensure fire spread to the commodity boxes. Figure 8. 11 shows the fuel load for this experiment. Ignition occurred at 00:00 and the fire was permitted to grow. At approximately 07:45 the fire becomes ventilation-limited. Water is applied through the side ‘B’ gable at 12:02 via a combination nozzle set to straight stream supplied with 100psi flowing 150gpm. The effects of the water application are evaluated for approximately 2 minutes. At 13:59 the experiment is transitioned to 3B. Table 8. 8 shows the experiment images at each of the events described in Table 8. 7. All data for this experiment is shown in Appendix I, Figures I.42-I.57.

<u>Event</u>	<u>Time</u>
Ignition	00:00
Temperature Decrease in Attic Space	07:45
20 Seconds of Water West Gable	12:02
Transitioned to Experiment 3B	13:59

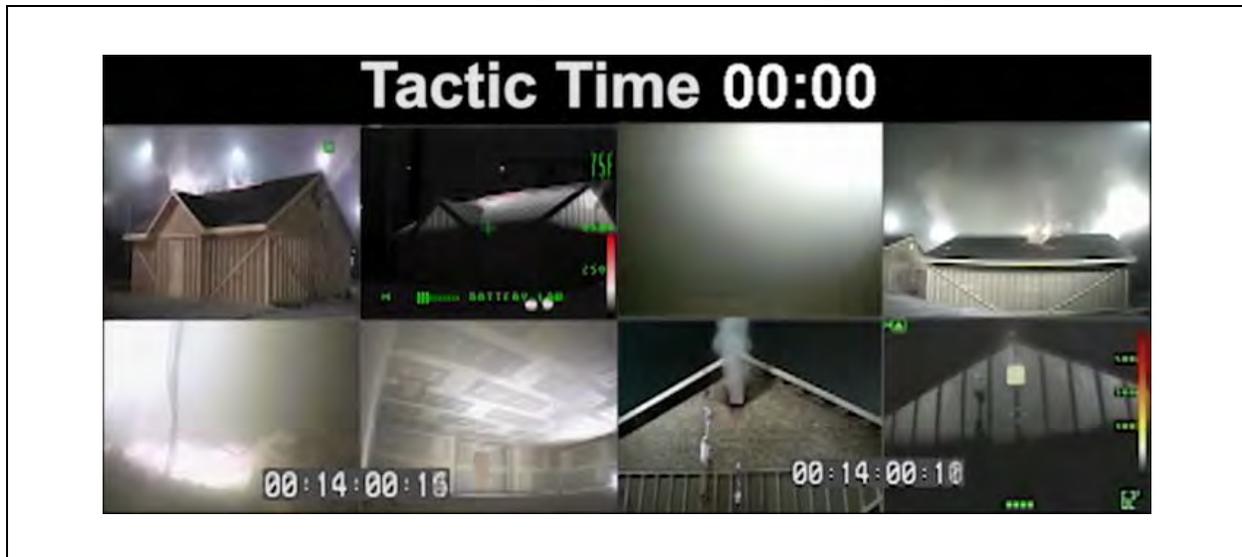
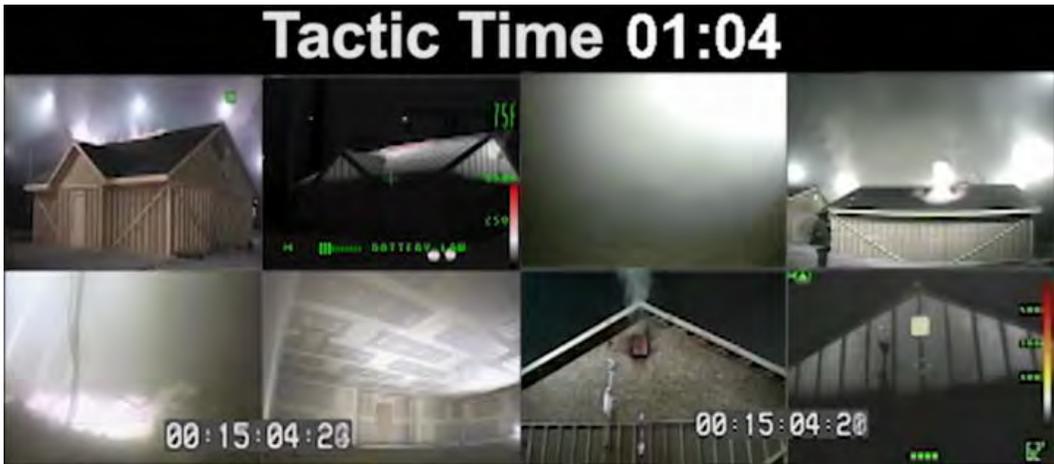
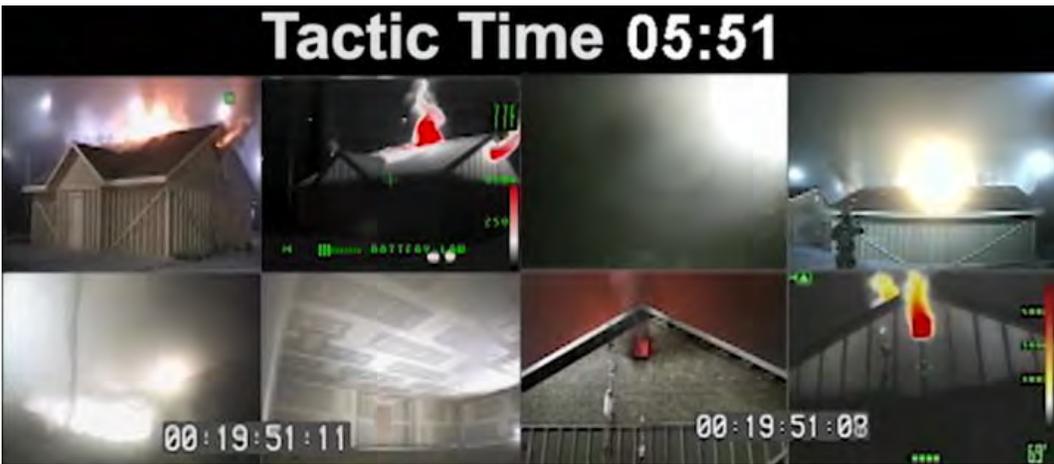
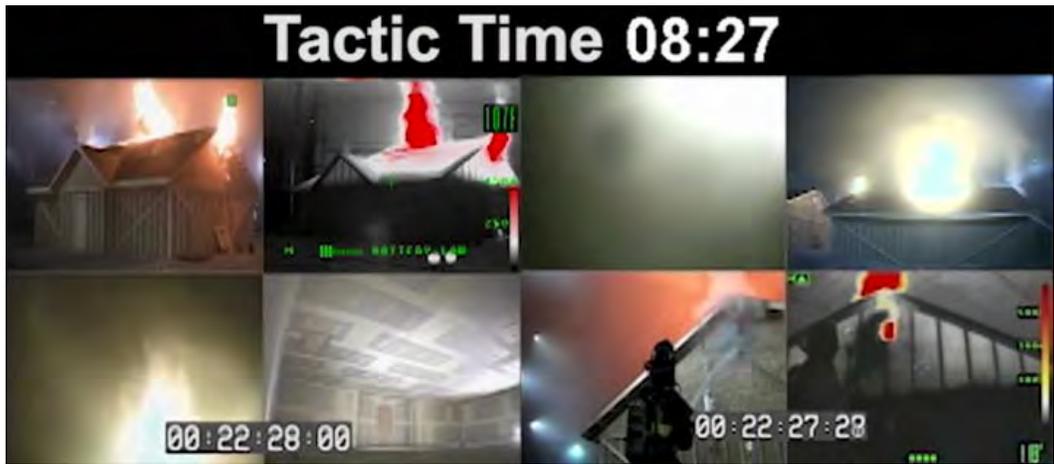
Table 8. 10: Attic Experiment 3B Chronological Images

Experiment 3B is a continuation of experiment 3A, intended to evaluate the fire dynamics and suppression effectiveness of water application through the gable vent of a ventilated or burned through attic space. The experiment begins at 00:00 after the conclusion of experiment 3A. A 4 ft. x 4 ft. roof vent is opened on the ‘C’ side at 1:03. At 5:51 flames are visible from the side ‘C’ roof ventilation hole and side ‘D’ gable. Water is applied from the side ‘B’ gable using the same combination nozzle and pressure/flow from before for 20 seconds at 8:27. The water application effect is monitored for a little over 1 minute. At 9:46 the experiment is concluded. Table 8. 10 shows the experiment images at each of the events described in Table 8. 9. All data for this experiment is shown in Appendix I, Figures I.58-I.71.

<u>Event</u>	<u>Time</u>
Experiment Begins from Experiment 3A (14:00)	0:00
4 ft. x 4 ft. Attic Vent Open	1:04
Flames from Vent & East Gable	5:51
20 Seconds of Water West Gable	8:27
Experiment Concluded	9:46
