Study of Residential Attic Fire Mitigation Tactics and Exterior Fire Spread Hazards on Fire Fighter Safety

UL Firefighter Safety Research Institute

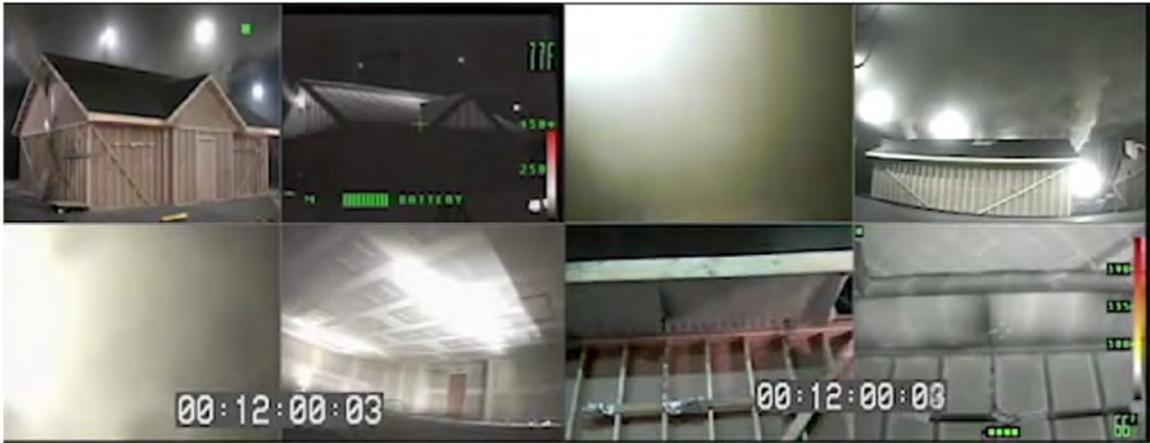
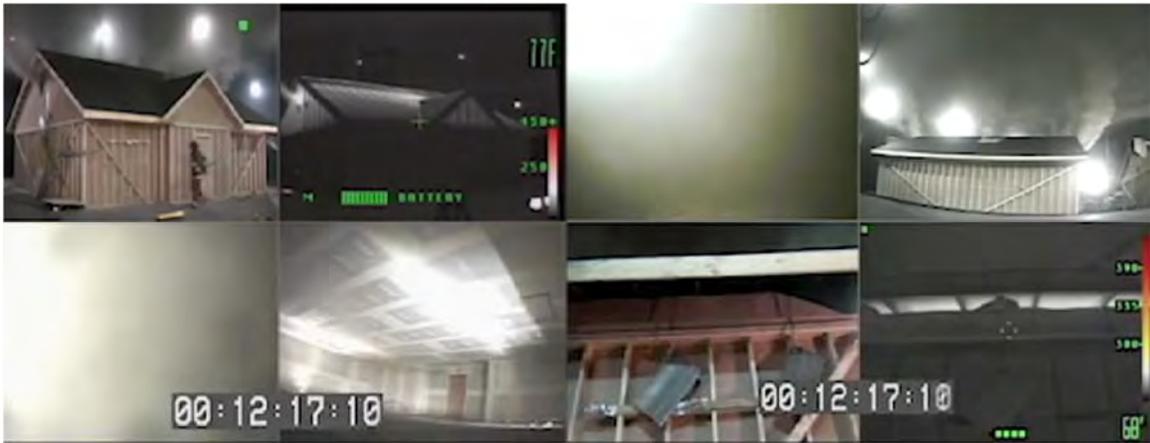
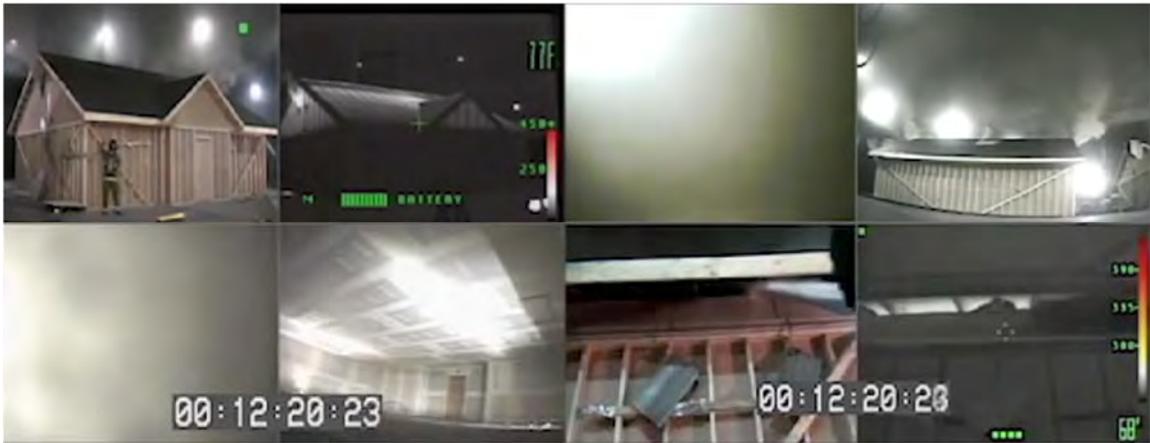
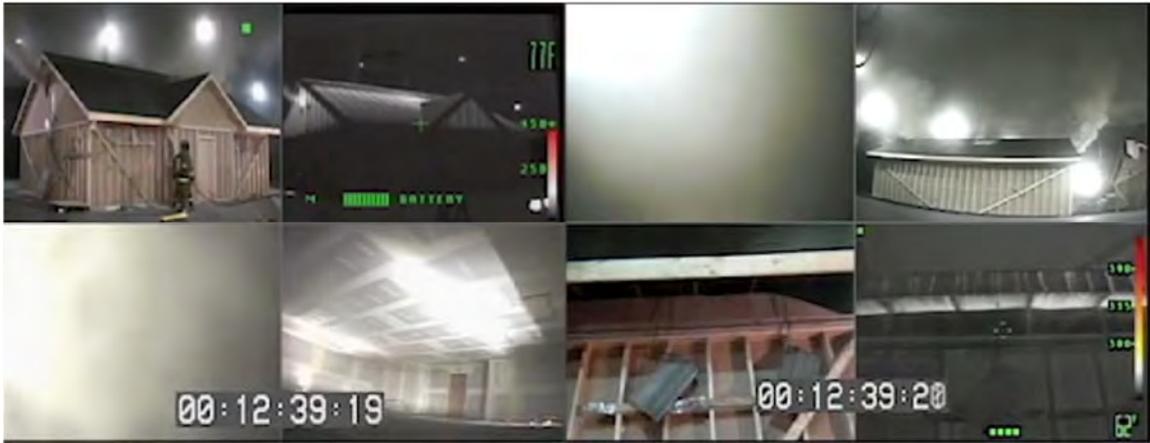
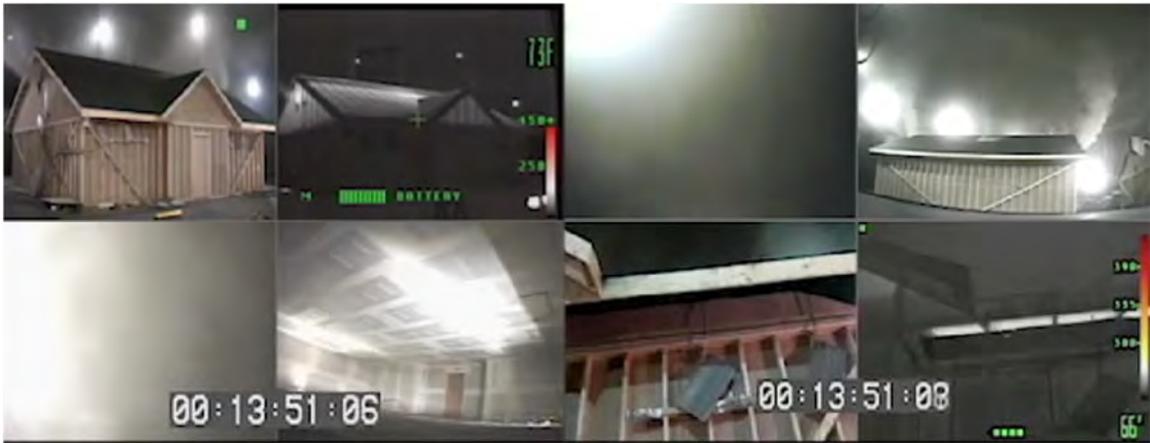
Table 8. 12: Attic Experiment 4A Chronological Images

This experiment was intended to investigate the fire dynamics and suppression effectiveness of water application through the eaves into an intact attic fire. Two (2) type IV commodity boxes were placed on a 4 ft. x 4 ft. cement board located centered in the attic space. Ignition was provided by an electric match located at the center of the boxes covered with shredded paper to ensure fire spread to the commodity boxes. Figure 8. 11 shows the fuel load for this experiment. Ignition occurred at 00:00 and the fire was permitted to grow. At approximately 08:00 the fire becomes ventilation-limited. The side ‘A’ East eaves are removed at 12:00, followed by water application through them at 12:17 with a combination nozzle set to straight stream supplied with 100psi flowing 150gpm. The side ‘A’ West eaves are removed at 12:20 followed by water application through them at 12:39 using the same nozzle, pressure and flow. The effects of the water application are evaluated for approximately 7 minutes and 45 seconds at which time a 4 ft. x 4 ft. roof vent is opened on the ‘C’ side at 19:07. Conditions were evaluated for the next two minutes with further decrease in interior temperature. The experiment was stopped 1:45 after the vent hole was opened.

<u>Event</u>	<u>Time</u>
Ignition	00:00
Temperature Decrease in Attic Space – Ventilation-limited	08:00
Side ‘A’ East Eaves Pulled	12:00
Water East Eaves Straight Stream – 12 Seconds	12:17
Side ‘A’ West Eaves Pulled	12:20
Water West Eaves Straight Stream – 12 Seconds	12:39
1 Minute After Water Application	13:51
3 Minutes After Water Application	15:51
4ft. x 4ft. Side ‘C’ Roof Vent Open	19:07
1 Minute After Open Vent	20:07
1:45 After Open Vent (End Experiment)	20:52

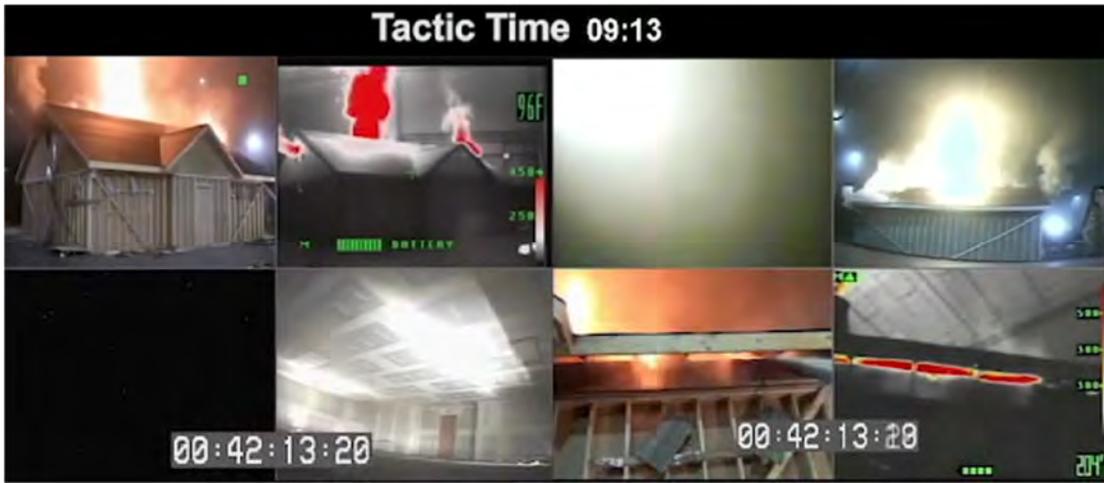
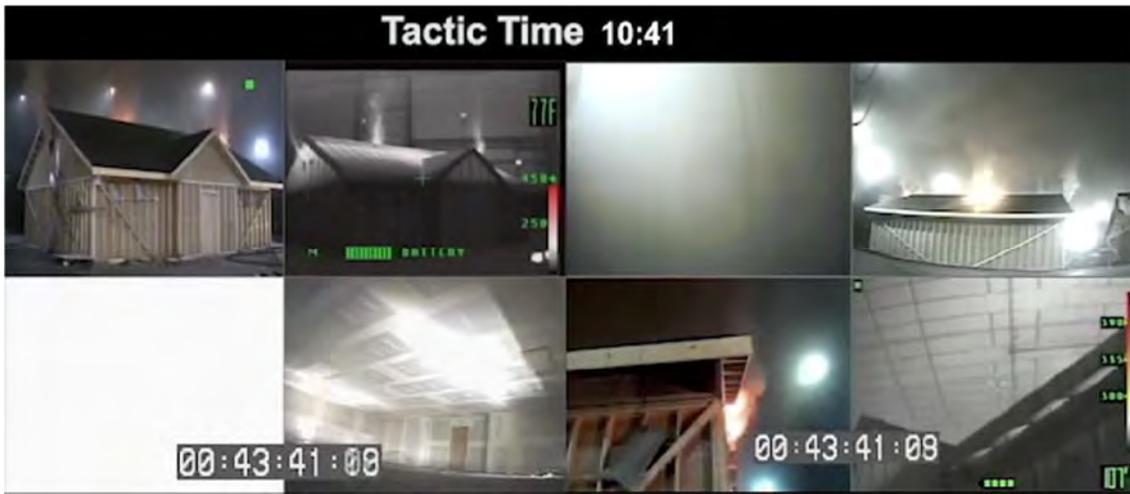
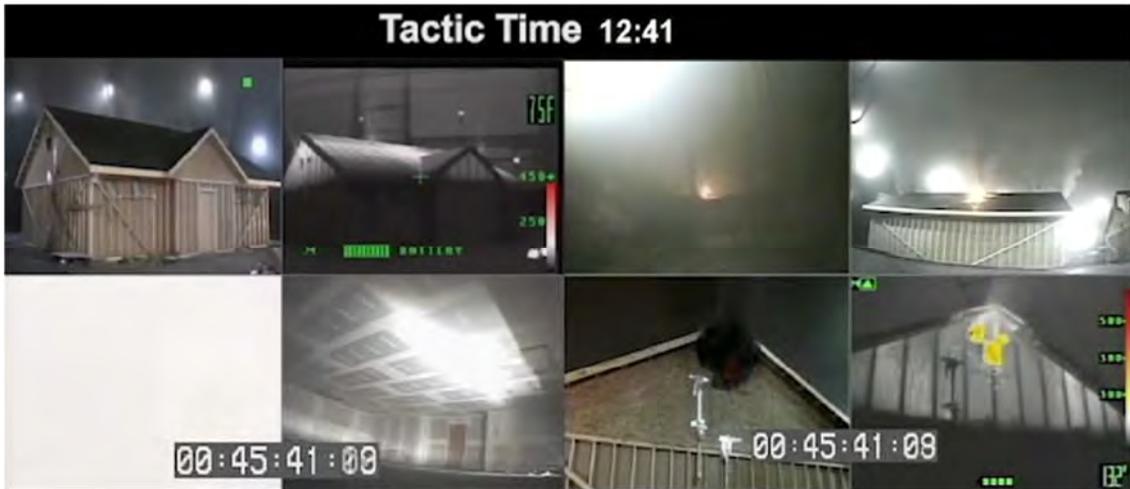
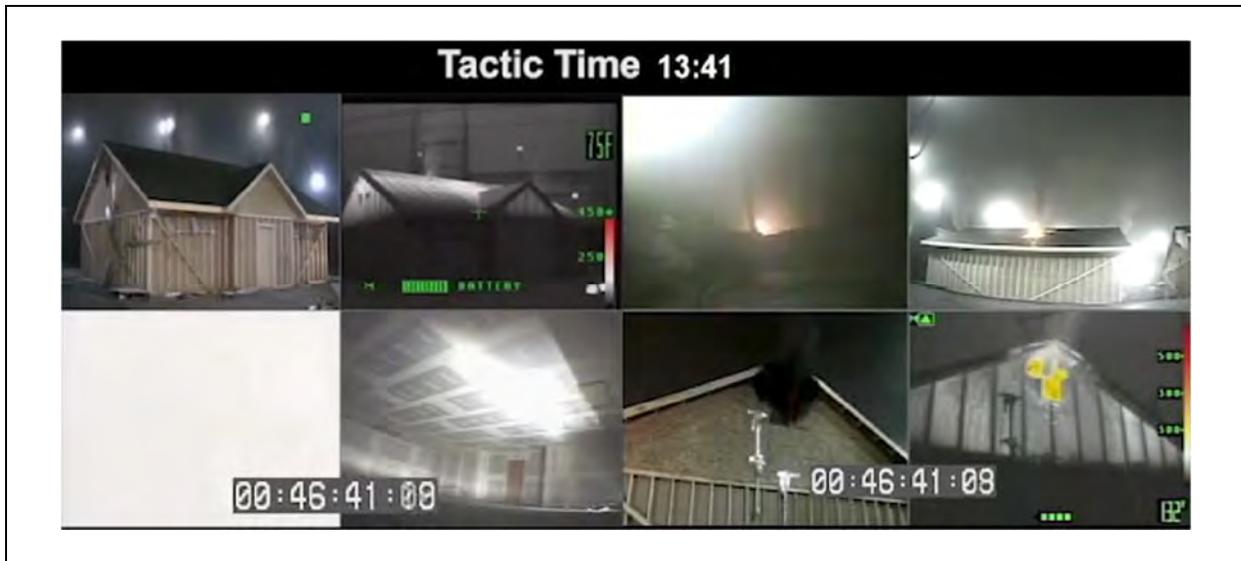
Table 8. 14: Attic Experiment 4B Chronological Images

This experiment was intended to evaluate the fire dynamics and suppression effectiveness of water application through the eaves on a ventilated or burned through attic. It was a continuation of experiment 4A, where the majority of the initial fuel load had been consumed and the remaining fuel could not heat adjacent surfaces enough to propagate flame spread. At the beginning of the experiment temperatures at the peak of the attic were below 150°F. Two (2) type IV commodity boxes were placed inside the East access hatch as additional fuel. Ignition was provided by an electric match located at the center of the boxes covered with shredded paper to ensure fire spread to the commodity boxes. Figure 8. 11 shows an example of the fuel load for this experiment. Ignition occurred at 00:00 and the fire was permitted to grow in the attic vented attic space. At approximately 08:15 the temperatures stabilize in the attic space representing roughly a steady state. Water is applied through the side ‘A’ eaves at 09:13 using a combination nozzle set to straight stream supplied with 100psi flowing 150gpm. The effects of the water application are evaluated for approximately 4 minutes where further decrease in interior temperature occurred. The test is concluded 4 minutes after water is applied.

<u>Event</u>	<u>Time</u>
Ignition	00:00
Relatively Steady State Temperatures in Attic	08:15
Water Through Side ‘A’ Eaves – 12 Seconds Each Side	09:13
1 Minute after water application	10:41
3 Minutes after water application	12:41
4 Minutes after water application	13:41

Attic Experiment 4B: Eave line attack, vented or burned through attic.

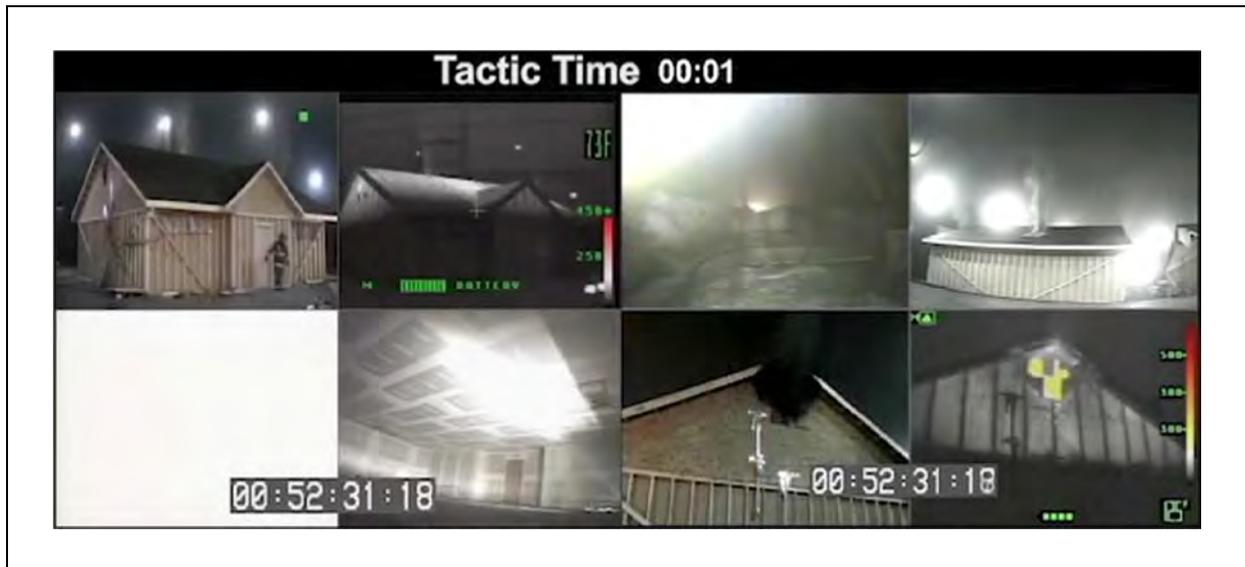
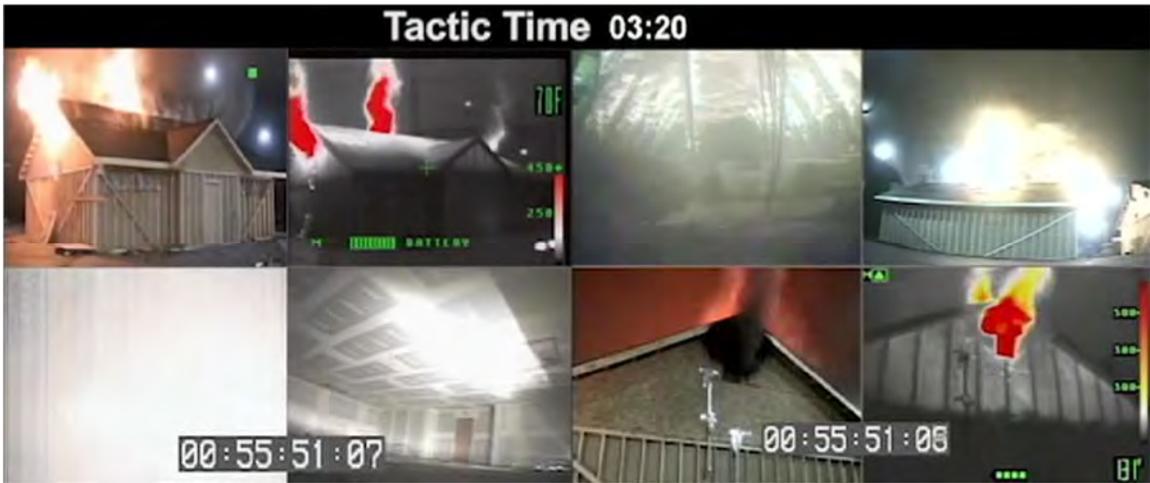
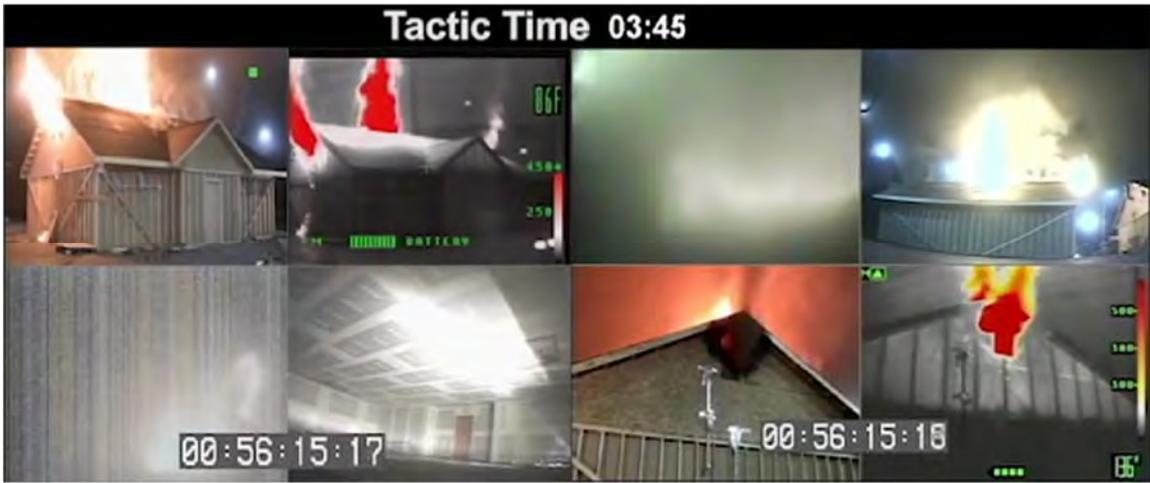
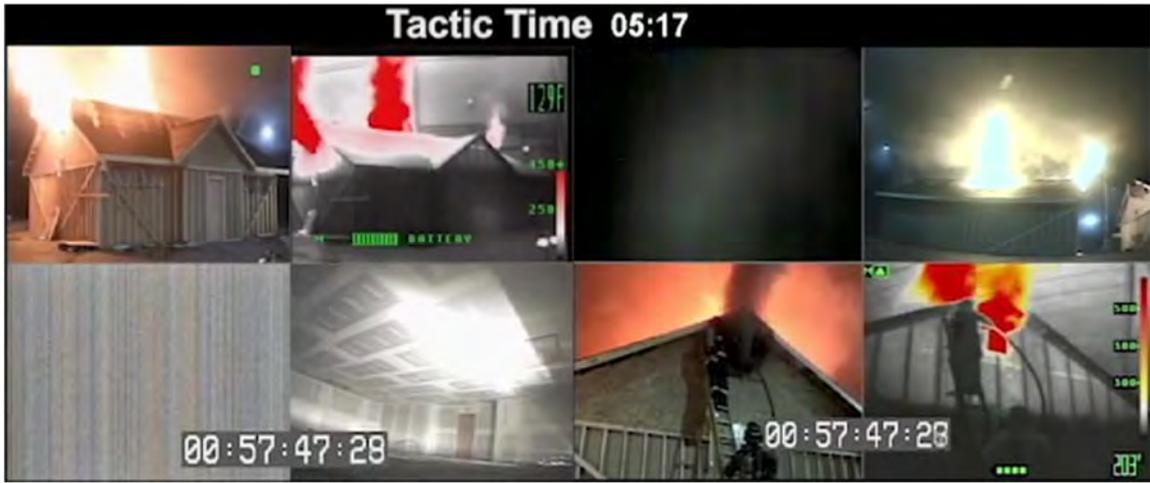
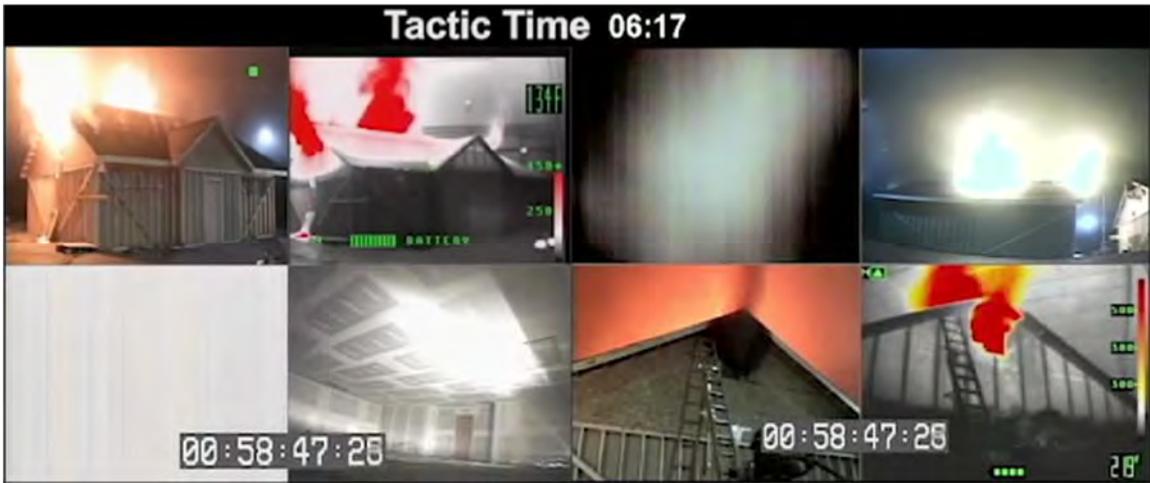
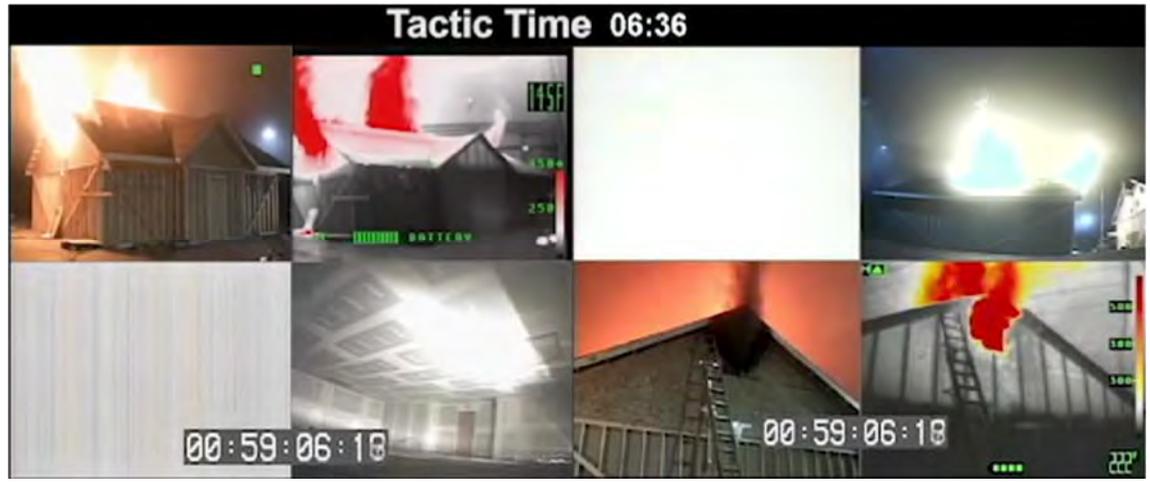
Table 8. 16: Attic Experiment 4C – Chronological Images

This experiment is intended to revisit suppression by gable attack and eave attack on a ventilated or burned through attic. At the conclusion of experiment 4B the majority of the initial fuel load had been consumed and the remaining fuel could not heat adjacent surfaces enough to propagate flame spread. The temperatures at the peak of the attic were below 150°F. Two (2) type IV commodity boxes were placed inside the West access hatch as additional fuel. Ignition was provided by an electric match located at the center of the boxes covered with shredded paper to ensure fire spread to the commodity boxes. Figure 8. 11 shows an example of the fuel load for this experiment. Ignition occurred at 00:00 and the fire was permitted to grow in the attic vented attic space. As the fire progresses roll over on at the peak of the attic space can be seen in the attic camera at 03:20. At approximately 03:45 the temperatures stabilize in the attic space. The rapid increase in the fire is most likely attributed to the pre-heated fuel which due to the flashover in the earlier experiment permitted heat to transfer into the material. Water is applied through the side ‘D’ gable vent at 05:17 for 50 seconds using a combination nozzle set to straight stream provided with 100psi flowing 150gpm. The effects of the water application are evaluated and 10 seconds after application and temperatures in the attic space are climbing rapidly at 06:17. Water is applied through the eaves 12 seconds on the East side and 15 seconds on the west side at 06:36 using the same nozzle, pressure and flow. Temperature are monitored for an additional 3 minutes after water application and the experiment is concluded at 10:12. Table 8. 16 shows the experiment images from at each of the events described in Table 8. 15. All data for this experiment is shown in Appendix I.

Roll Over Seen in Attic Camera	03:20
Relatively Steady State Temperatures in Attic	03:45
Water Through Side 'D' Gable – 50 Seconds	05:17
10 Seconds After Water Application	06:17
Water Through Side 'A' Eaves – 12 Seconds East, 15 Seconds West	06:36
1 Minutes After Water Application	08:12
3 Minutes After Water Application (End Experiment)	10:12

Attic Experiment 4C: Eave line attack, vented or burned through attic.

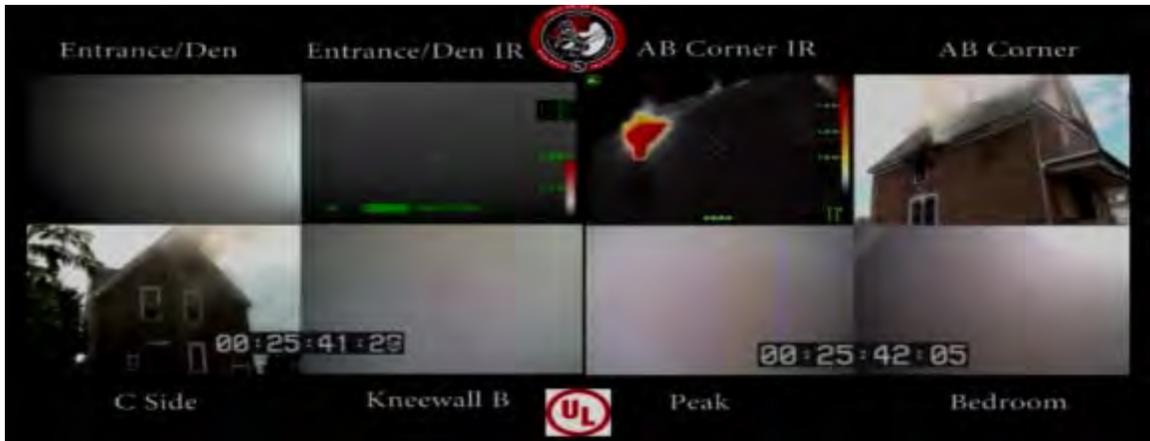
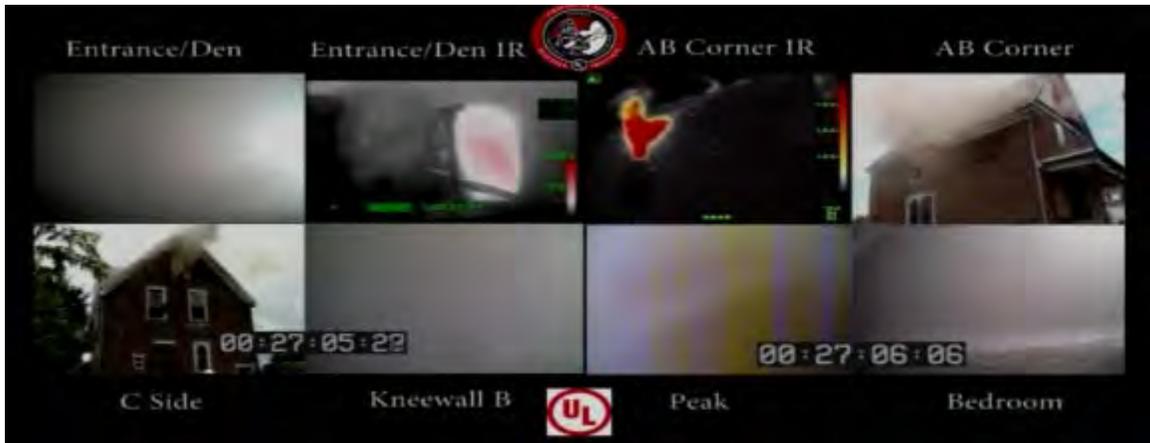
Table 9. 1: Field Experiment 1 Chronological Images

25:08, the door of the attic space was opened, and then at 25:41 and 26:30, the ‘C’ side and ‘A’ side windows were opened, respectively. The knee wall patch was opened at 27:05. Conditions were monitored for two minutes followed by 7 s of exterior water applied to the fire room at 29:00. Conditions were monitored further with exterior water applied to the fire room for 10 s at 35:58. At 39:10, the nozzle mounted in the stairwell to simulate an interior attack was turned on for 10s. At 42:36 water was applied for 30 s to all the area where there was visible fire, i.e. the exterior siding, the roof, the fire room, etc. At 51:40, the deck gun was applied to side A of the structure. Conditions were monitored while the deck gun suppressed the side ‘A’ fire. At 52:36 the Side B visible fire was suppressed using the exterior line at which time the experiment was turned over to Milwaukee Fire Department for complete suppression. Table 9. 2 below lists all actions and at what time they occurred, Table 9. 1 provides the images of all 8 camera views at the times listed.

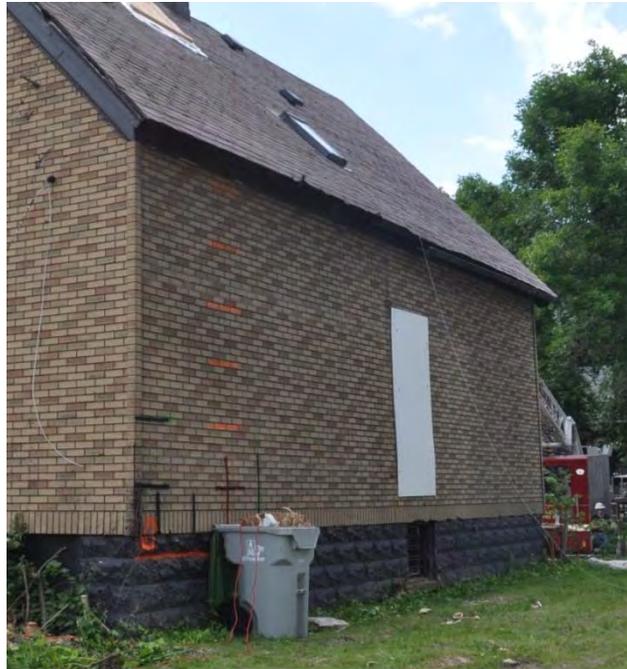
Figure 9. 35: Experiment 3 – North 25th Street Exterior Ignition Source

A standard size city trash can, 65 gallons, was utilized as the ignition source loaded with construction debris such as wood, paper and plastic refuse. The can was placed up against the structure and ignition was provided via an electric match (See Figure 9. 35). The fire grew up the exterior of the house and into the open eave space. The change in temperatures monitored can be seen in Figure 9. 36.

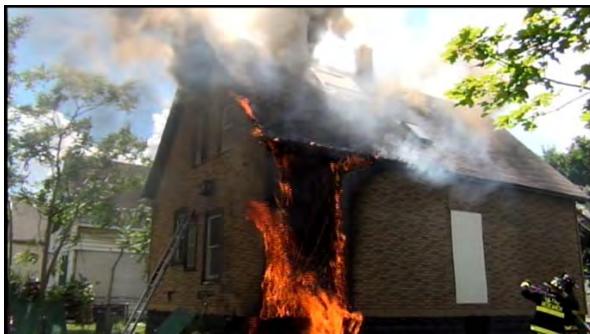
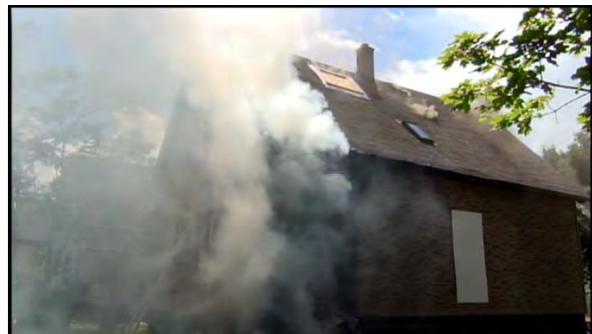
Figure 9. 36: Experiment 3 - Eave Attack Effectiveness

Initial fire service intervention by a single crew was performed on the exterior side ‘B’ of the structure. Suppression with an automatic nozzle flowing 150gpm set to straight stream was performed along the eaves where the fire had penetrated into the joist bays. Figure 9. 37 indicates temperatures prior to the application of water in the joist bay averaged over 1200°F and in the peak averaged over 550°F. After the 14 seconds of water through the eaves the temperatures reduced to below 200°F in both the peak and joist areas, while no increases occurred in any of the attic living spaces. Water also indirectly effected the flames in the trash can as seen in the series of images in Figure 9. 36 and the bulk of the visible fire was extinguished.

(a) 10s Before Water Application

(b) 10s After Water Application

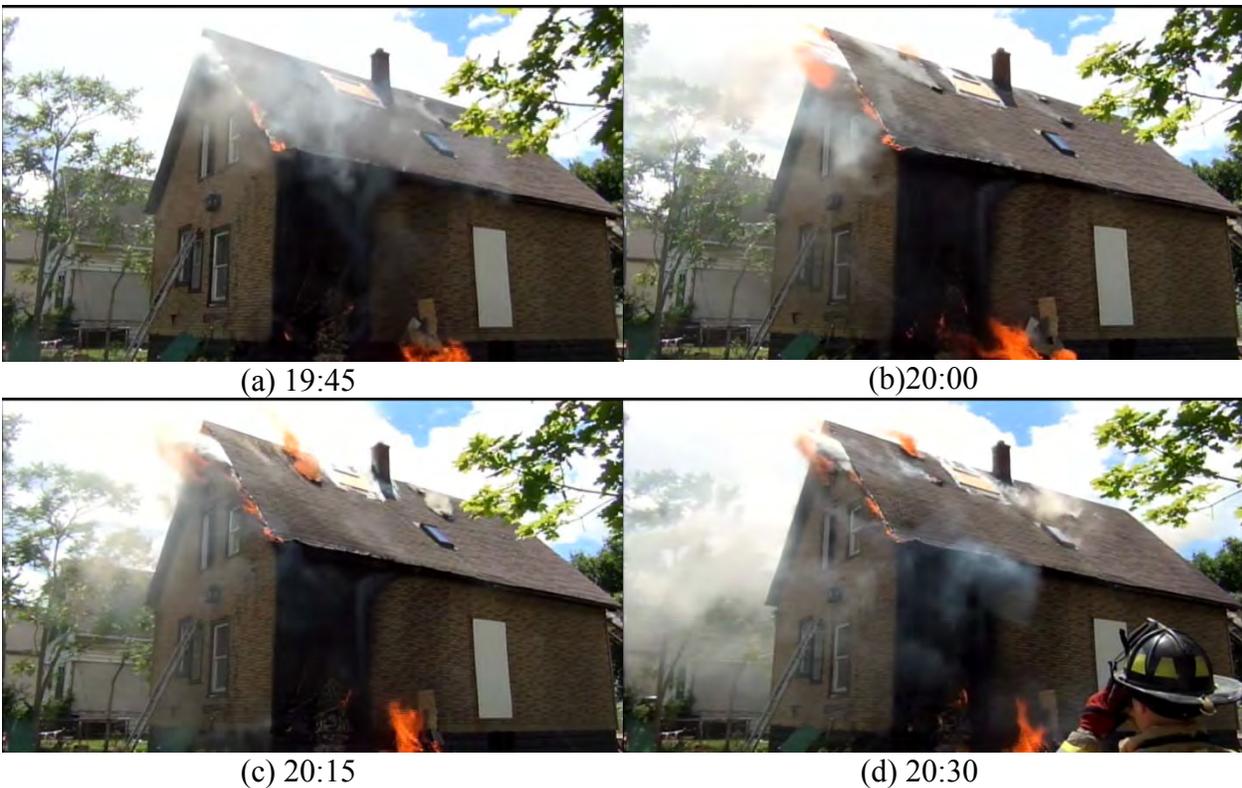
Figure 9. 39: Experiment 3 - Regrowth Progression 19:45-20:30

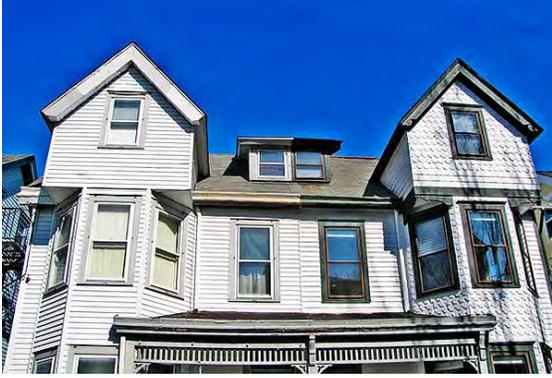
Figure 10. 1. Traditional Duplex with vinyl siding on left and wood siding on the right

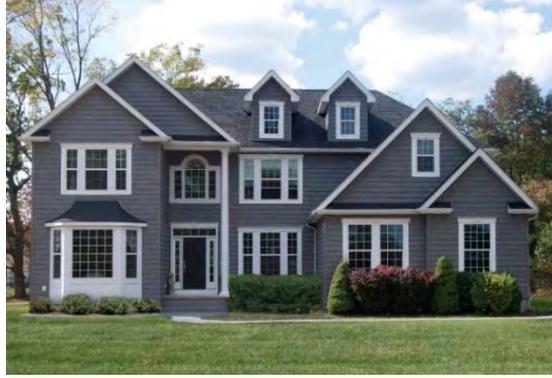
Figure 10. 2. Modern home with energy efficient wall systems with the same look as a wood lap sided home

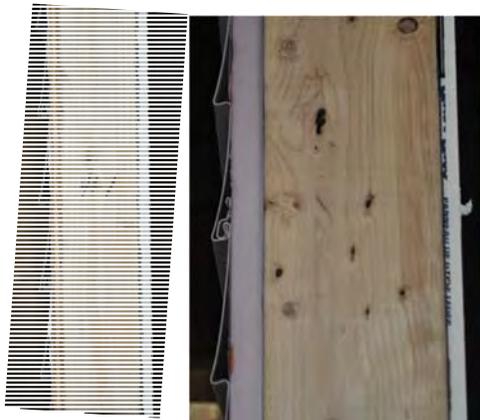
Figure 10. 3. Two vinyl sided wall sections with different energy efficiencies

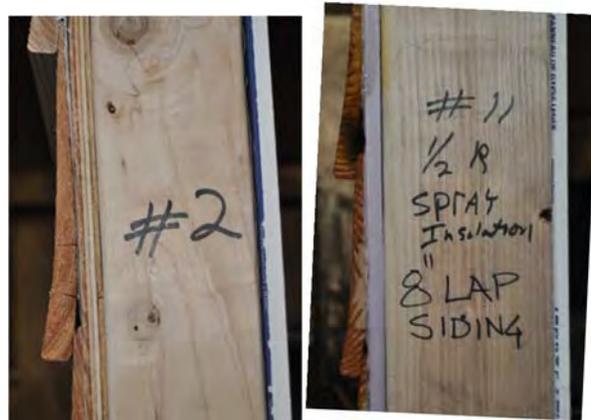
Figure 10. 4. Two wood sided wall sections with different energy efficiencies

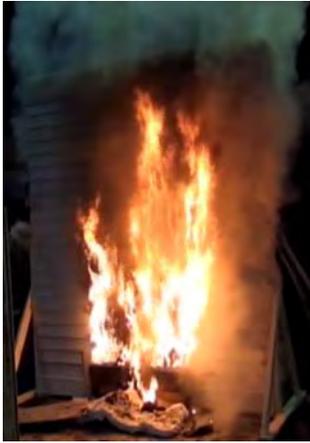
Figure 10. 5. Exp. 3 – Vinyl Siding over plywood

Legacy construction practices using cement based stucco and solid wood wall sidings provided a form of fire resistance to the structure, preventing or slowing even large outdoor and rubbish fires from extending into a structure. **Modern homes now commonly utilize plastic siding as the outer layer. This evolution in building materials has led to an increased ignition potential from exposure to outside fires such as mulch and grass fires, as well as fires extending from garbage and rubbish bins kept next to the structure.** The wall system experiments show that stucco, fiber cement, and wood siding would not sustain burning even after 10 minutes of exposure from a 100kW heat source. By comparison, the plastic wall sidings ignited in one minute or less and grew rapidly. A 100 kW source is equivalent to a small fire measuring approximately 2 ft wide by 2 ft deep with flames 2 feet high. This could be a mulch, grill, small trash can or plastic potted plant fire. These images show 6 different wall types after 2 minutes of exposure to the 100kW burner.

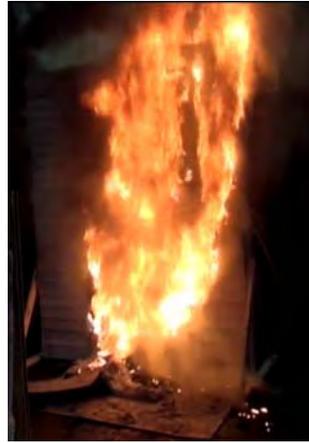
Figure 10. 6. Exp. 5 – Vinyl siding over polystyrene

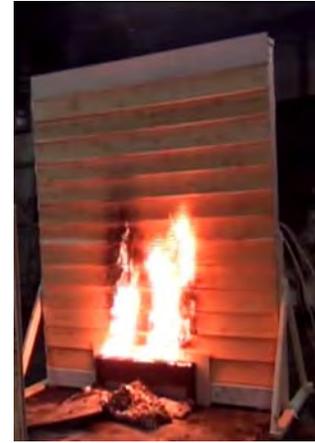
Figure 10. 7. Exp. 14 – Wood Lap Siding

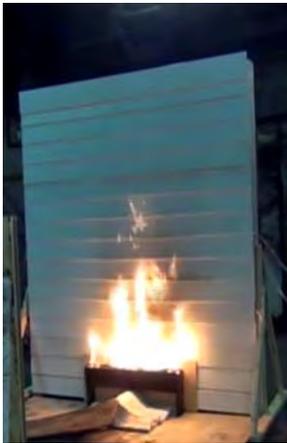
Figure 10. 8. Exp. 19 – Fiber Cement Siding

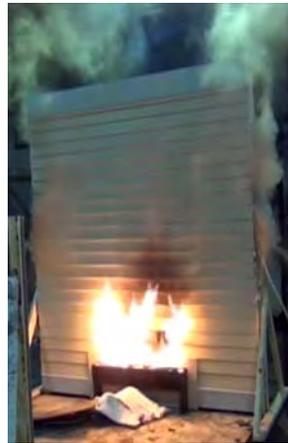
Figure 10. 9. Exp. 20 - Aluminum Siding

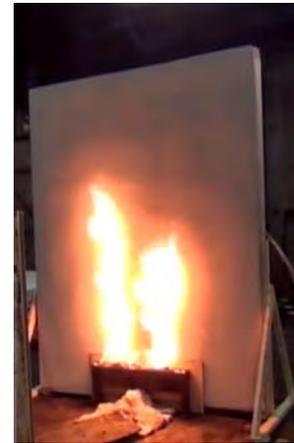
Figure 10. 10. Exp. 26 - Stucco Siding

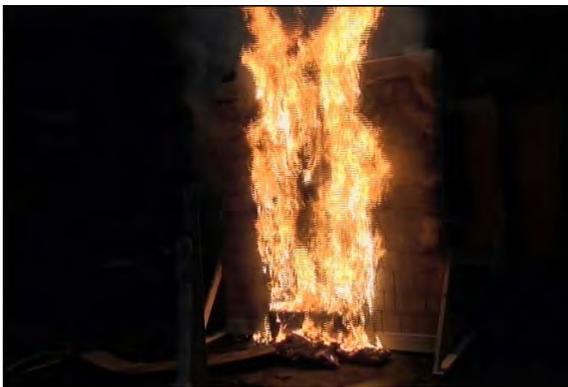
Figure 10. 11. Flame spread 2 minutes after ignition of a polypropylene shingle sided wall over polystyrene sheathing

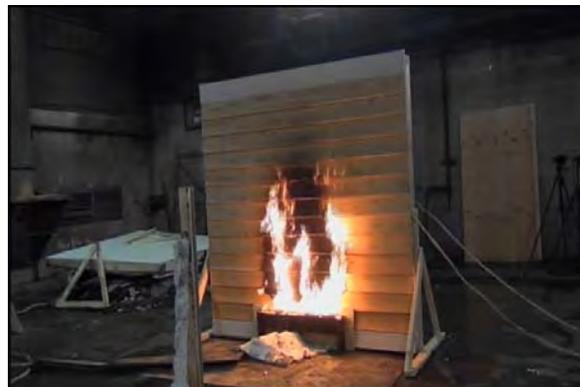
Figure 10. 12. Flame spread 2 minutes after ignition of a wood lap sided wall over polystyrene sheathing

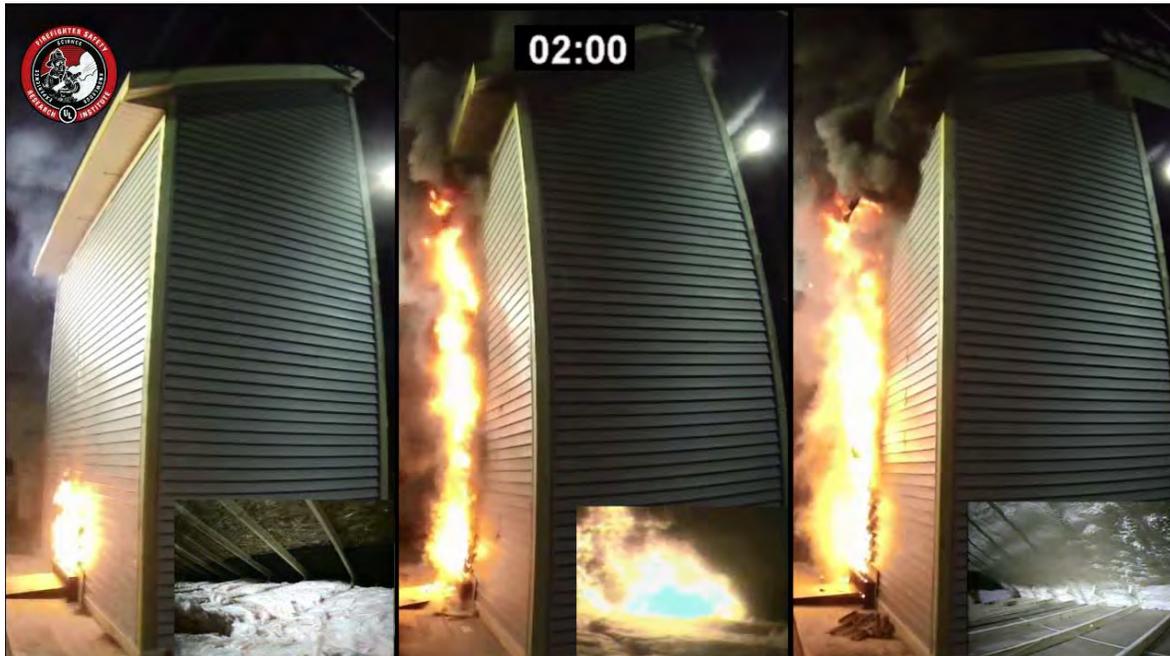
Figure 10. 13. Wall and Eave experiment as Vinyl Siding/Polystyrene Sheathing/Fiberglass Insulation system transitions to an attic fire (2 minutes after ignition)

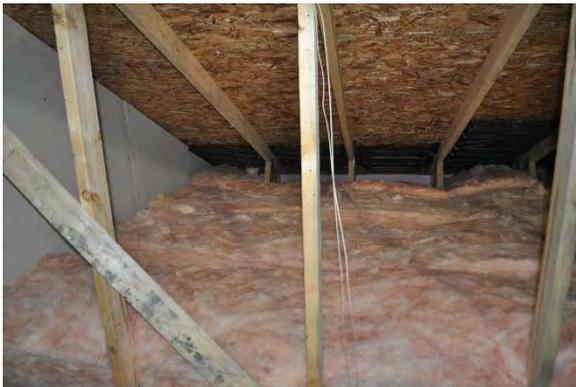
Figure 10. 18. View of vented attic from the attic

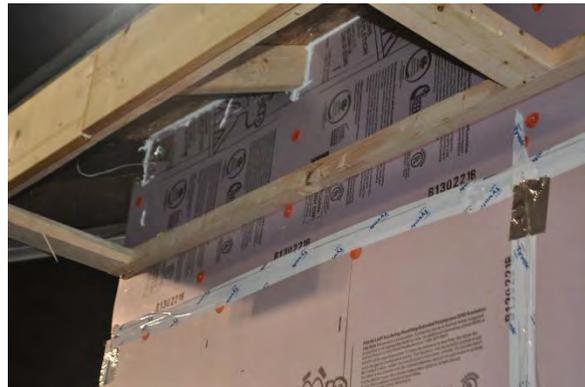
Figure 10. 19. View of unvented attic construction eaves

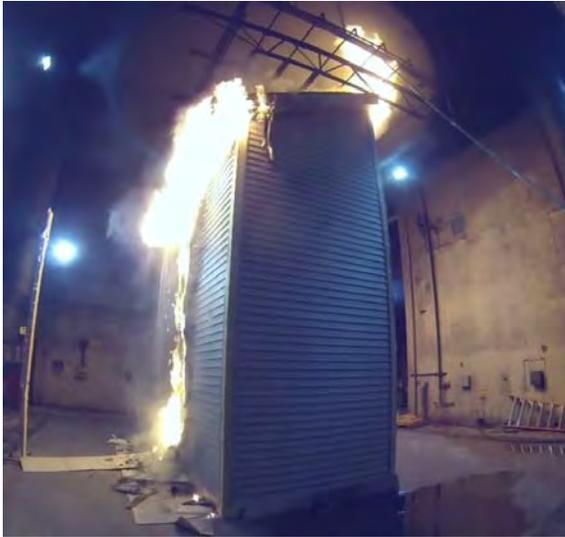
Figure 10. 20. Burning at eave line with vented attic (Experiment 1)

With the two story wall configuration used in the tests, fire exposure to a surface opposite the test wall was minimal during the fire's spread up the wall. However, when the fire reached the eave line, exposing the attic and involving the eaves and soffits, heat flux measurements of radiant energy at the wall opposite indicated a significant increase in exposure fire potential. **Therefore, the projection of the flames out of the eaves and the additional fuel load at the eave/soffit line combine to increase the radiant energy directed at any adjacent structures, increasing the exposure threat.** In scenarios where the wall and roof voids are filled with spray foam insulation, this effect is even more pronounced since there is more fuel available than with other insulation and sheathing combinations such as plywood over fiberglass batts or even foam board over fiberglass batts.

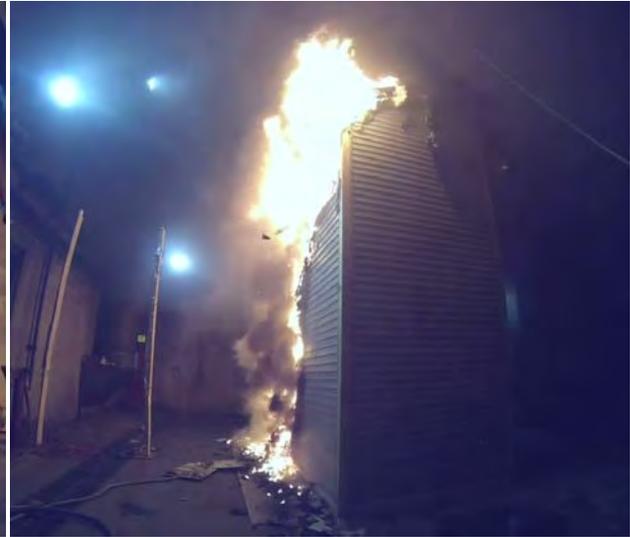
Figure 10. 21. Burning at eave line with the unvented attic (Experiment 3)

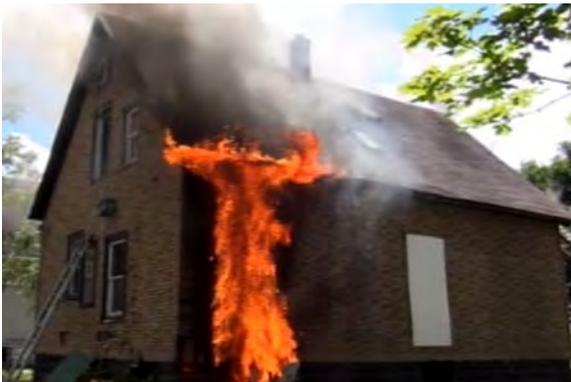
Figure 10. 22. Fire extending from a trash can into the eaves during a field experiment in Milwaukee, WI.

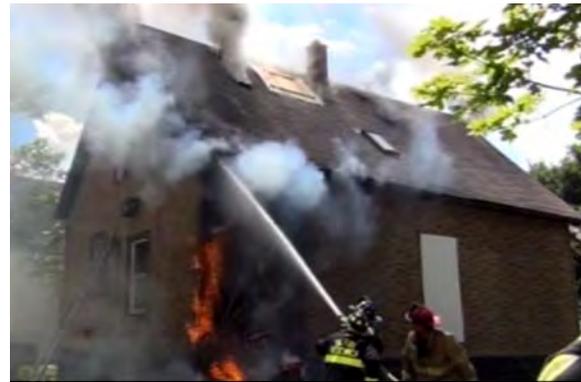
Figure 10. 23. Water applied to extinguish the exterior fire and flow into the eaves before interior operations were commenced.

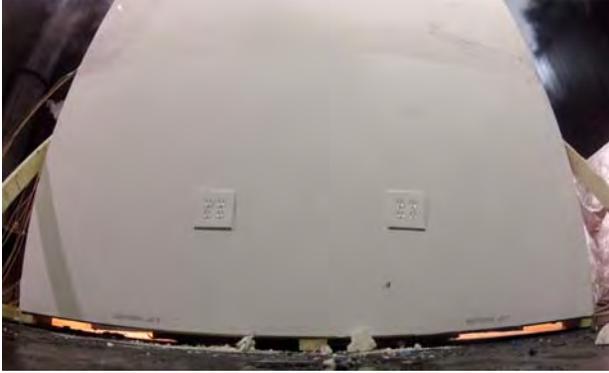
Figure 10. 24. Wall Experiment 13 before receptacle burn through

In all experiments where the gypsum wall board contained no penetrations, there were limited heat increases noted on the occupant side of the wall, and only slight discoloration of the drywall as an indication of thermal damage to that part of the system. Once electrical receptacles were included in the wall system, flames were noted on the interior side of the wall at the receptacle locations. This hazard is amplified when plastic receptacle boxes are used as they tend to melt away, providing a larger unrestricted opening for the fire to spread into the interior.

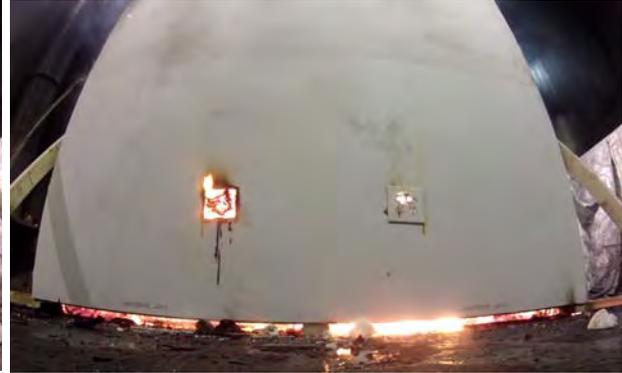
Figure 10. 25. Wall Experiment 13 after fire penetrates the receptacles

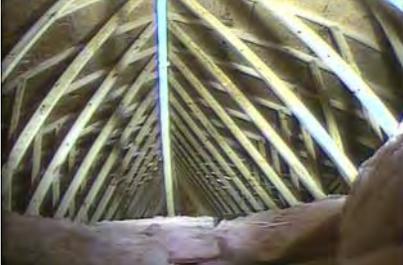
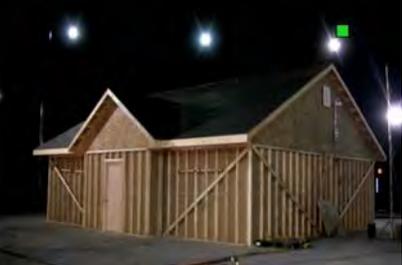
<p>Ignition</p>

Table 1. Attic fire growth to ventilation-limited in 5 minutes. Views from inside attic and front of structure.

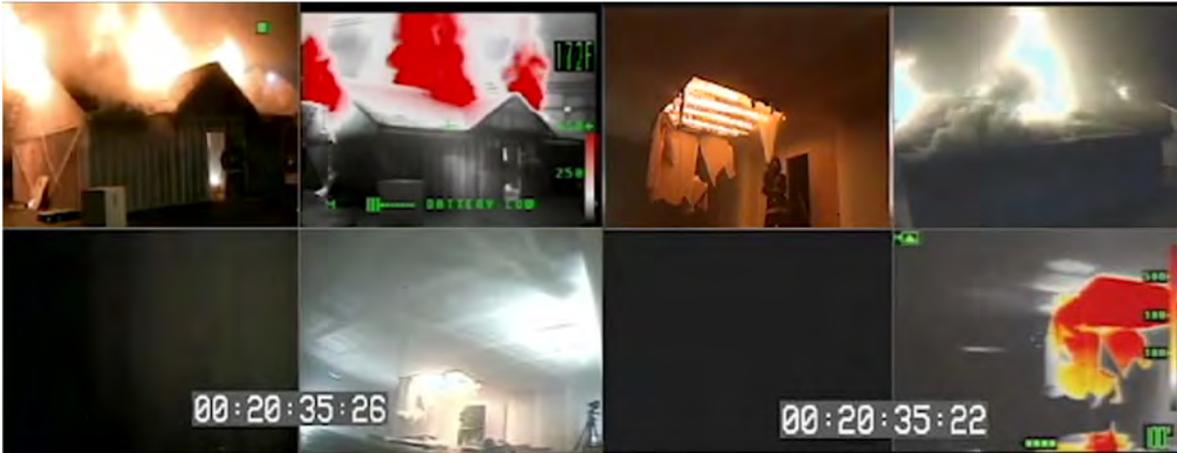
Figure 10. 26. Burning at interior ventilation opening in the ceiling during Attic Fire Experiment 2B

A small opening in the ceiling will supply some air to the attic fire, but without an outlet like open gables or a large hole in the roof, there is not a flow path through the attic sufficient enough to lead to rapid fire growth. There will be local mixing of fuel and air at the opening that will produce flaming, but this will only be able to exist at that opening and not throughout the attic because there is no increase in airflow throughout the attic (Figure 10. 26).

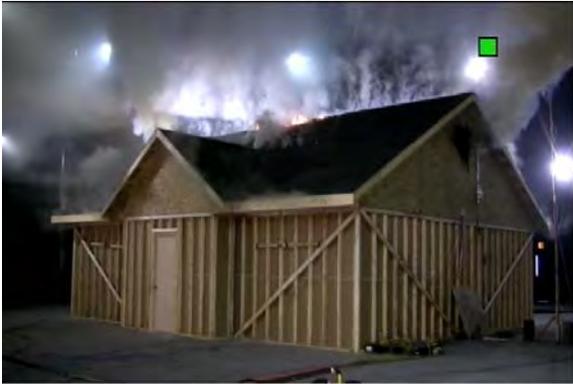
Figure 10. 29. Attic Fire Experiment 3 during peak temperatures in the attic with gable vents opened.

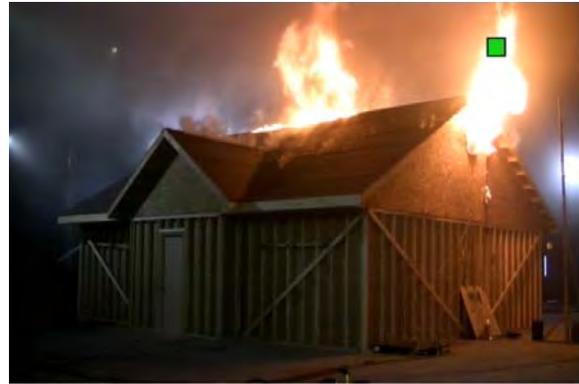
Figure 10. 30. Attic Fire Experiment 3 during peak temperatures in the attic with gable vents and roof vent opened.

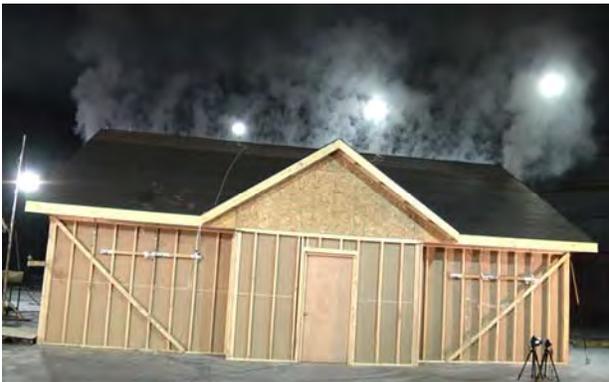
Figure 10.31. Smoke coming from the ridge vent.

Two common attic vents are mushroom vents and continuous ridge vents. Mushroom vents are commonly made of metal and allow fire gases to exit for the duration of the fire. They are installed on the slope of a peaked roof and the material, whether metal or plastic, flows away from the opening if the mushroom cap melts. Continuous ridge vents are nearly always made of plastic and allow fire gases to vent until they heat up. **As the vents heat, the plastic melts and collapses on the opening at the peak, creating a very effective seal.** The sealed opening (the equivalent of 10 ft² in these experiments) restricts air flow out of the attic, leading to a ventilation-limited fire. Thus, the true nature of the fire may be hidden during your size up. **Once the ridge vent seals, the eaves will act as both the source of air as well as the exhaust and you may notice a pulsing of smoke out of the eaves.** This is a sign that you have a ventilation-limited fire in the attic.

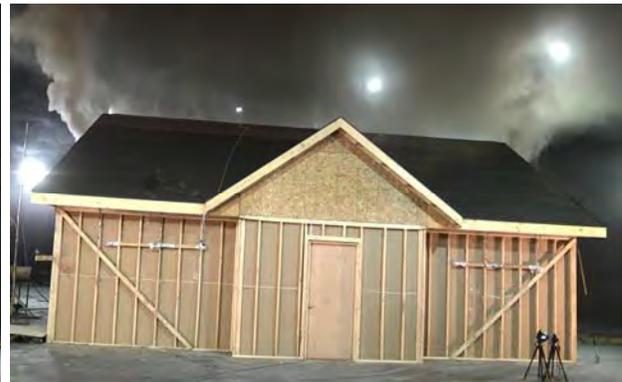
Figure 10.32. Ridge vent after sealing.

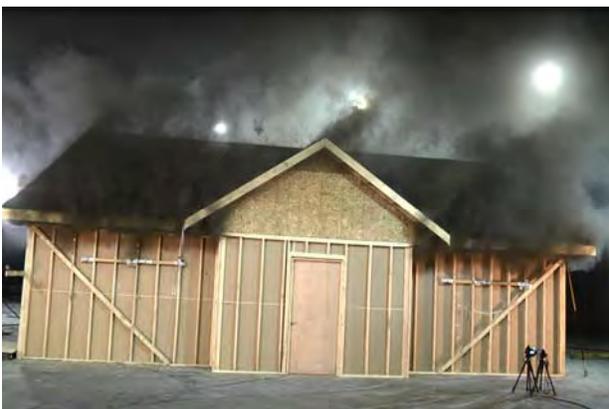
Figure 10.33. Smoke pulsing from eaves after ridge vent sealed.

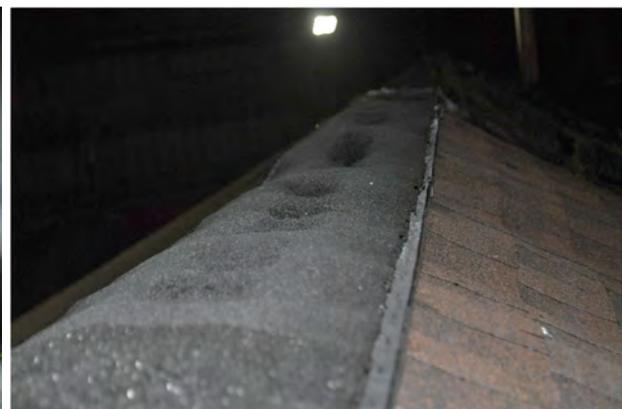
Figure 10.34. Ridge vent after experiment.

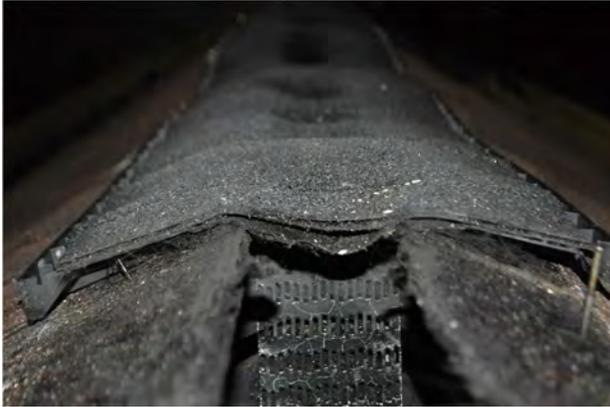
Figure 10. 35. Section cut away after experiment to see ridge vent seal.

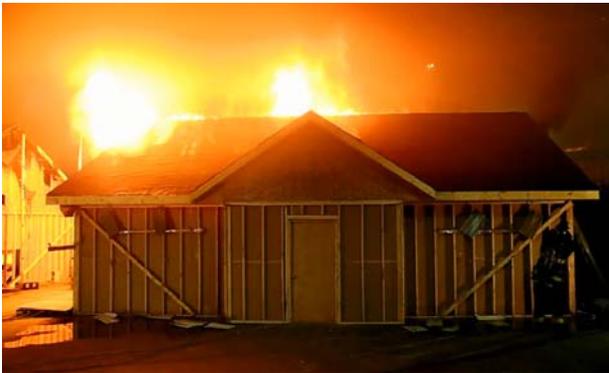
Figure 10.36. Conditions at the start of eave attack during Attic Experiment 4
