Study of Residential Attic Fire Mitigation Tactics and Exterior Fire Spread Hazards on Fire Fighter Safety

UL Firefighter Safety Research Institute

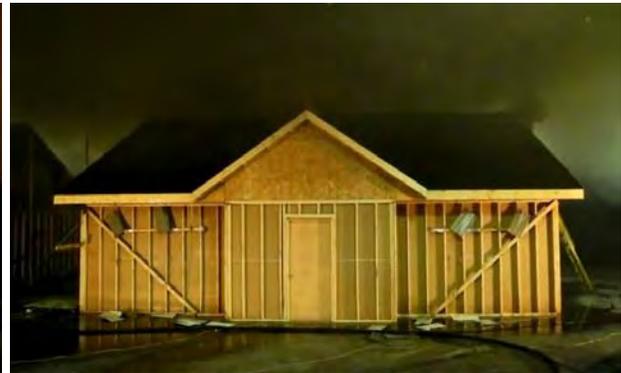
Figure 10.37. Conditions at the end of eave attack during Attic Experiment 4

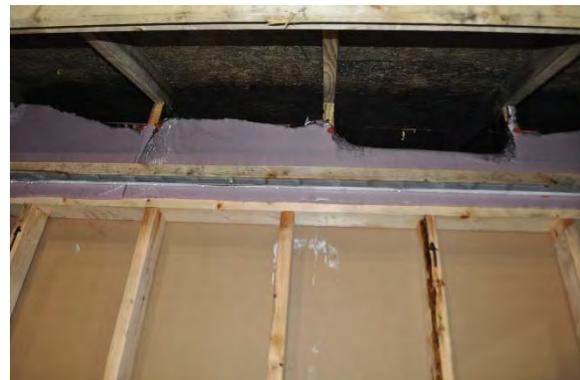
Figure 10.39. View into the eaves after Attic Fire Experiment 4

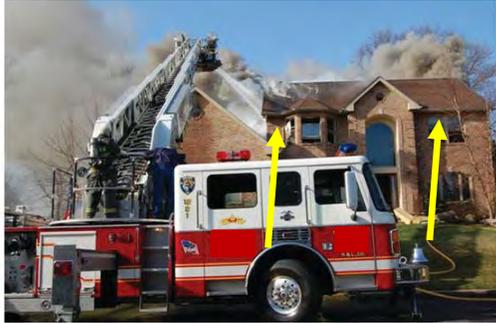
Figure 10. 41. Master stream flowing down into attic fire and not into eaves.

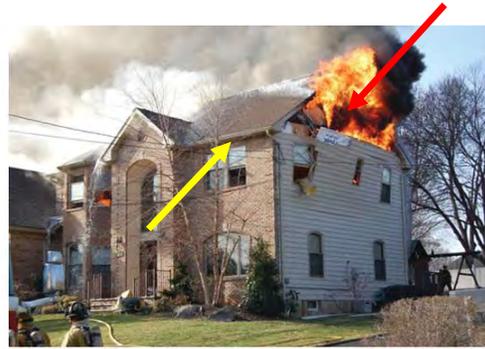
Figure 10. 42. Potential to flow water where fire is coming from instead of where fire is.

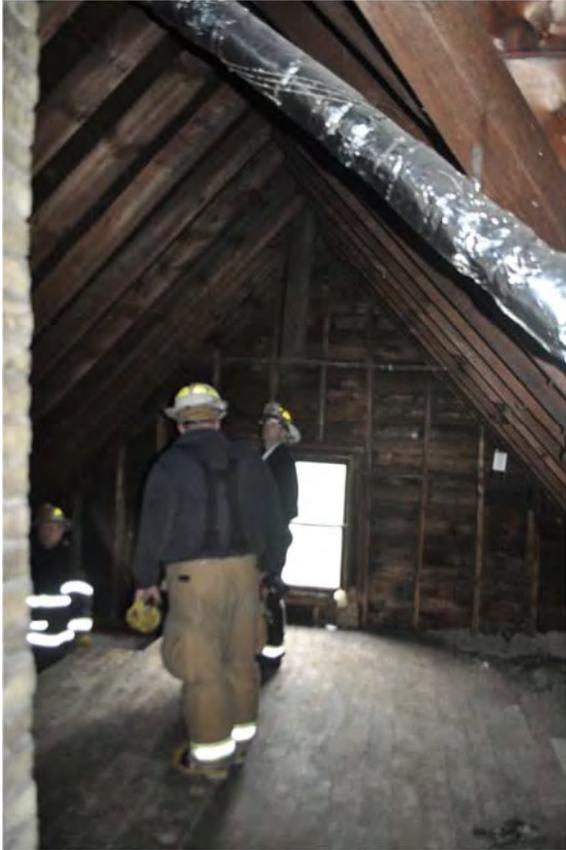
Figure 10. 43: North 9th St attic prior to finishing

Utilizing the upper $\frac{1}{2}$ story of a structure for living space creates unique compartmentation not found on lower levels of the building (Figure 10. 43 through Figure 10. 46). The interior living space is surrounded on three sides by void spaces separated only by drywall and possibly insulation (Figure 10. 47). **During a structure fire, it is possible for fire to enter void spaces and surround crews conducting interior operations** before they notice a rise in temperatures or see any signs of fire. Any penetration into the void space from the interior creates a flow path, allowing fire to spread into the interior and exposing the crews. This fire spread may not occur immediately following the opening of the wall or ceiling, as the void space fire is likely ventilation-limited. Thus, firefighters may breach a separation and then continue further into the structure. **Even though there is a delay between making the breach and the change in conditions, once initiated, the transition to untenable conditions in the area of operation occurs in seconds.** In Figure 10. 48 the temperatures at 3 feet in the attic increased 300 degrees in 5 seconds. When things go bad, they go bad fast.

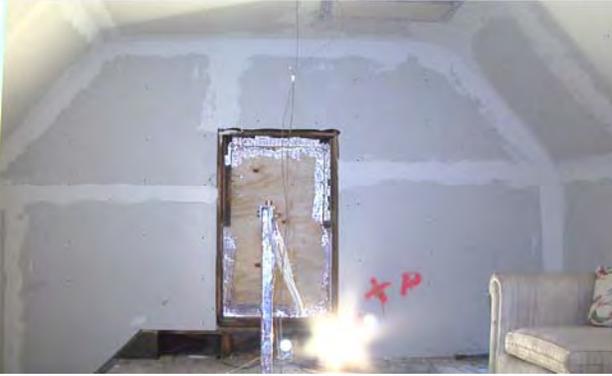
Figure 10. 44: North 9th St attic after finishing

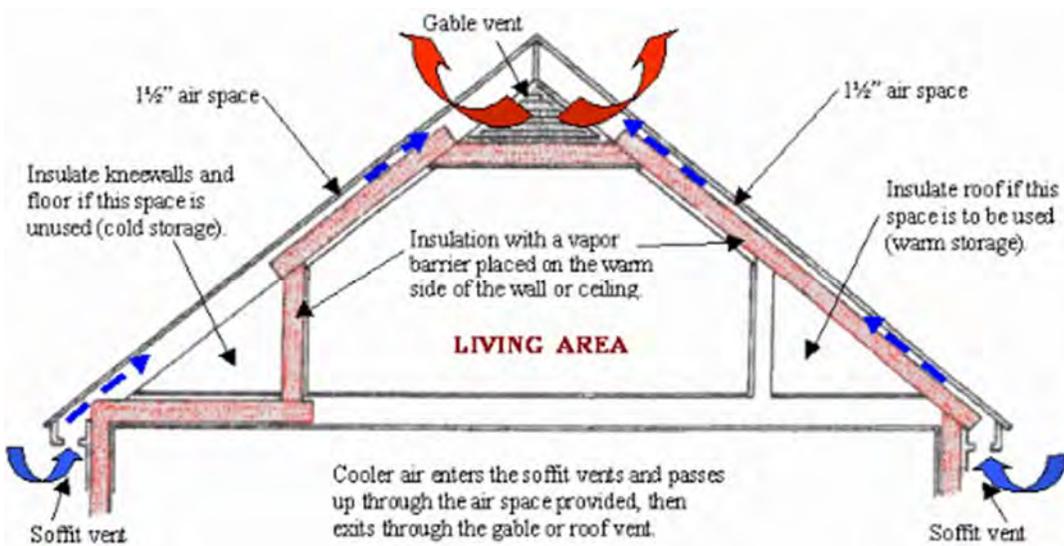
Figure 10. 47. Potential ventilation scenarios for 1/2 story structures.

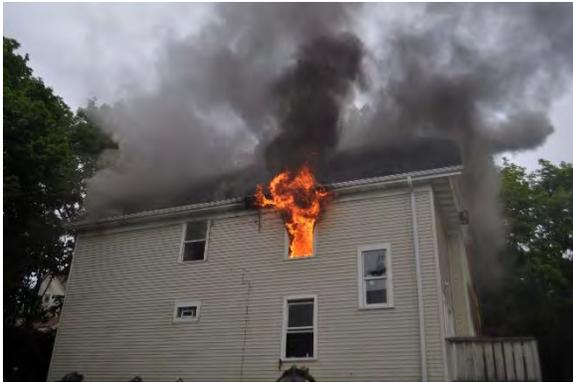
Figure 10. 50. Fire on second floor with extension into the knee wall. Water should be flowed to extinguish the room (from inside or outside) and then flow into the eaves (from inside or outside) before accessing the attic.

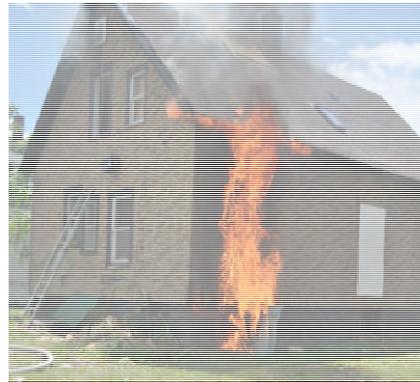
Figure 10. 51. Fire on outside with extension into the attic. Water should be flowed to extinguish the exterior fire and then flow into the eaves before accessing the attic.

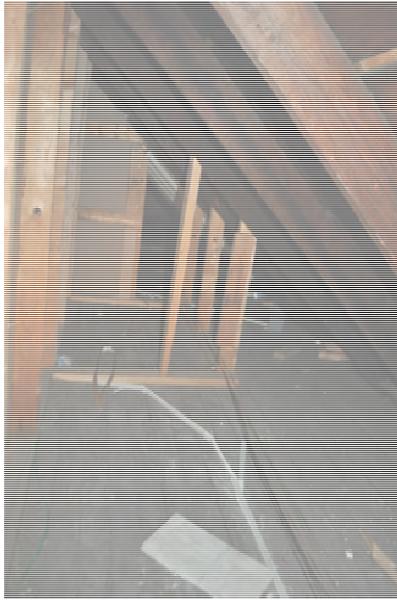
Figure 10. 52. Knee wall access showing difficulty of flowing water past the rafters.

Knee wall construction creates interconnected void spaces where the wooden structural members provide a relatively large surface area of exposed fuel along with air flow conducive to spreading fire (Figure 10. 52). The experiments demonstrated that getting effective stream reach and penetration inside a knee wall and other attic voids is hindered in much the same way as are streams applied into open attics through gable ends or from the floor below (Figure 10. 53). In both cases, structural members effectively broke up the stream before it could successfully penetrate the fire area. The experiments also demonstrated that water should initially be applied into the knee walls at multiple locations through small holes, in order to suppress the burning gases, before large sections of the knee wall are opened for complete extinguishment. This tactic will maximize the benefit of energy absorption through steam conversion while minimizing the spread of fire along the flow path created by the openings made for the nozzle. Once the gases are suppressed or cooled, focus on getting water into the rafter bays where air moving from the eave line to the peak will sustain and accelerate the remaining fire. This is similar to the concept that makes the eave attack successful; the sheathing is where the air and fuel come together most effectively, so this is where suppression efforts should be focused. Don't wait to see fire in a knee wall before you apply water to the void space or the surfaces. **Tests have demonstrated that the most effective way to get a handle on knee wall fires is to control the source fire, cool the gasses prior to making large breaches in the barrier, and then aggressively open the knee walls to complete extinguishment, focusing on wetting the underside of the roof decking.**

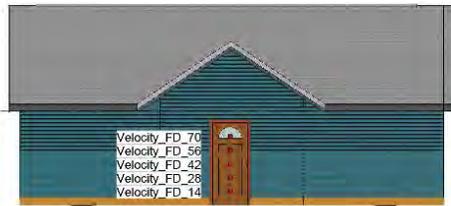
Velocity at Front Door Test 2 - Large Hole Unvented

Figure I. 22: Attic Experiment 2A Front Door Velocity

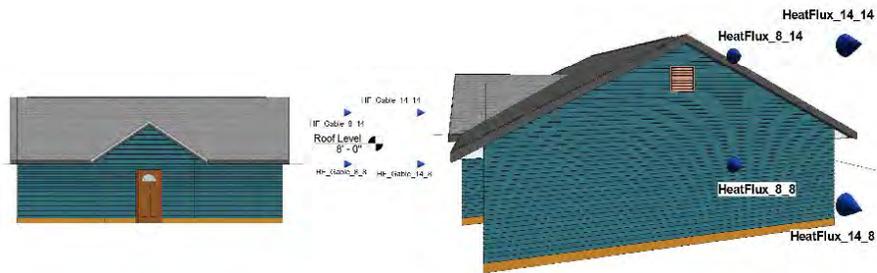
Heat Flux Gable End Test 2 - Large Hole Unvented

Figure I. 24: Attic Experiment 2A Gable Heat Flux

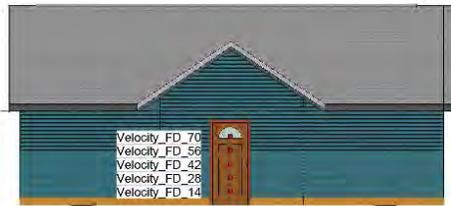
Velocity at Front Door Test 2B - Large Hole Below Vented

Figure I. 37: Attic Experiment 2B Door Velocity

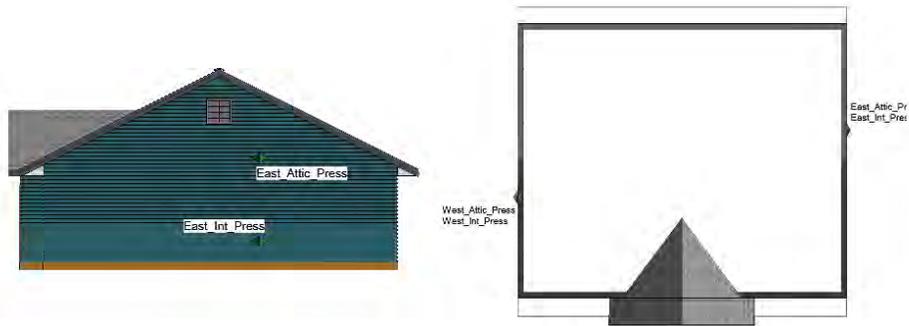
Attic Pressure Test 2B - Large Hole Below Vented

Figure I. 40: Attic Experiment 2B Attic Pressure
